TECHNICAL SERVICE BULLETIN

Rattle From The Right Loadspace Trim Panel At High Audio System Volumes

25-2493

Ford 2025 Bronco	B&O Audio System
----------------------------	------------------

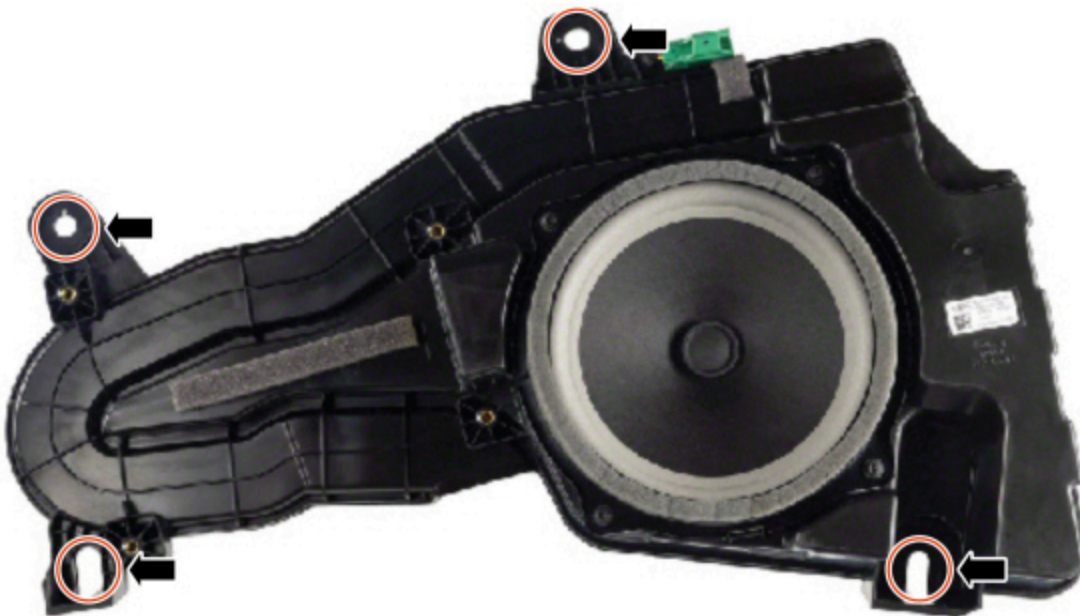
Figure 3

3. Remove the subwoofer and inspect the subwoofer for broken plastic mounting tabs. Refer to WSM, Section 415-00 Information and Entertainment System. (Figure 3)

- (1). Yes - replace the subwoofer. Proceed to Step 5.
- (2). No - proceed to Step 5.

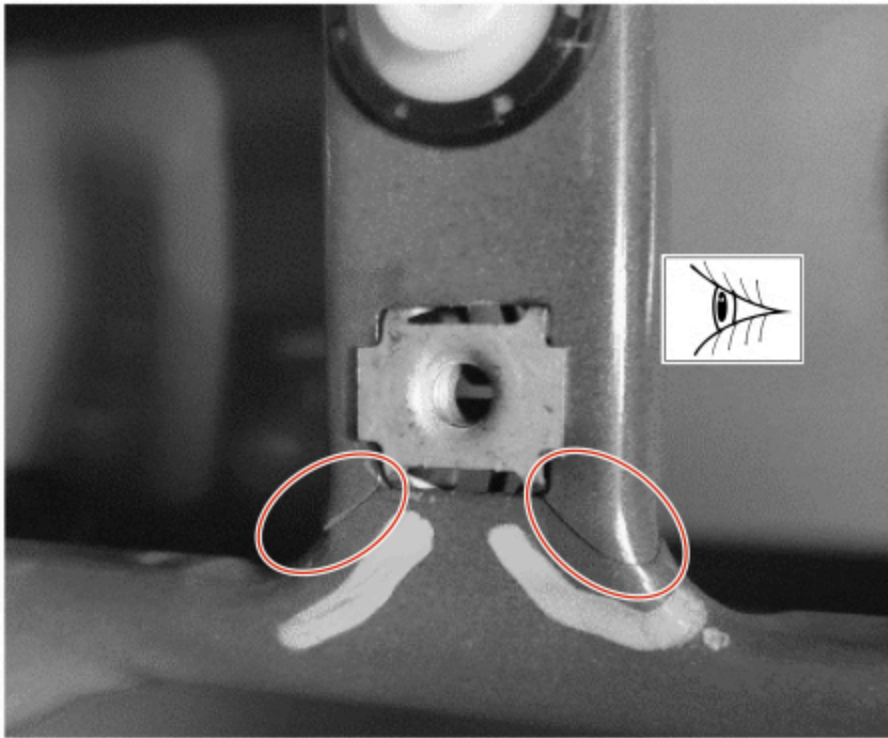
Figure 4

5. Inspect the top mounting point of the subwoofer for a crack in the metal as seen in Figure 4. Is the metal mounting point cracked? (Figures 4-5)

(1). Yes - proceed to Step 6 for the temporary repair and inform the customer that they will need to return at a later date when the permanent fix is available.

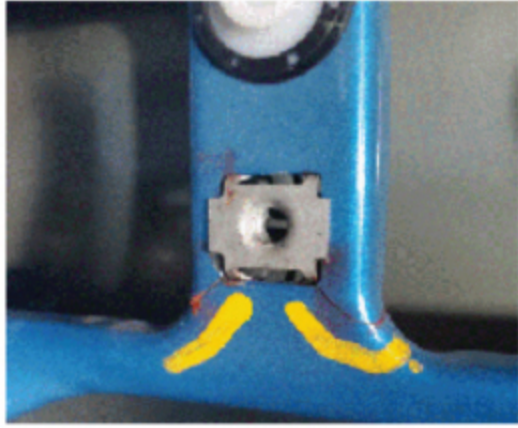
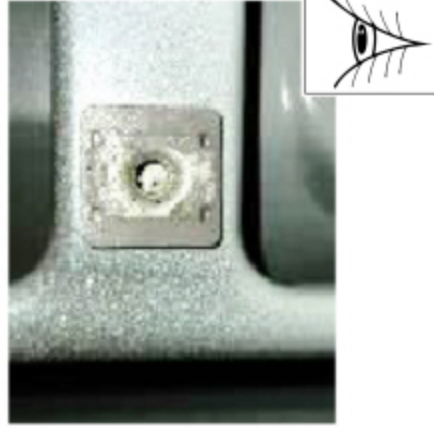
Figure 7

7. Is the retaining nut in the metal bracket rubber? (Figure 7)

- (1). Yes - proceed to Step 8.
 - (2). No - replace the retaining nut with updated rubber version.
- 8.** Reassemble the vehicle.
- 9.** After the vehicle is reassembled, operate the audio system at high audio levels. Does the loadspace trim panel still exhibit additional rattles?
- (1). Yes - address the rattle by adding foam tape where necessary to limit loadspace panel vibration.
 - (2). No - proceed to Step 10.
- 10.** Reprogram the DSP module using the latest software level of the FDRS scan tool.
