Model series 243 - Noise during load change on transmission mount

Topic number	LI22.10-P-079966
Version	1
Function group	22.10 - Engine mounts, engine brackets
Date	10/29/25
Validity	Model 243
Reason for change

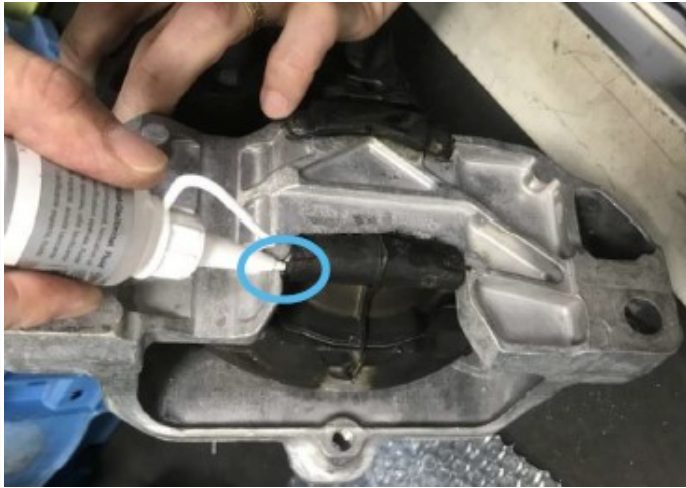
Tolerances in front left bearing of major assembly carrier (transmission mount) A 243 240 25 00 can cause the noise complaint.

Remove affected bearing and coat with anti-seize agent A 000 989 36 60 (Krytox), as specified in pictures, and install bearing again.

Attachments	
File	Description
Getriebelager A2432402500 Krytox Applikation 2.jpg	Apply Krytox between suspension spring steel sheet (black) and aluminum housing, all four areas must be fully coated
