HRV Short Fiberglass

<b>Bulletin Type:</b>	TSB	<b>Publication Date:</b>	October 2025
<b>Bulletin #(s):</b>	25-020	<b>Make(s):</b>	Heartland
<b>Job Code(s):</b>	98.01.26	<b>Model(s):</b>	Corterra TT, Mallard, Prowler, Eddie Bauer TT
<b>Flat Rate(s):</b>	8.0HR	<b>Model Year(s):</b>	2025

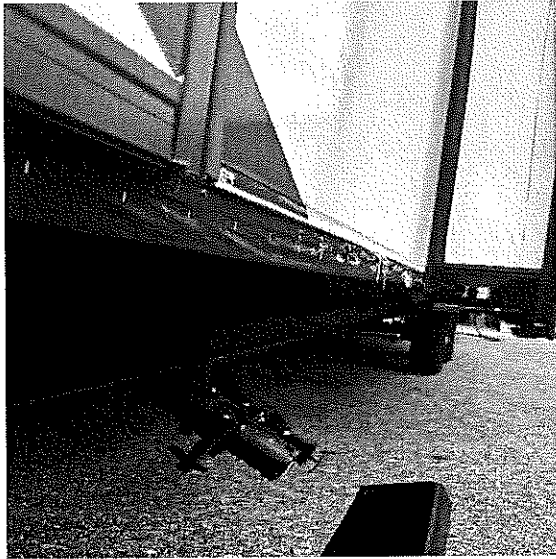
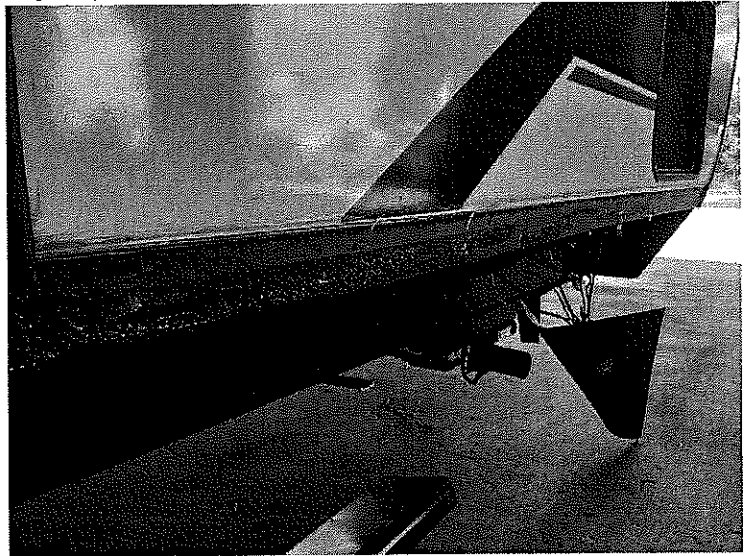
<b>Incident:</b>	Short Fiberglass walls need additional sealing.
<b>Affected Units:</b>	Certain 2025 Heartland Mallard, Prowler, Eddie Bauer Travel Trailer and Corterra Travel Trailers.
<b>Parts Kit: 0462569</b>	Parts Kit #: 0462569
	Part Kit Contents: 8 x 8FT J Wrap Trim P/N 0304979 – metal exterior - .024 x 4 x 192 belt rail Black (Approx per unit length) 6 x Quad – Sealant OSI Quad – 10.2 oz. Black – 028756 – P/N -0267445 1 x 3M Tape – All weather Flashing – 3” X 75’ – 3M 877 – Tan P/N 0109499 3 x Butyl – Tape – Butyl - .125” x 1.50” x 30’ Grey – General P/N 0120317
<b>Misc. Tools &amp; Supplies:</b>	Screw Gun, caulk gun
<b>Parts Return Information:</b>	N/A

Photos of units with short fiberglass positioned above the floor decking

1. Submit pre-authorization to Heartland RV with photos of the short fiberglass.
2. Remove all skirt metal for both sides of the unit.
3. Remove all belt rail from the unit, this will be replaced with new belt rail.
4. Once the the belt rail is removed, add quad seal (P/N 0267445) to the joint where the sidewall meets the decking. Make sure to tool out the sealant and verify that the sealant covers the joint.
5. Add 3M flashing tape (P/N 0109499). Install the 3M flashing tape approximately 1 inch up above the bottom of the fiberglass and then down below the floor decking, making sure to cover the seam.
6. Install the new belt rail making sure to install butyl tape behind before installing.
7. Seal the belt rail with caulk
