Technical Service Bulletin (TSB)
Radio USB Software Update to U40.20

REFERENCE:	TSB: 08-349-25 GROUP: 08 - Electrical	Date:	October 22, 2025	REVISION:	–
VEHICLES AFFECTED:	2026 (RU) Chrysler Pacifica This bulletin applies to vehicles built on or before September 05, 2025 (MDH 0905XX) equipped with: <ul style="list-style-type: none"> • Uconnect 5 Nav w/10.1" Display (Sales Code UBN). • Uconnect 5 Nav w/10.1" Display (Sales Code UEN). • Uconnect 5 w/10.1" Display (Sales Code UBG). • Uconnect 5 w/10.1" Display (Sales Code UEG). 			MARKET APPLICABILITY: <input checked="" type="checkbox"/> NA <input type="checkbox"/> MEA <input type="checkbox"/> SA <input type="checkbox"/> IAP <input type="checkbox"/> EE <input type="checkbox"/> CH NOTE: This bulletin applies to North America markets.	
CUSTOMER SYMPTOM:	The customer may comment on one or more of the following: <ul style="list-style-type: none"> • Compass is not working. • Navigation screen intermittently freezes. • Black bar appears over the media screen as if the radio is in night mode (Rearview Camera (RVC) Functions Normally).

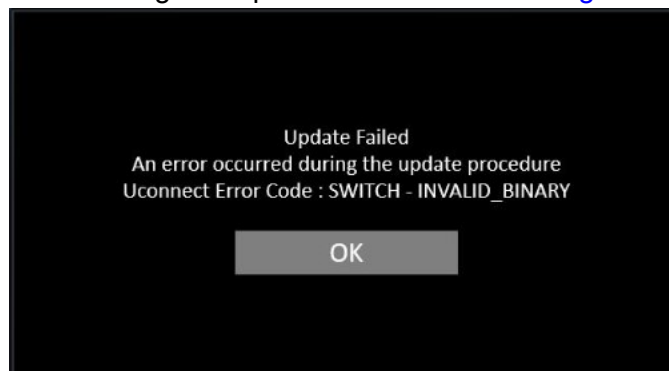
Fig. 5

Error Message

16. Sometimes the radio will display an error pop up “SWITCH- INVALID_BINARY “ after successful radio update. Please ignore this error message and press “OK” to continue [Fig. 5](#).
