REFERENCE:	TSB: 18-031-25 REV. C GROUP: 18 - Vehicle Performance	Date:	October 22, 2025	REVISION:	18-031-25 REV. B
VEHICLES AFFECTED:	2025 (DT) RAM 1500 Pickup This bulletin applies to vehicles equipped with a 3.0L I6 Hurricane SO Twin Turbo ESS (Sales Code EFH).			MARKET APPLICABILITY: <input checked="" type="checkbox"/> NA <input checked="" type="checkbox"/> MEA <input checked="" type="checkbox"/> SA <input checked="" type="checkbox"/> IAP <input checked="" type="checkbox"/> EE <input checked="" type="checkbox"/> CH NOTE: This bulletin applies to the North America, South America, Enlarged Europe, Middle East & Africa, India & Asia Pacific, and China markets.	
CUSTOMER SYMPTOM:	<p>Customers must experience a Malfunction Indicator Lamp (MIL) illumination and the vehicle must exhibit/set one or more of the following Diagnostic Trouble Codes (DTCs):</p> <ul style="list-style-type: none"> ● **P06DD-00 - Engine Oil Pressure Control Circuit Performance/Stuck Off. ● P0073-00 - Ambient Air Temperature Sensor Circuit "A" High. ● P0071-00 - Ambient Air Temperature Sensor Performance. ● P2C90-00 - Crankcase Ventilation System - Hose "A" Disconnected. ● P1CEA-00 - Boost Side EVAP Purge System

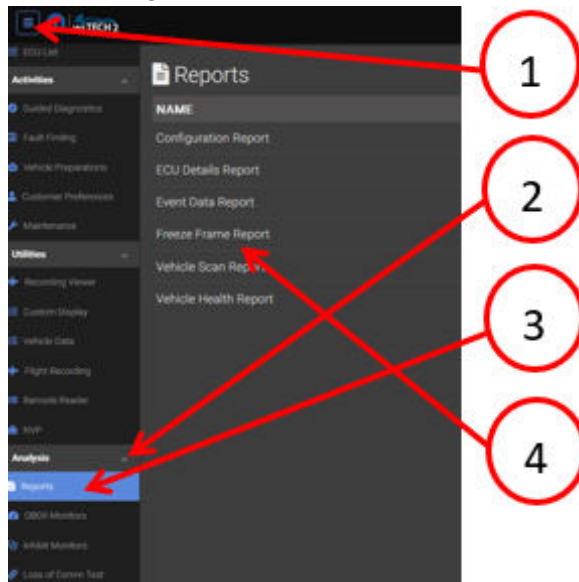
Fig. 1
Navigate To Freeze Frame Report

4. In the wiTECH tool, select the hamburger icon in the upper left corner Fig. 1.

5. Navigate down to Analysis on the left column and select the drop down arrow Fig. 1.

6. Select Reports Fig. 1.

7. Select Freeze Frame Report Fig. 1.

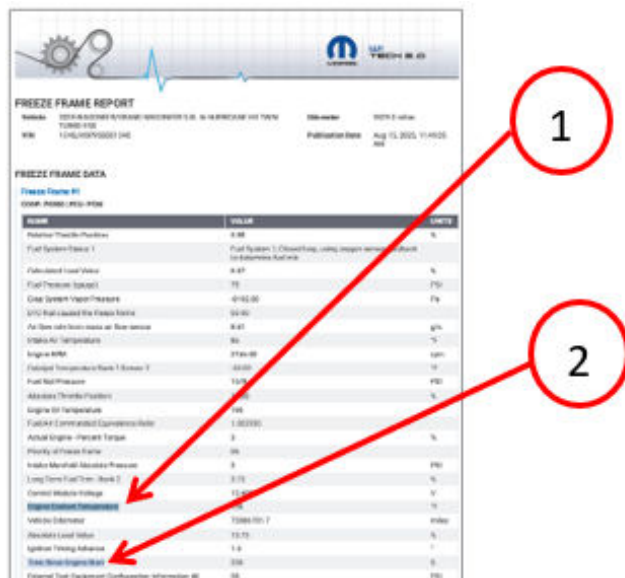
Fig. 2
Freeze Frame Report

8. To confirm the cold start catalyst heating, use wiTech Freeze Frame data and confirm that DTCs P0300-00, P0301-00, P0302-00, P0303-00, P0304-00, P0305-00 and/or P0306-00 was set under following condition:

- Engine coolant temperature °F less than 50 °C (122 °F) Fig. 2.
- Time since engine start is less than 30 seconds Fig. 2.
