Technical Service Bulletin (TSB)
Multiple Systems Repair Bundle Campaign

REFERENCE:	TSB: 23-019-25 REV. B GROUP: 23 - Body	Date:	October 25, 2025	REVISION:	23-019-25 REV. A
VEHICLES AFFECTED:	2024 - 2025 (JL) Jeep Wrangler This bulletin applies to vehicles built on or after July 01, 2024 (MDH 0701XX) and on or before February 28, 2025 (MDH 0228XX).			MARKET APPLICABILITY: <input type="checkbox"/> NA <input type="checkbox"/> MEA <input type="checkbox"/> SA <input checked="" type="checkbox"/> IAP <input type="checkbox"/> EE <input type="checkbox"/> CH NOTE: **This bulletin applies to India & Asia Pacific markets.**	
CUSTOMER SYMPTOM:	<p>Customers must experience a Malfunction Indicator Lamp (MIL) illumination and the vehicle must exhibit/set one or more of the following Diagnostic Trouble Codes (DTCs):</p> <ul style="list-style-type: none"> ● P0133 - O2 Sensor 1/1 Slow Response. ● P2251 - O2 Sensor 1/1 Negative Current Control Circuit/Open. ● P0131 - O2 Sensor 1/1 Circuit Low. ● P2626 - O2 Sensor 1/1 Pump Cell Current Trim Circuit/Open. ● P0607 - ECU Internal Performance. ● C140A - Transfer Case Motor Control. ● P02EE - Cylinder 1 injector Circuit Performance. ● P02EF - Cylinder 2 i

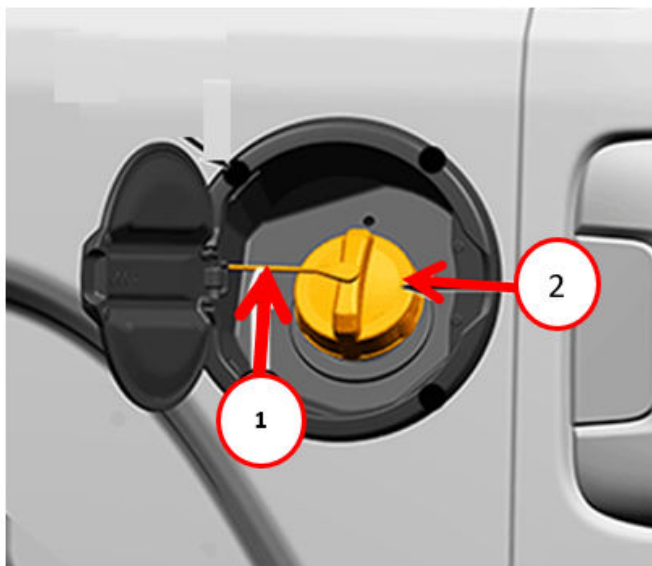
Fig. 1
Fuel Cap Replacement

13. Is the fuel cap tether strap broken?

14. Remove the fuel cap tether strap fastener securing the strap to the fuel door housing [Fig. 1](#).

15. Replace the fuel cap tether strap and the fuel cap assembly.
