STAR ONLINE PUBLICATION

Case Number: S2508000088

Symptom/Vehicle Issue: Vehicle Complaints After a Recent Firmware Over The Air (FOTA) Update for the Telematics Box Module (TBM)

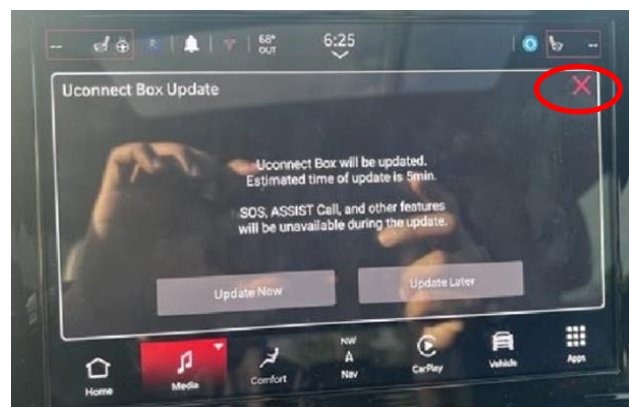
For vehicles that have not completed the Uconnect Box update and have the below radio display, if the owner chooses not to install the update have the owner select the red X.

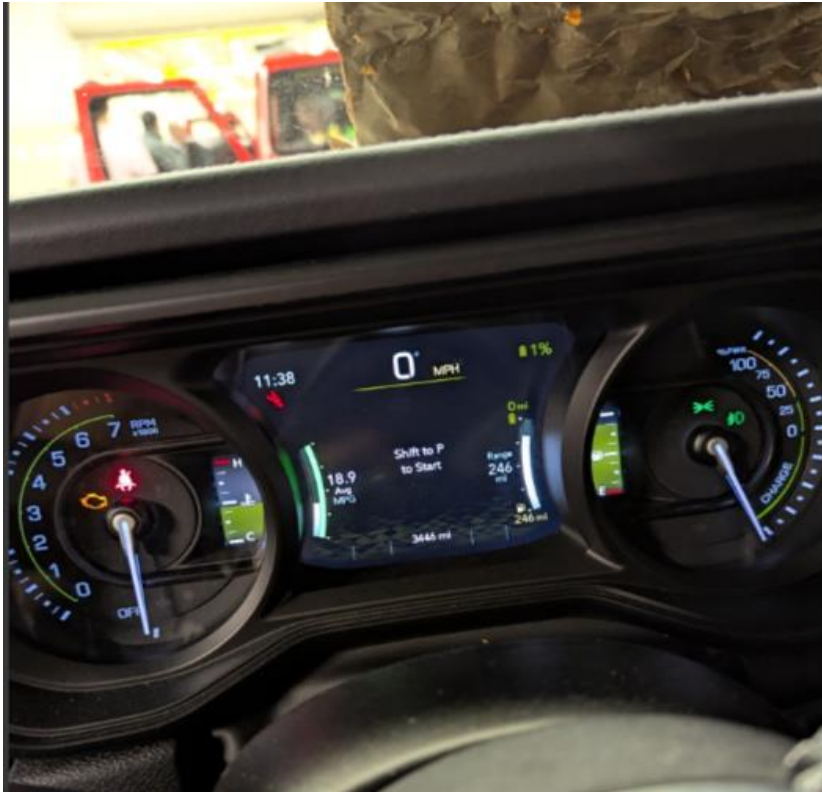
Vehicle message while in drive: Shift to Park

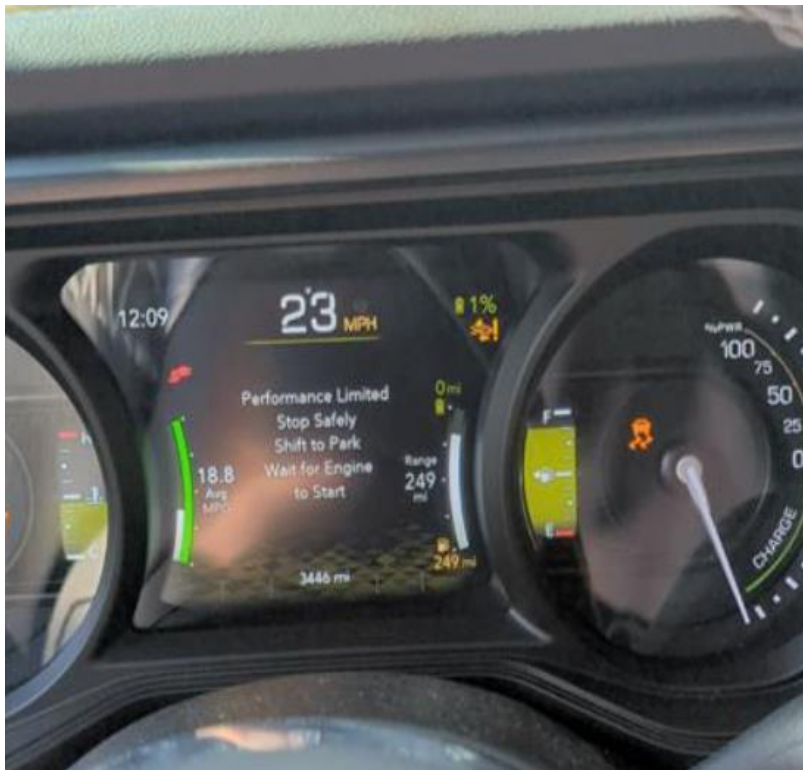
Vehicle message that appears while driving: Performance limited shift in park

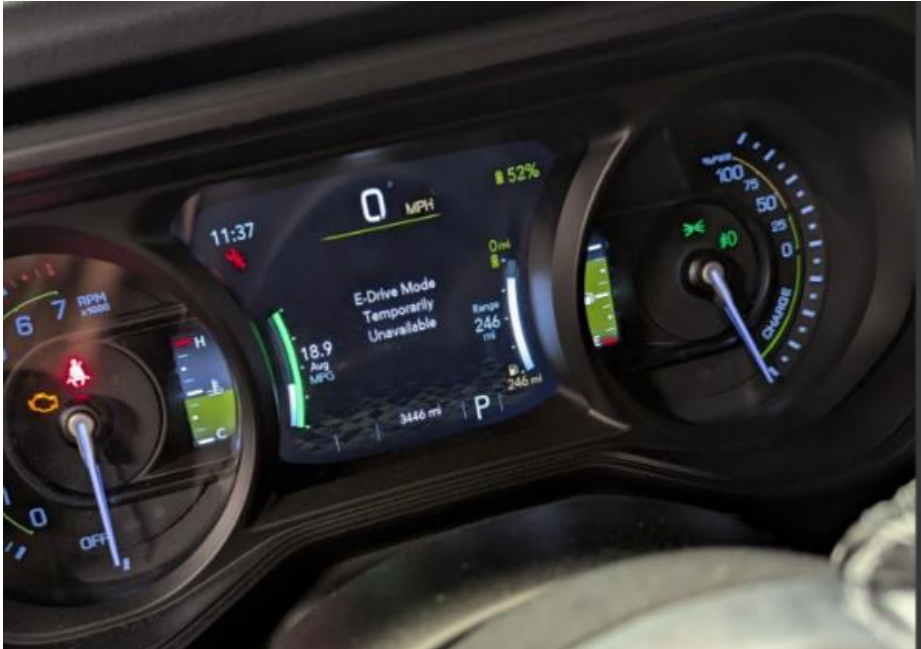
Vehicle message while in park.
