Technical Service Bulletin (TSB)
Brake Warning Lamp On

REFERENCE:	TSB: 08-275-25 REV. B GROUP: 08 - Electrical	Date:	October 18, 2025	REVISION:	08-275-25 REV. A
VEHICLES AFFECTED:	2025 - 2026 (B1) Jeep Renegade 2025 - 2026 (H1) Jeep Commander 2025 - 2026 (M1) Jeep Compass 2025 - 2026 (N4) RAM Rampage This bulletin applies to vehicles built on or after **March 27, 2025 (MDH 0327XX)** and on or before September 26, 2025 (MDH 0926XX) .			MARKET APPLICABILITY: <input type="checkbox"/> NA <input type="checkbox"/> MEA <input checked="" type="checkbox"/> SA <input type="checkbox"/> IAP <input type="checkbox"/> EE <input type="checkbox"/> CH NOTE: This bulletin applies to the South America market.	
CUSTOMER SYMPTOM:	Customers must experience a Malfunction Indicator Lamp (MIL) illumination and the vehicle must exhibit/set the following Diagnostic Trouble Code (DTC): <ul style="list-style-type: none"> • C1215-86 - Brake Light Switch - Signal Invalid. Customers may comment on one or more of the following: <ul style="list-style-type: none"> • "ABS" warning displays on the Instrument Panel Cluster (IPC). • Excessive force required when depressing the brake pedal when trying to start the engine

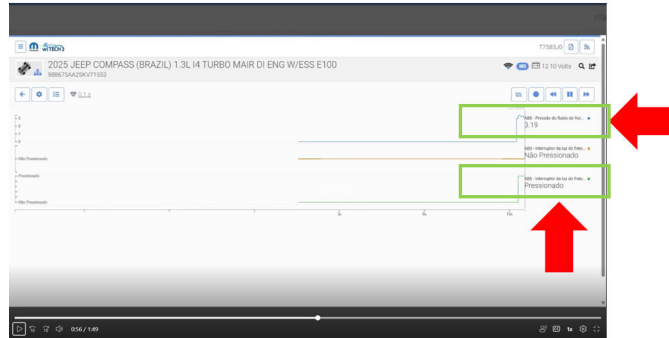
Fig. 6

8. Monitor through the graphs the behavior by slowly stepping on the brake pedal, when activating the first stage of the switch the pressure should be up to 4 Bar (H1/ M1 / N4) and 6 Bar (B1) [Fig. 6](#).

Monitor Pressure Readings

9. Is the Bar pressure greater than 4 Bar (H1/ M1 / N4) and 6 Bar (B1) [Fig. 6](#)?
 - a. YES>>> Proceed To Step 10.
 - b. NO>>> This bulletin has been completed. Use Inspection LOP (08-80-84-90) to close the active RSU.
10. Disconnect the negative battery terminal.

11. Remove the brake pedal switch from its seat by turning it counterclockwise, until it comes off the brake pedal.

12. Position the switch on its seat on the pedal and turn it clockwise, until it is completely fixed (you will notice the click of the lock).
13. Connect the negative battery terminal.
14. Clear DTCs.
15. Start the engine, place the transmission in Park "P" position and deactivate the parking brake.
16. Check the residual brake pressure again [Fig. 7](#) by monitoring through the graphs the behavior by slowly stepping on the brake pedal, when activating the first stage of the switch the pressure should be less than or equal to 4 Bar (H1/ M1 / N4) and 6 Bar (B1) or less than or equal to 6 Bar (Renegade).

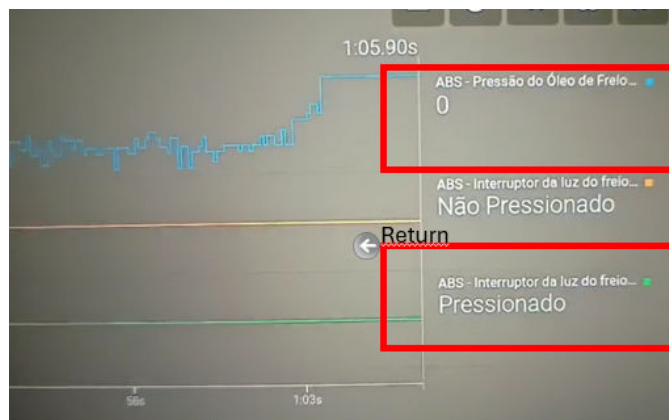
Fig. 7

Pressure Readings
