Model Series 463 AMG: Active Distance Assist and  
Active Brake Assist IC Message and DTC U0416FE

| Topic number | LI54.71-P-078112 |
| Function group | 54.71 - Camera and radar-assisted assistance systems |
| Validity | 463 AMG |

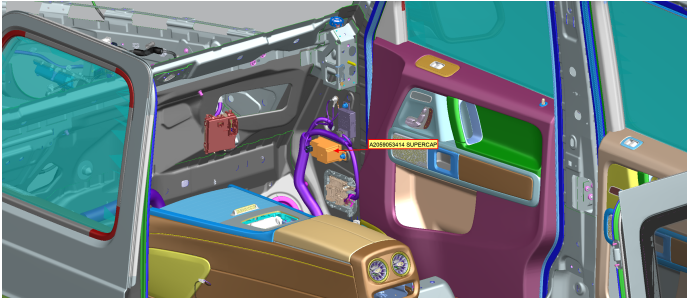
| File | Description |
|---|---|
| <a href="#">Steuergerät+SUPERCAP+Lage+im+Fzg+weit..png</a><br> | Picture 1 - Connection from Supercap to Drive Unit |

Missing wire between Drive Unit (N145) and Supercap (C8).

- Using a red/white cable with cross-section 0.35 mm² and overall length of approximately 2m.
- Connect Drive Unit (N145) plug A pin 18 to the 3-pin plug of the Supercap (C8) terminal 15 pin 2. Reference the new wire routing location as shown by the red line in "Picture 1 - Connection from Supercap to Drive Unit".
- The new wire should be added to the existing wiring harness as shown by the red line "Picture 1 - Connection from Supercap to Drive Unit".
- Z-Splice is the preferred method using A 000 982 91 10 for the Supercap (C8) connection.
