Check engine light illuminated, Fault P012800. M274 Hybrid

Topic number	LI20.10-P-074508
Version	3
Function group	20.10 - Coolant pump, coolant thermostat
Date	10/28/25
Validity	Models 205 and 253 plug-in hybrid
Reason for change	Software available for 2020 GLC350e 253.953

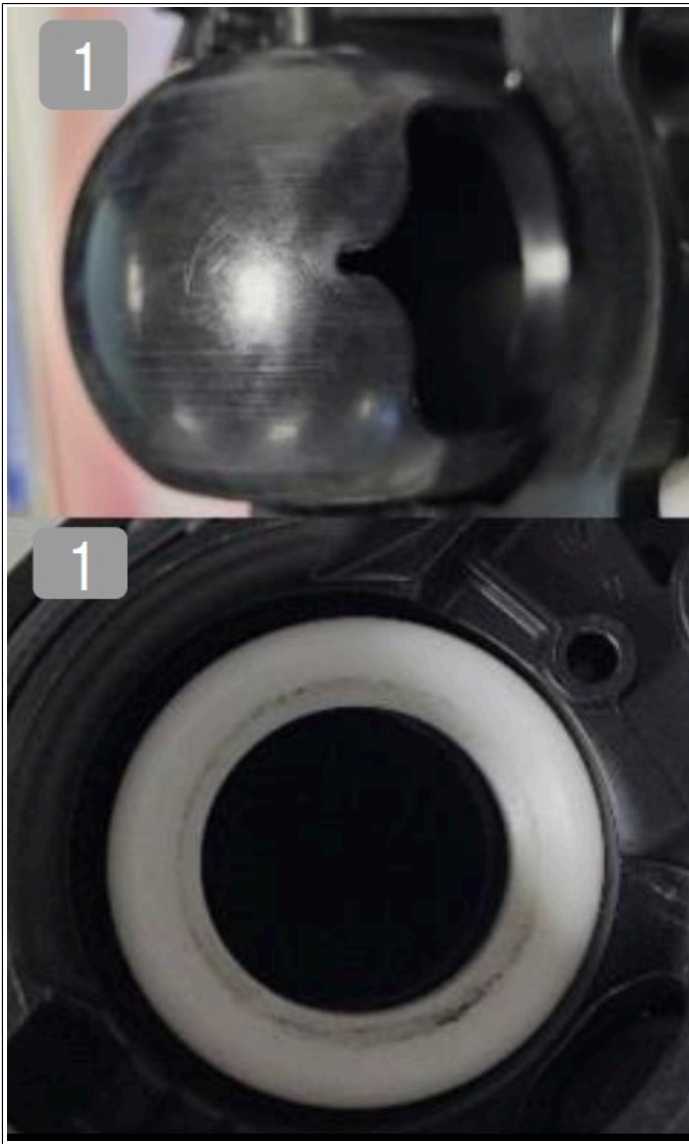
Attachments	
File	Description
Thermostat ball NOK.jpg

Fault code stored P012800-The coolant temperature is below the coolant thermostat specified temperature.

- 1- Update HVAC with latest software
- 2- Perform guided test for fault P012800 and performed repairs per XENTRY diagnosis.
- If thermostat requires replacement flush cooling circuit in both directions with 150L of water.
