GROUP	MODEL
ELE	2025MY EV9 (MV1a)
NUMBER	DATE
383 (Rev 1, 10/24/2025)	April 2025

## TECHNICAL SERVICE BULLETIN

### SERVICE ACTION: SUNROOF LOGIC IMPROVEMENT & SUNROOF/REAR ROLLER BLIND INITIALIZATION (SA615)

This issue number is SA615.

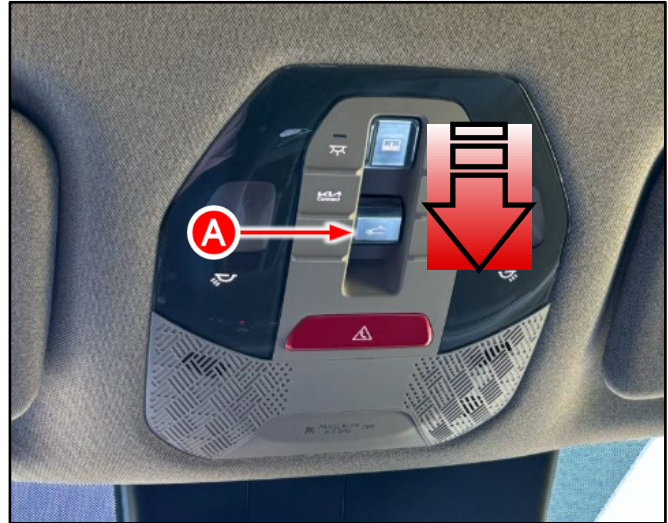
This bulletin provides information to upgrade the Roof Control Module 'RCM' system software on certain 2025MY EV9 (MV1a) vehicles produced from May 17, 2024 through June 6, 2025, which may exhibit an inoperative sunroof or rear roller blind due to a loss of motor position data during states of 'sleep' or 'low' power. To rectify this concern, follow the procedure outlined in this publication to apply the improved logic to the 'RCM' module and perform the sunroof and rear roller blind reinitialization. Refer to [SST081](#) for software upgrade instructions using Kia Diagnostic System (KDS) tablet and VCI-II and confirm the Upgrade Event Number/Name, ROM ID Information, and Manual Mode passwords (if applicable) on the applicable vehicle.

1. Turn the ignition 'ON'.
2. Close the sunroof completely (if opened).
3. Lightly press (half click) the sunroof switch (A) forward until the sunroof motor moves once, then release the sunroof switch.
4. Press (full click) and hold the sunroof switch (A) forward until the sunroof glass opens and closes.
5. Release the sunroof switch (A).
6. Confirm normal operation of the sunroof.
7. Proceed to the 'Rear Roller Blind Initialization Procedure' below.

**DO NOT** release the sunroof switch (A) until the operation has completed. If the switch is released prematurely, the initialization procedure will need to be restarted.
