Grecale (MHEV) Momentary Coolant Leak

DATE: October 15, 2025

MODELS INVOLVED: Grecale MHEV (M182) (All MY).

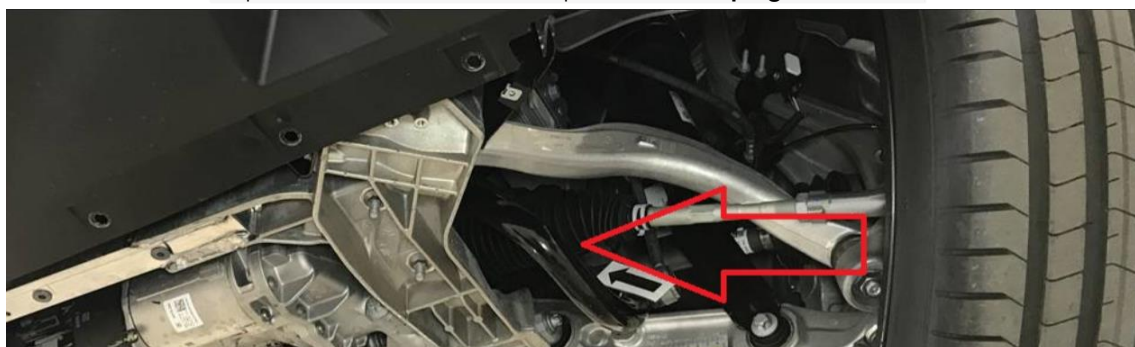
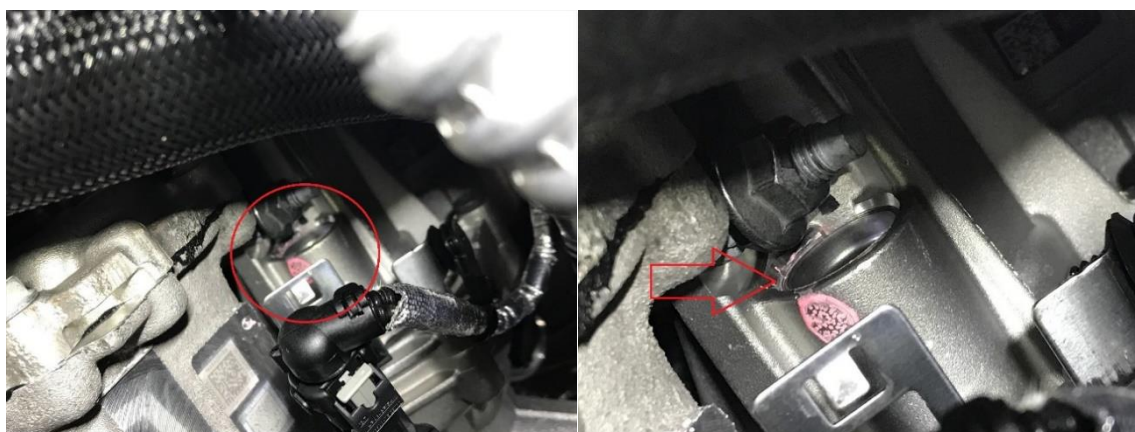
The weeper chamber is designed to collect a small amount of coolant (less than 3ml/hour) that may pass through the dynamic seal of the water pump.

- This is normal during the first hours of engine operation.
- It may leave a red stain or shadow around the chamber.
- This process allows the seal's mating surfaces to self-adapt and helps drain vapor condensation.
- This momentary leakage does not affect pump performance and does not require replacement.

Refer to the pictures below for an example of **the weeping chamber**:

- If coolant **continues to drip** after the test:
This may indicate that debris is trapped in the dynamic seal or the seal is not functioning properly.
 - Replace the water pump (possible permanent damage to the dynamic seal).
 - Take **clear photos and a video** of the leak and attach them to your warranty claim.
- If the leak **stops**:
 - No further action is needed.
 - Clean all accessible surfaces around the water pump (without removing other components).
