MAS004900 RU 25-30

Rapid Update 808 Maserati Grecale – EPS cable clip check

VEHICLES INVOLVED: Grecale (M182) MY24 MY25

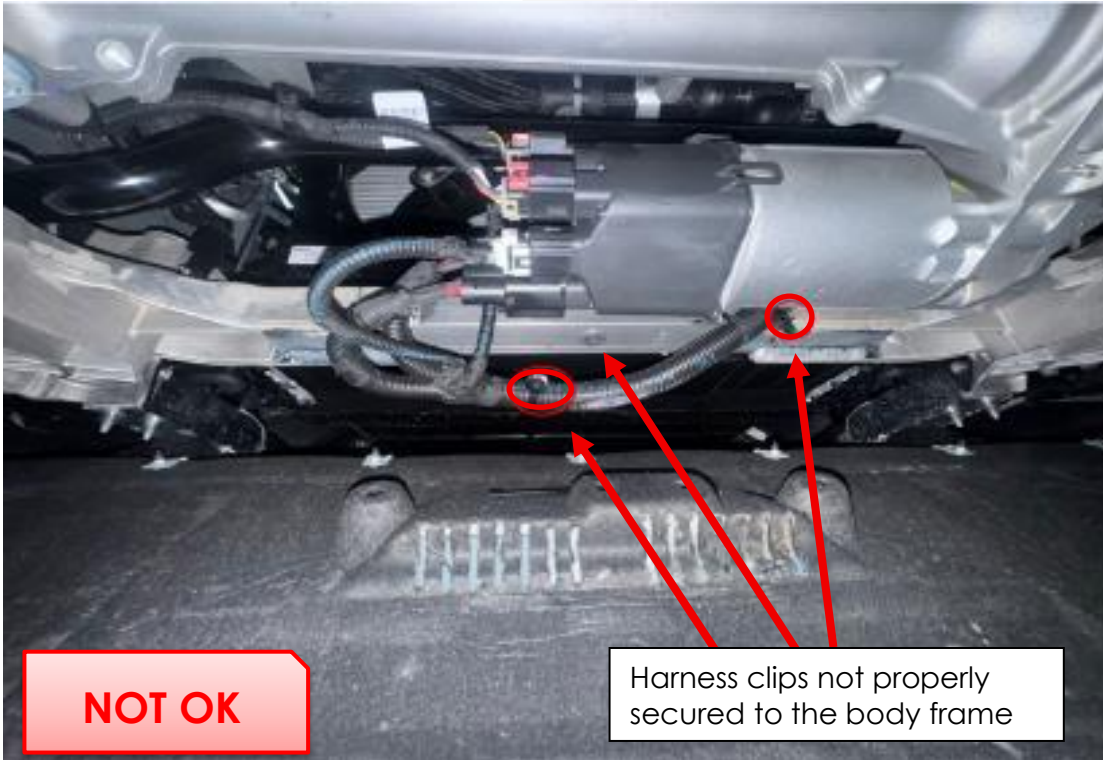
1. Always check ModisCS+ to see if the vehicle is involved in this action and if it has not been previously performed.
2. Raise the car onto the lift and remove the engine cover following the instructions provided.
 - a. **9.14.076 UNDER-ENGINE GUARD - Removal/refitting or replacement**
3. Once you have viewed the compartment under the engine, locate the EPS wiring harness and check the wiring layout, paying attention to the position of the clips that secure the wiring to the body.
4. If all the **clips are correctly secured and clipped in** the designated points, then the vehicle **is OK** and no further work is necessary. Proceed to step 9.

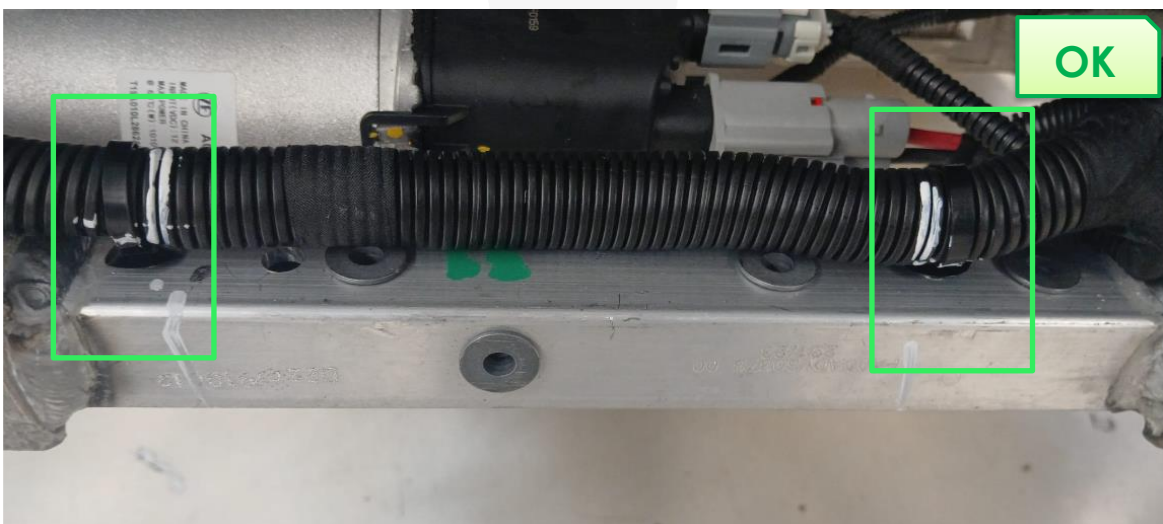
5. If Any Clips Are NOT Properly Secured:

- Before reattaching, inspect the wiring harness sheathing and clips for any signs of wear or damage.
- **If clips and harness are OK** then reposition and secure the clips to the designated mounting points. Replace any damaged zip tie clips if needed.

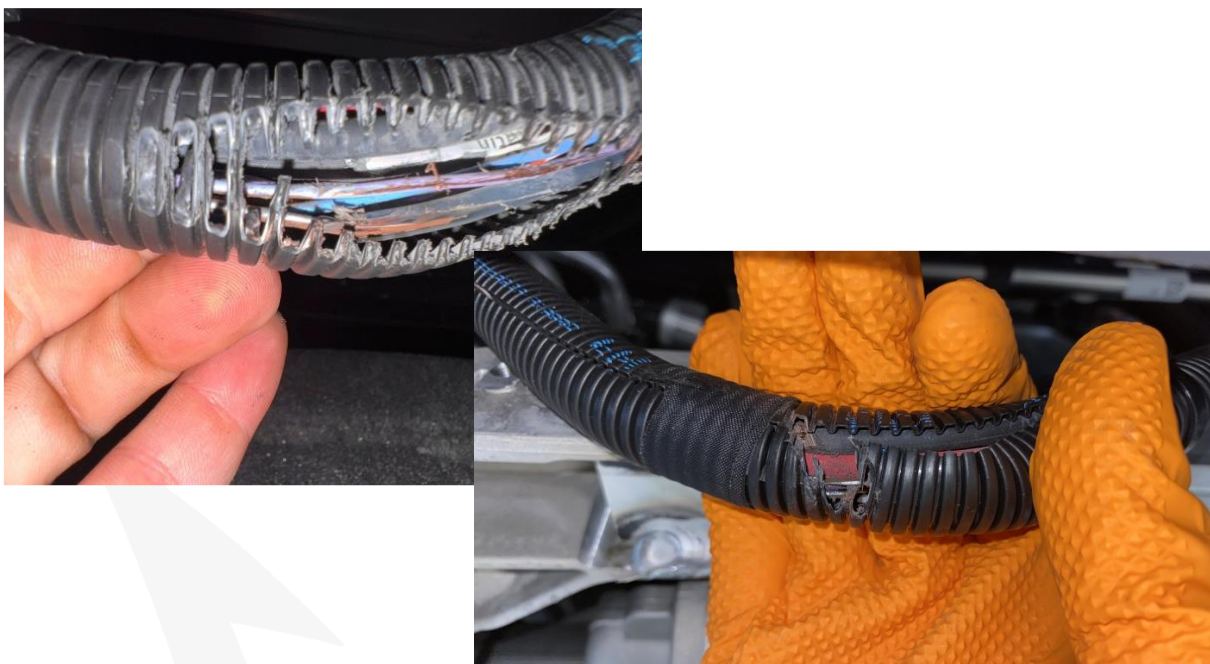
6. If the wiring harness **covering** shows **signs of damage** of any kind, remove the protective corrugated tubing around the wiring harness **in the damaged section only** and check for signs of damage on the individual circuit.

Note: Although no damage is expected on the wiring branch, **as a precaution, perform** the check and open a report at the BOL as "**Information to the factory**" to document the damage found.

ATTENTION: If **any damage is found to the wiring**, any damaged wires can be repaired according to the workshop procedure, taking care to then cover any damaged corrugated pipe with several layers of **anti-abrasive cloth tape**:

It is recommended to apply at least 3 (three) rounds of taping to protect the wiring from abrasion and to carefully check that all edges are correctly glued, securing them with non-woven tape. **Recommended tape to be used: Tesa® 51026, Tesa® 4657 PV0, Coroplast 137xrt, etc.**
