**Diagnostic Sheet**

# TBM2 Diagnostic Guide

**IMPORTANT NOTICE** This bulletin supersedes MAS004818 DS 25-24 released on July 31, 2025. It contains updated information, please ensure all previous versions are discarded.

**MODELS AFFECTED:** M182 Grecale 2.0 L4 MHEV and M189 GranTurismo(All MY).

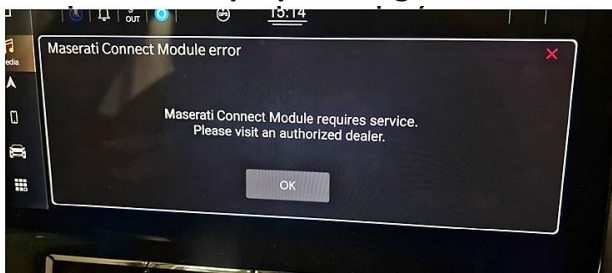
**Concern A.1: Pop-up message – Maserati Connect Module Requires Service**

DTC Check:

If DTC B22A996 is present, → Go to **Procedure 1**

If DTC B22A996 is not present, → Go to **Procedure 2**

### Procedure 1 (DTC B22A996)

Check Variable **2796 - "ECU Internal Fails"** via the scan report

- If only 1 of 5 parameters failed → HW fault, replace the TBM
- If all 5 parameters failed → SW fault, perform reset below:

1. Clear DTCs
2. Key OFF → Wait 2 minutes → Key ON → Wait 2 minutes
3. Read DTCs
4. Repeat up to 3 times. If DTC persists, replace the TBM.

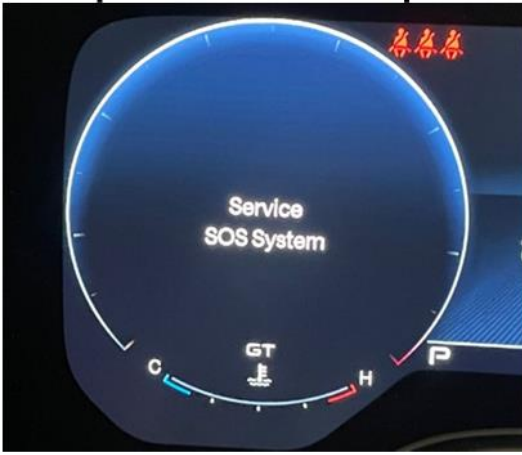
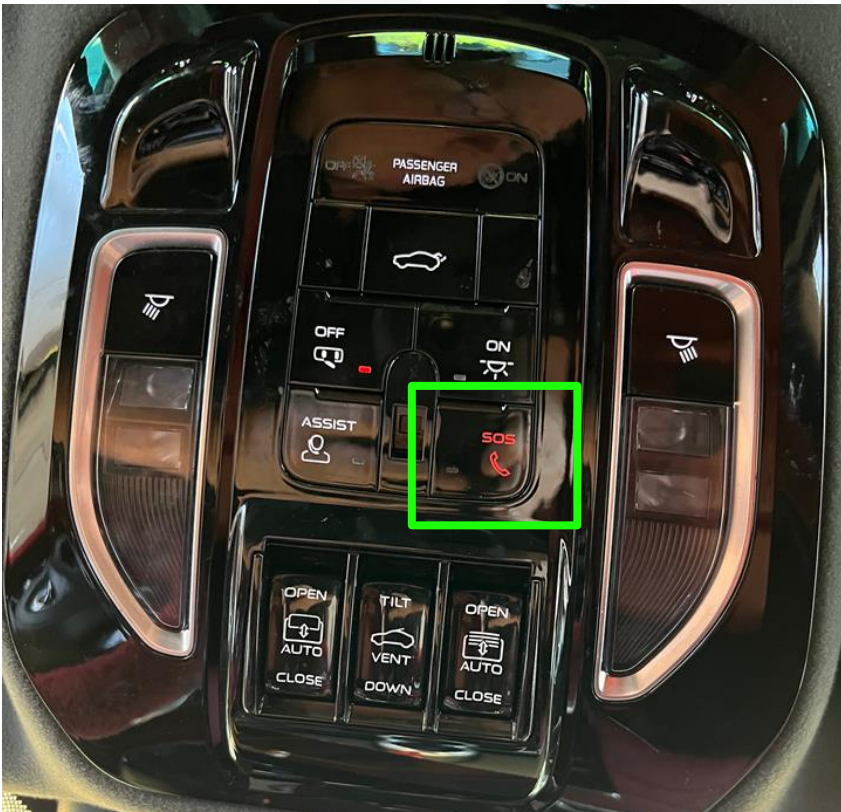
## Concern A.2: Pop-up message – SOS

If any of the listed DTCs are present, perform electrical diagnosis per TechDocs:

- B1401-11 Emergency Call Speaker-Circuit Short to Ground
- B1401-12 Emergency Call Speaker-Circuit Short to Battery
- B1401-13 Emergency Call Speaker-Circuit Open
- B1401-2B Emergency Call Speaker-Wires Shorted Together
- B143A-12 Microphone 1-Circuit Short to Battery
- B143A-13 Microphone 1-Circuit Open
- B143A-2B Microphone 1-Wires Shorted Together
- B1560-13 Cellular Antenna 1-Circuit Open
- B1561-11 Cellular Antenna 2-Circuit Short to Ground
- B1561-13 Cellular Antenna 2-Circuit Open
- B1562-14 GPS Antenna-Circuit Short to Ground or Open
- U0452-86 Implausible Data Received From Restraints Control Module-Signal Invalid

These DTCs are associated with the red warning light on the SOS button.

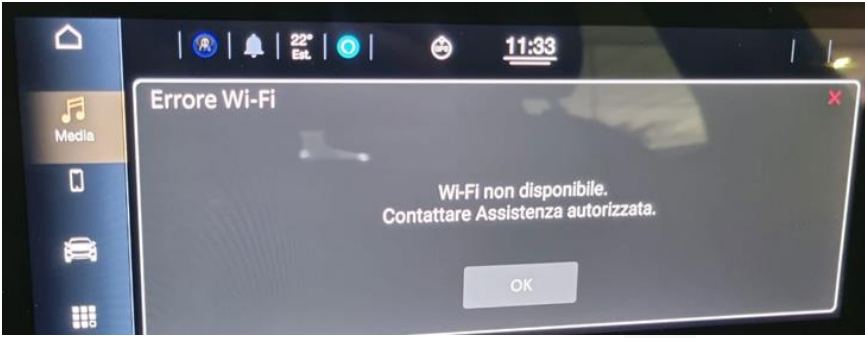
**Concern A.3: Pop-up message – Wi-Fi unavailable. Contact authorized support.**

If DTC B22A996 is present:

Check Variable “2796 - ECU Internal Fails” via the scan report

- If the Wi-Fi Module fails, → It is a HW fault, replace the TBM.

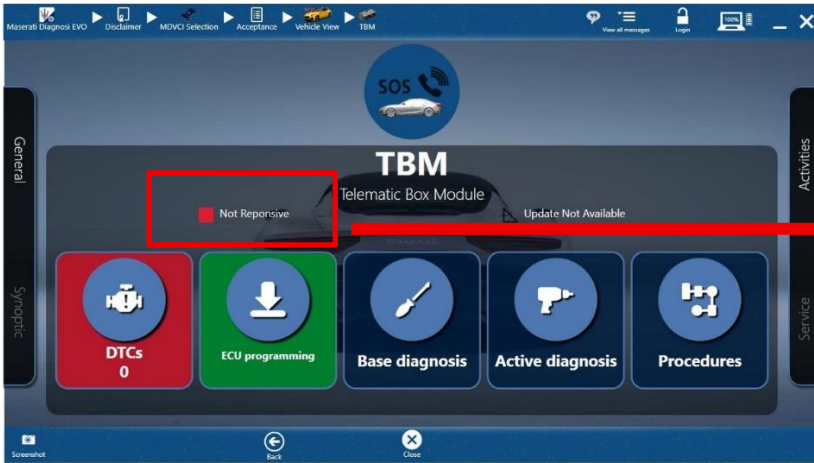
**Concern B: TBM Communication Missing (offline on Vehicle Scan Report, in red)**

CAN node 35 (TBM)
present

- Check if the TBM is set as Present on the proxy side
- Verify TBM electrical integrity (power/grounds, connectors, wiring)
- Document any electrical anomalies with photos
- If no fault is found and the issue persists, → Open BOL for Technical Support

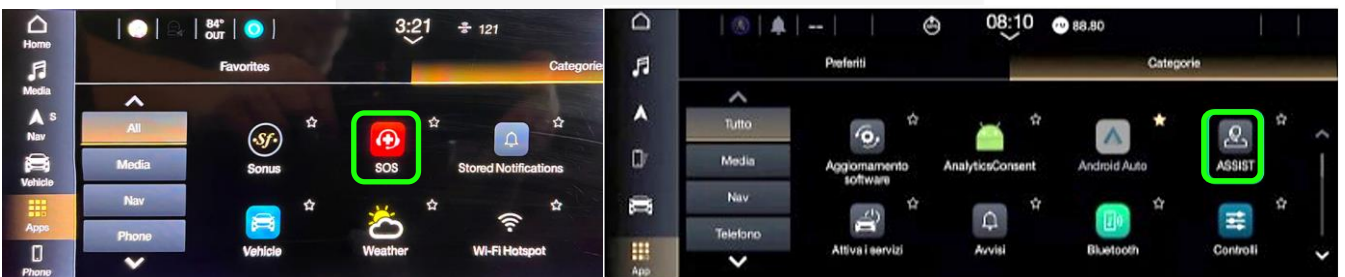
**Concern D: Non-selectable Icons (SOS, Assist, Wi-Fi)**

ASSIST ICON **NOT** HIGHLIGHTED = OFF

ASSIST ICON HIGHLIGHTED = ON

Follow **SECTION 08.71 – 1**, → **Procedure 08.71.224.35 TBM – CONNECTION UNLOCK** in TechDocs.  
If the issue persists, → Open BOL for Technical Support.
