MAS004933 RU 25-31

# Rapid Update 623

## Grecale - Premium Alarm System Reactivation

**VEHICLES INVOLVED:** Grecale (M182) MY23

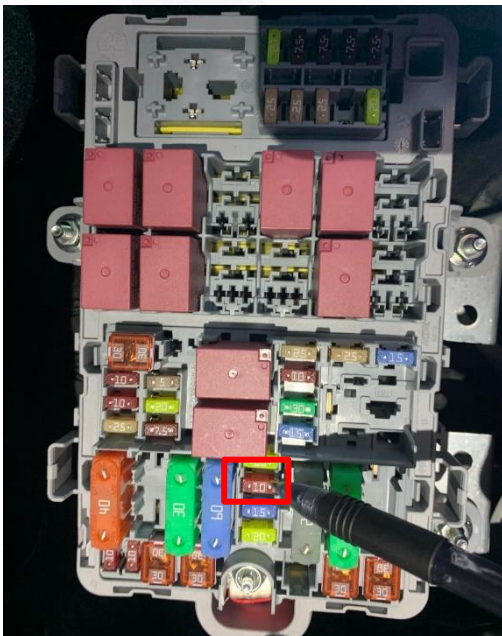
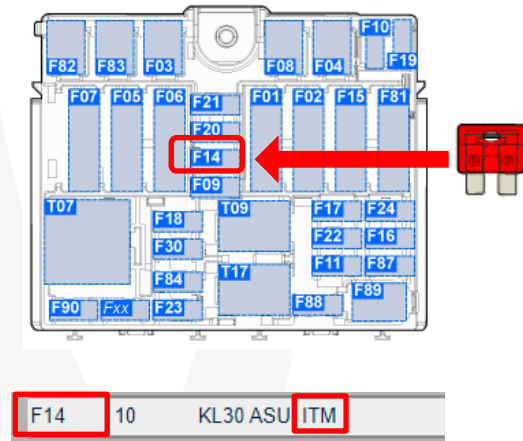
The updated ITM software also fixes an issue where the volumetric alarm could activate on its own and helps reduce 12V battery drain.

1. Access the Rear Distribution Unit (RDU) and re-install the **F14 10A** fuse that was removed previously per Rapid Update 599, indicated in the pictures below:
