GROUP	MODEL
GEN	2023-2024MY Multiple Models
NUMBER	DATE
099 (Rev 3, 10/21/2025)	February 2024

TECHNICAL SERVICE BULLETIN

SERVICE ACTION: TIRE MOBILITY KIT

INSPECTION & REPLACEMENT/REPAIR (SA556)

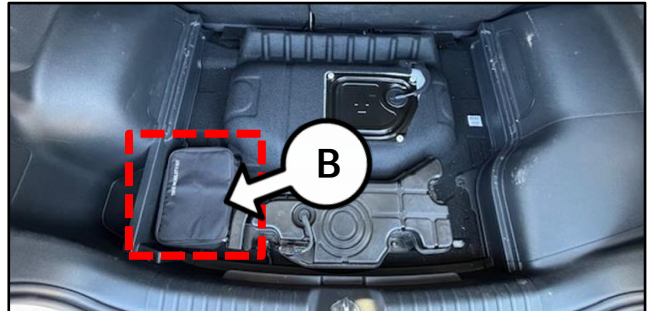
3. Remove the Tire Mobility Kit (TMK) sealant can (B).

Note: If the TMK sealant can is missing, no further action required. Claim 'TMK Inspection Only' Labor Op.

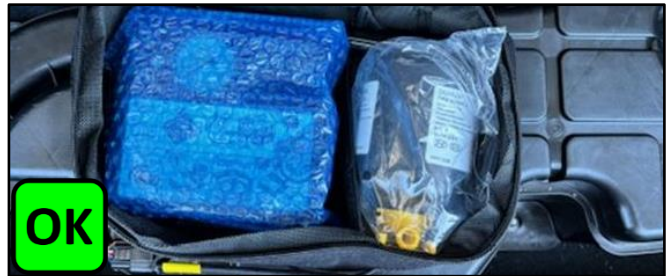
- If sealant has not leaked from the TMK can (B) (OK), proceed to step 4.

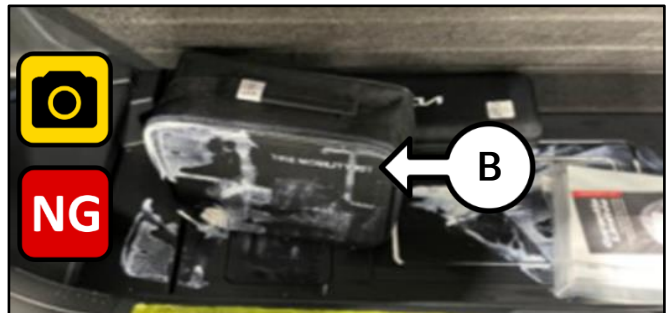
- If sealant has leaked from the TMK sealant can (NG), replace the sealant can (B), take one (1) clear KVID photo and proceed to 'Replacement Procedure' on page 5.

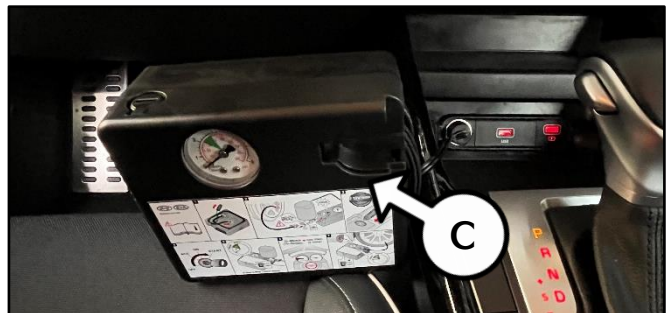
If leaked sealant has penetrated the inflator bag, test the inflator (C) for proper operation. If inflator and/or other damaged parts require replacement due to leaked sealant, follow normal warranty procedures and attach a KVID photo of the damaged component to the warranty claim.

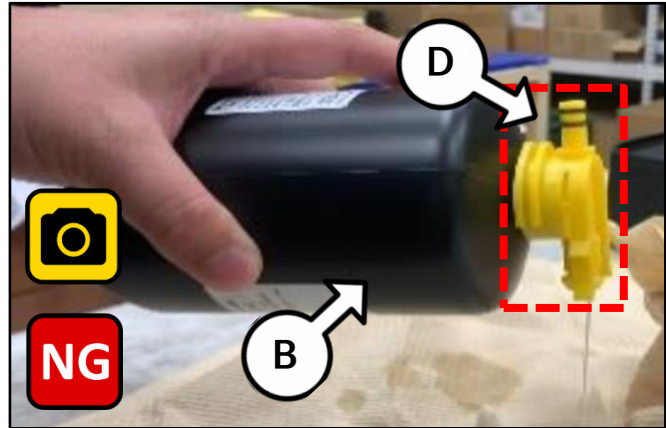
4. Remove sealant can (B) from the bag and position horizontally so the spout is facing downward.
 - If sealant has **not** leaked from the sealant can cap (D) (OK), proceed to the 'Repair Procedure' on page 4.
 - If sealant has leaked from the sealant can cap (D) (NG), replace the sealant can (B), **take one (1) clear KVID photo** and proceed to 'Replacement Procedure' on page 5.
