Service Bulletin

Bulletin No.: PIT6234A

Date: October, 2025

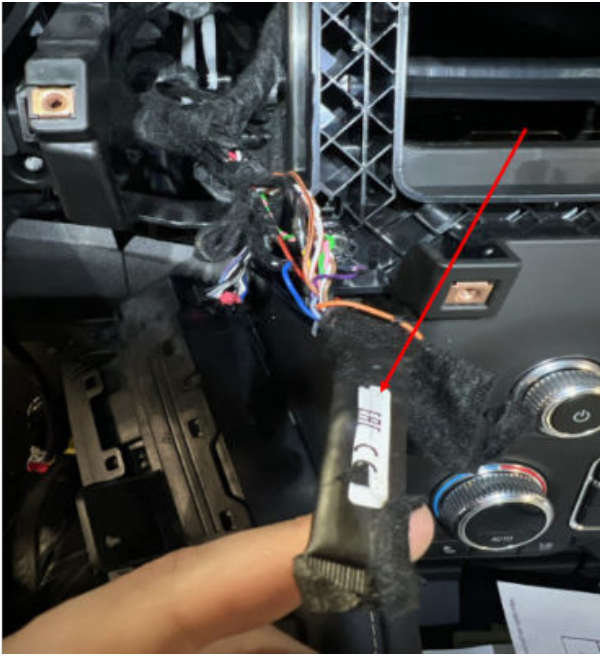
6730520

Involved Region or Country	North America
Condition	Some customers may state after starting the vehicle and shifting into gear that the vehicle goes back into park and then completely shuts down like the ignition is turned off. At this point, this has not been known to be an intermittent issue and will happen every time.
Cause	The cause of this condition could be an aftermarket device, as shown below. This device has been found to be installed behind the ignition mode (start) button and also down near the SDGM and BCM. When installed it has been taped to the wiring harness and wrapped in factory looking felt tape making it difficult to locate.

Inspect the vehicle for any aftermarket devices and remove before any further diagnoses.
