# Service Bulletin

Bulletin No.: PIT6132C

**Subject: Hum Buzz Vibration Type Noise From HVAC When Set To Defrost Or Floor Positions**

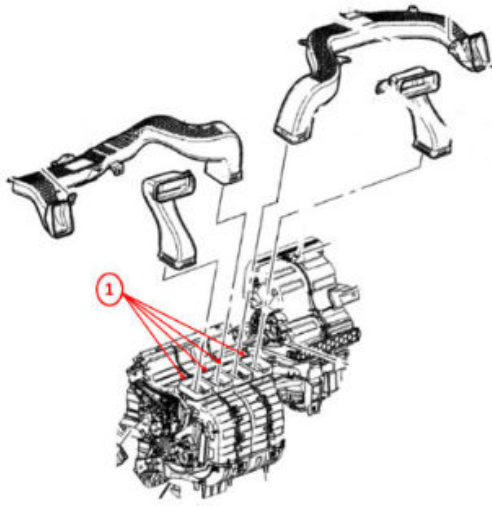
6727886

<b>Involved Region or Country</b>	North America
<b>Condition</b>	<p>Some customers may comment of a hum, buzz, or vibration type noise coming from the HVAC when the mode is set to the defrost or floor positions along with higher blower speeds and higher temperature settings. If the HVAC mode is changed to include the instrument panel dash vents the noise will be gone.</p> <p><b>Note:</b> Replacing the HVAC case will not correct this condition and if the HVAC case is replaced the new case will need the repair shown below to resolve the noise.</p>
<b>Cause</b>	<p>The cause of this concern could be the HVAC instrument panel dash vent door seals (2) vibrating against the HVAC case, shown below. This concern only happens when the HVAC instrument panel dash vent doors (2) are in the closed position along with the HVAC set to a higher temperature and blower speed.</p>
