SIB 51 09 25

DIFFICULTY OPENING/CLOSING THE TAILGATE

2025-10-29

E-Series	Model Description
G01	X3 Sports Activity Vehicle

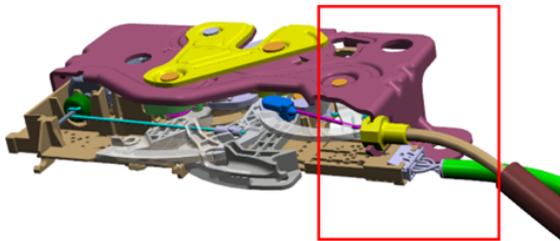
Oxidation/corrosion on the tailgate latch electrical connector and/or mechanical cable.

This is caused by pressure washing the tailgate for a long period of time at close distance, resulting in water entering the vehicle through the gaps of the tailgate.

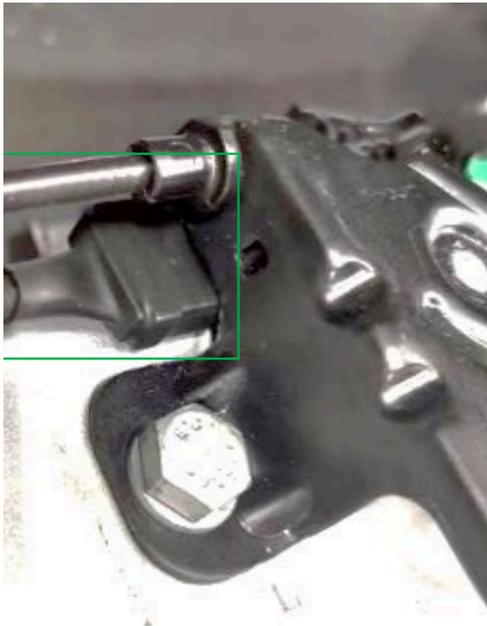
1. Verify the customer's concern(s).
2. Inspect the electrical connector and mechanical Bowden cable on the tailgate latch for any buildup of oxidation/corrosion.

3. If there is a buildup of oxidation / corrosion, with prior customer approval, carefully remove the buildup and install a heat shrink tube around the tailgate latch electrical connector with a diameter of 18 mm and a length of 100 mm.

5. To avoid the risk of future corrosion, the electrical connections on the tailgate latch must be coated with NYOGEL 760G at the four points as shown in slide one of the attached document.
