SIB 66 13 23

CAMERA-BASED ADAS: CCM FOR RESTRICTED FUNCTION – KAFAS CAMERA HOOD DEFORMATION

2025-10-29

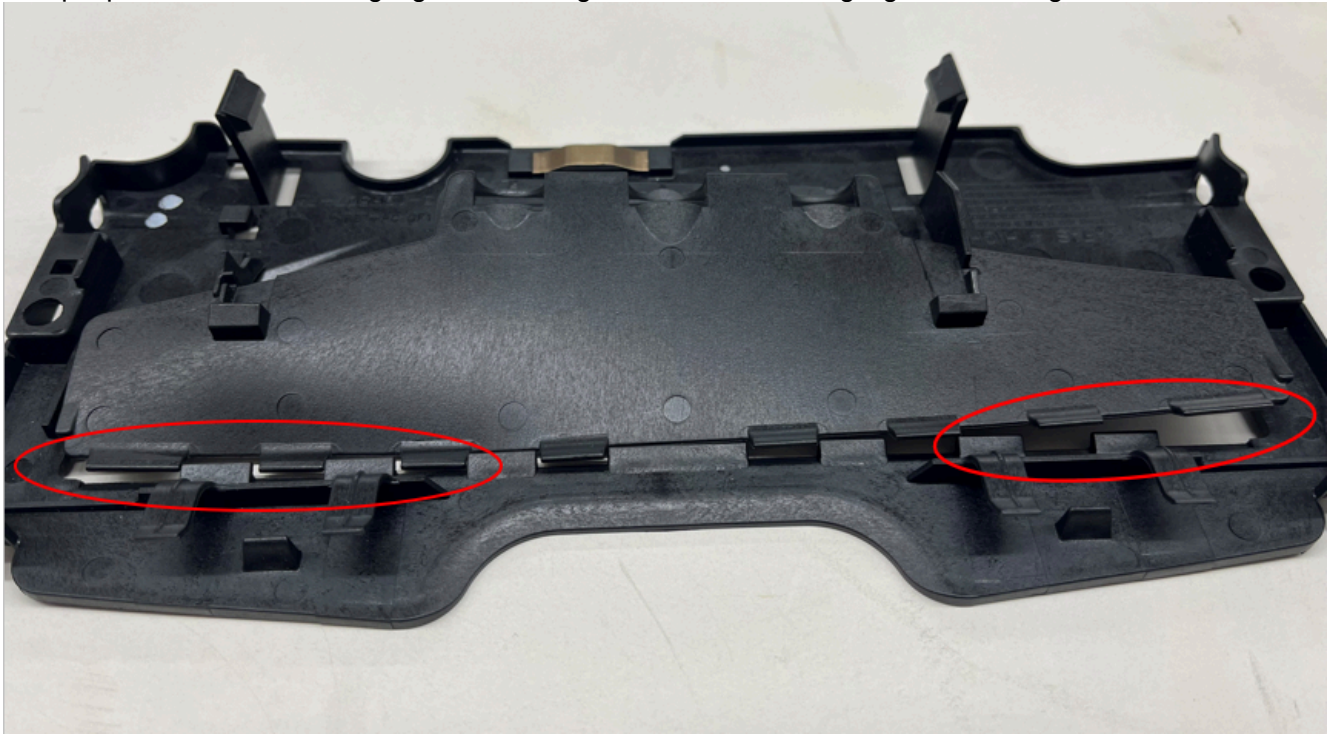
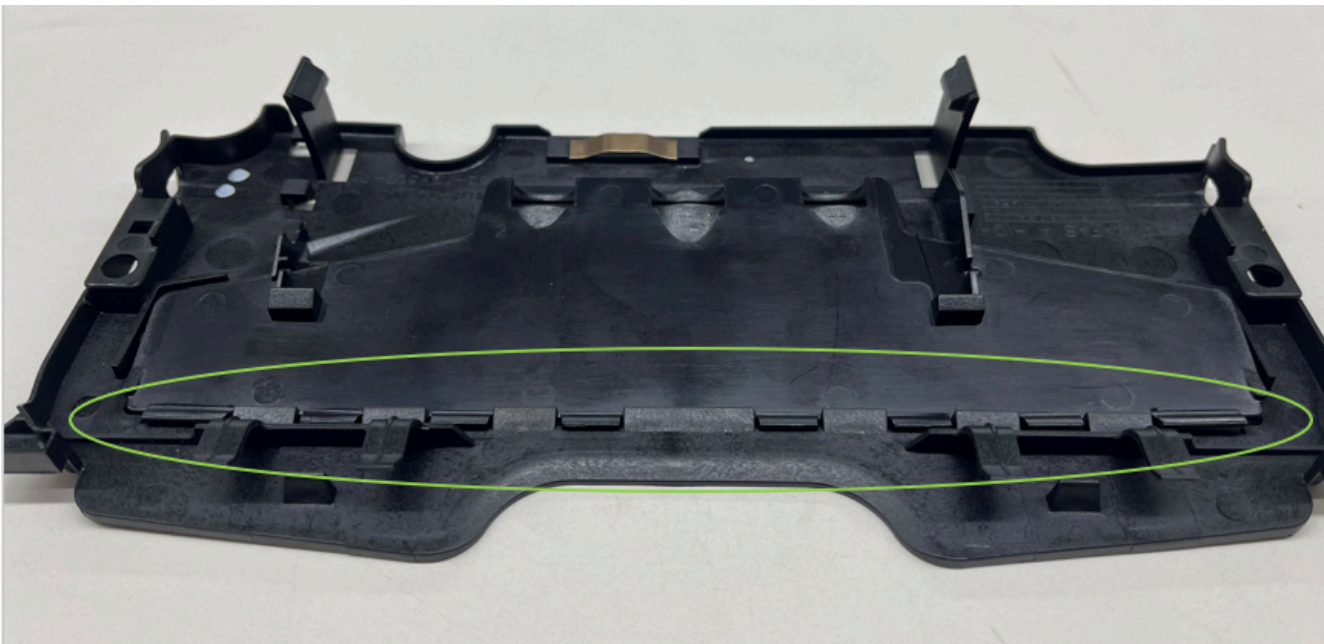
The KAFAS 4 High camera reaches temperatures that the KAFAS camera hood material cannot withstand. This results in deformation/distortion of the KAFAS camera hood.

2. When installed, check whether the KAFAS hood is in contact with the holder/mount all the way around. See example photos below. **Red** highlighted showing distortion. **Green** highlighted showing no defect.

If you find distortion, replace the KAFAS camera hood with part number 51 31 5A93179 for (F97 G01) front windscreen trim or part number 51 31 5A9A552 for (F98 G02). Then follow the below modification steps.

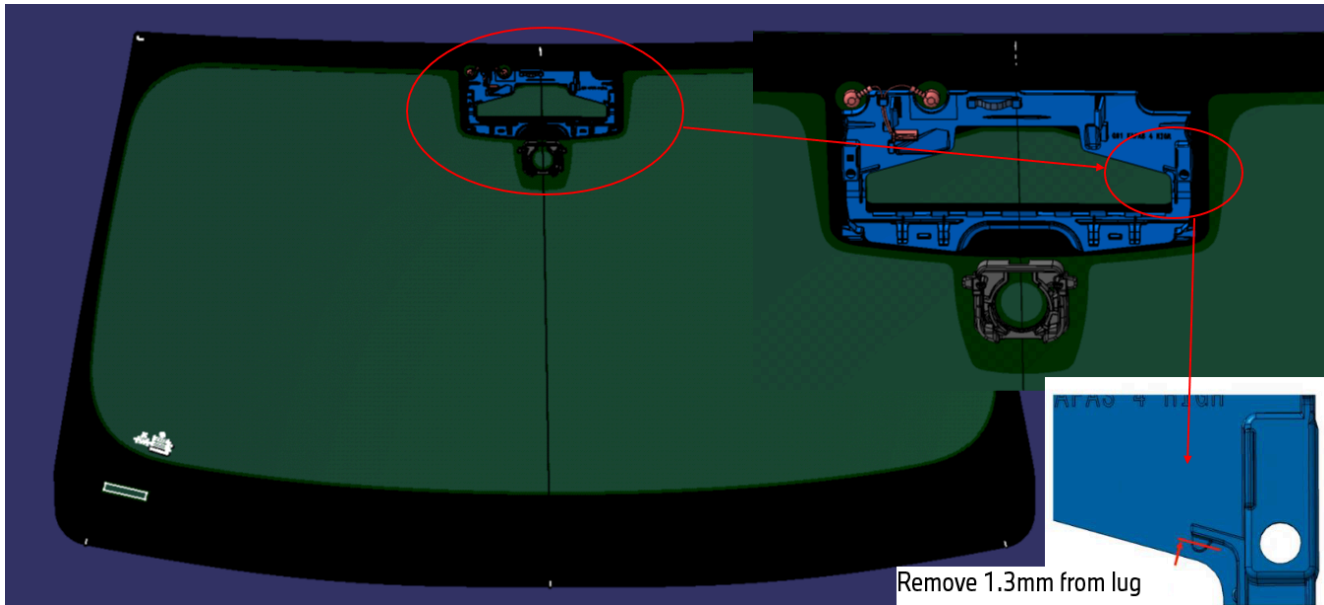
The mounting point for the KAFAS camera hood must be adjusted.

Mask the KAFAS window. Draw off dust while grinding.

Using a grinding tool (for example Dremel®), shorten the entire surface of the retaining lug by 1.3 mm. See example photo with location for modification. Then deburr and clean it thoroughly, and remove the adhesive tape.

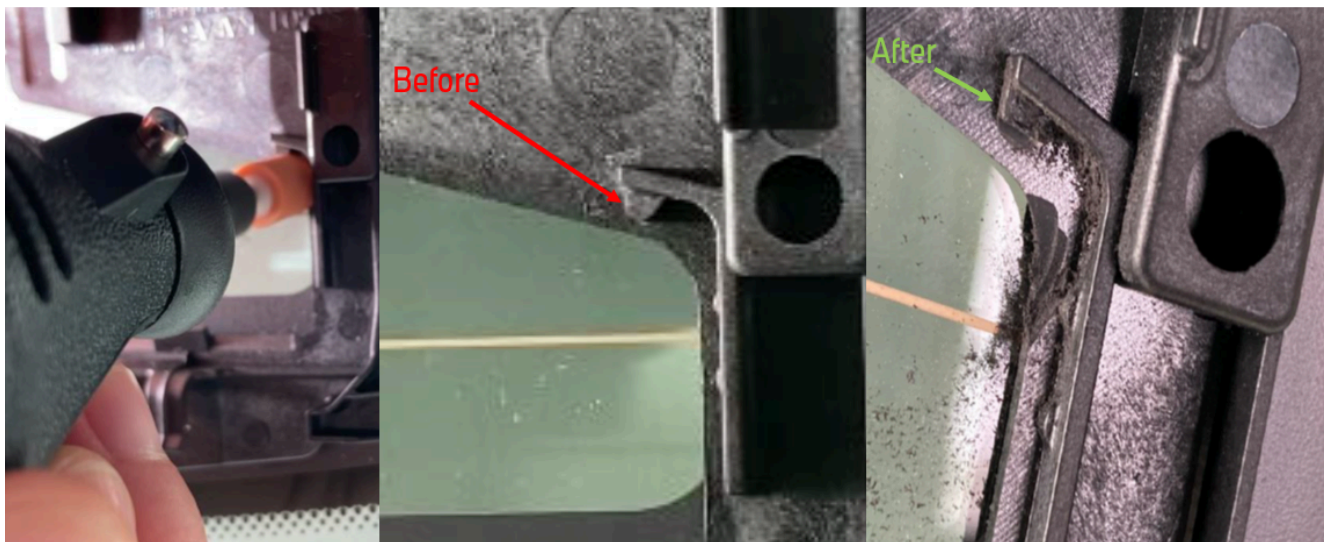
Before and after photos showing the modification below.

Mount the KAFAS camera hood. Make sure that it is in contact with the holder all the way around, especially in the modified retaining lug area.
