SIB 23 01 25

SERVICE ACTION: check ASA Clutch Release Lever And Replace If Necessary  
2025-10-24

Model	Model Description	Model Code
KA1	R 1300 GS (With option 22A ASA)	0M23
KA2	R 1300 GS Adventure (With option 22A ASA)	0M33

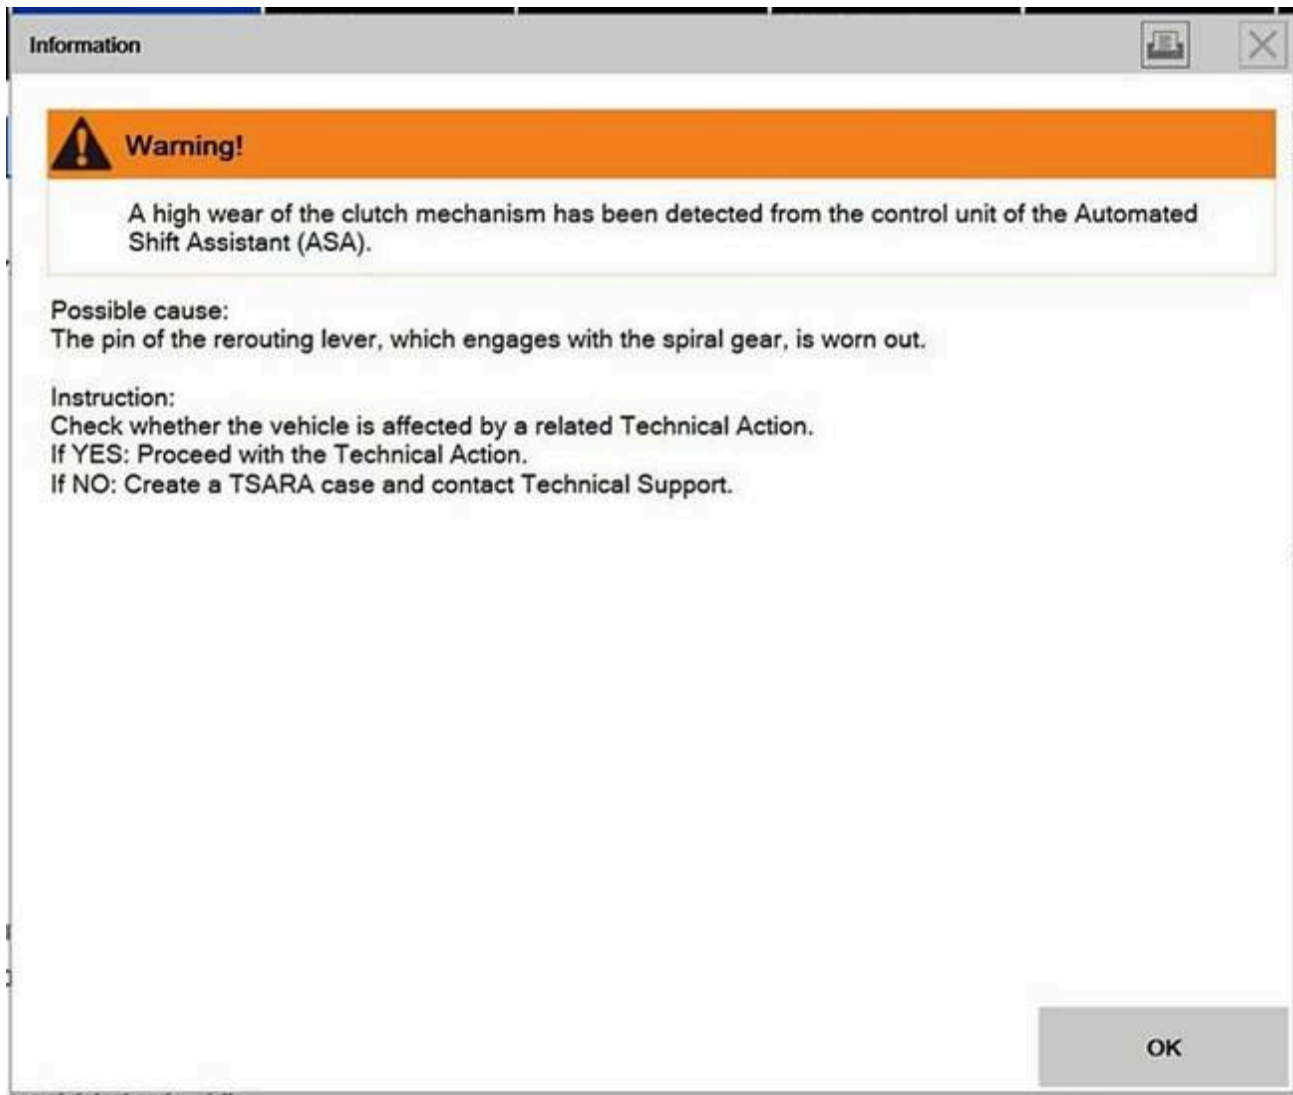
### Pop-Up Example:

1. Check Total Distance of the Motorcycle. Has 1,864 miles (3,000 km) been reached?
  - a. If **NO** – The milage has not been met in order for ISTA to identify premature wear and must wait until the milage is met to perform and complete this campaign at the next workshop visit.
  - b. If **YES** – The Milage has been met, move to step 2.
2. Connect the Motorcycle to ISTA and Identify the vehicle and look for the relevant POP-UP screen (example below) and check for specific fault memory "S 1038 – ASA worn out coupling mechanism" is stored

- a. If **NO** pop-up screen appeared and the fault S 1038 ASA is **NOT** stored, then the motorcycle is operating as designed and you can claim "The Check" labor below only.
- b. If the pop-up screen **appeared** and the S 1038 ASA fault **is stored**. Then the ASA clutch release lever needs replaced per repair procedures "11 00 050 Remove / Installing engine and then 23 41 006 Replacing ASA clutch operation lever (engine removed)".
- c. If the pop-up screen appeared and the unit is not part of this campaign a TSARA case is required to progress.
