## SIB 77 04 25

SERVICE SOLUTION: Rework MY25 or Newer C 400 GT, C 400 X Top Case  
2025-10-13

Part Number	Part Description	For Model Year 25 or newer
77 43 8 829 760	43.5 Liter Top Case	C 400 GT, C 400 X

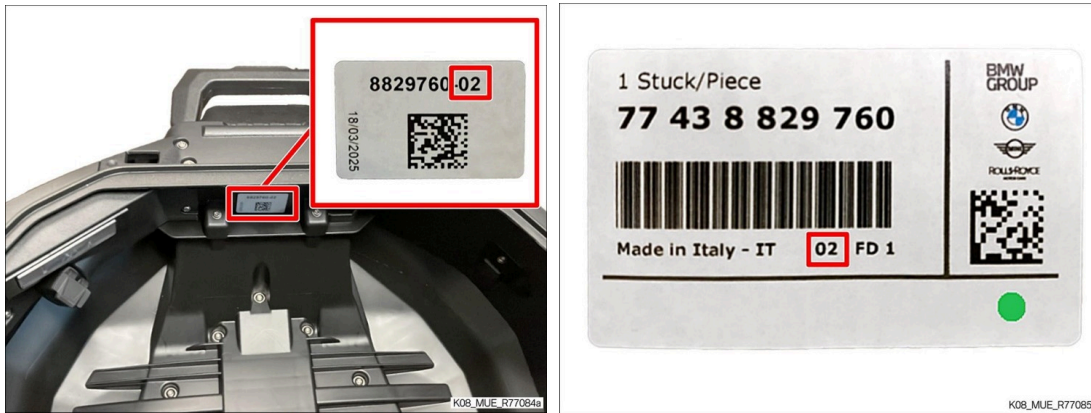
The affected top cases are identifiable by a Revision Index near the part number sticker inside the top case and on the outside of the top case packaging (cardboard box).

Shows an example of inside the top case, the revision index can be found next to the part number on the data matrix code (QR code) sticker the example below being (02 revision index).

Shows the example on the product packaging. The revision index can be found on the part number sticker below the bar code the example being (02 revision index).

If a top case has a revision index of **01, 02, or 03**, you need to check for a clearly visible **green dot** on the sticker location as seen in the figure on the right above.

NOTE: The **green dot** indicates the top case was reworked at the factory and does not need any rework performed in this SIB and the dealer can disregard this service solution.

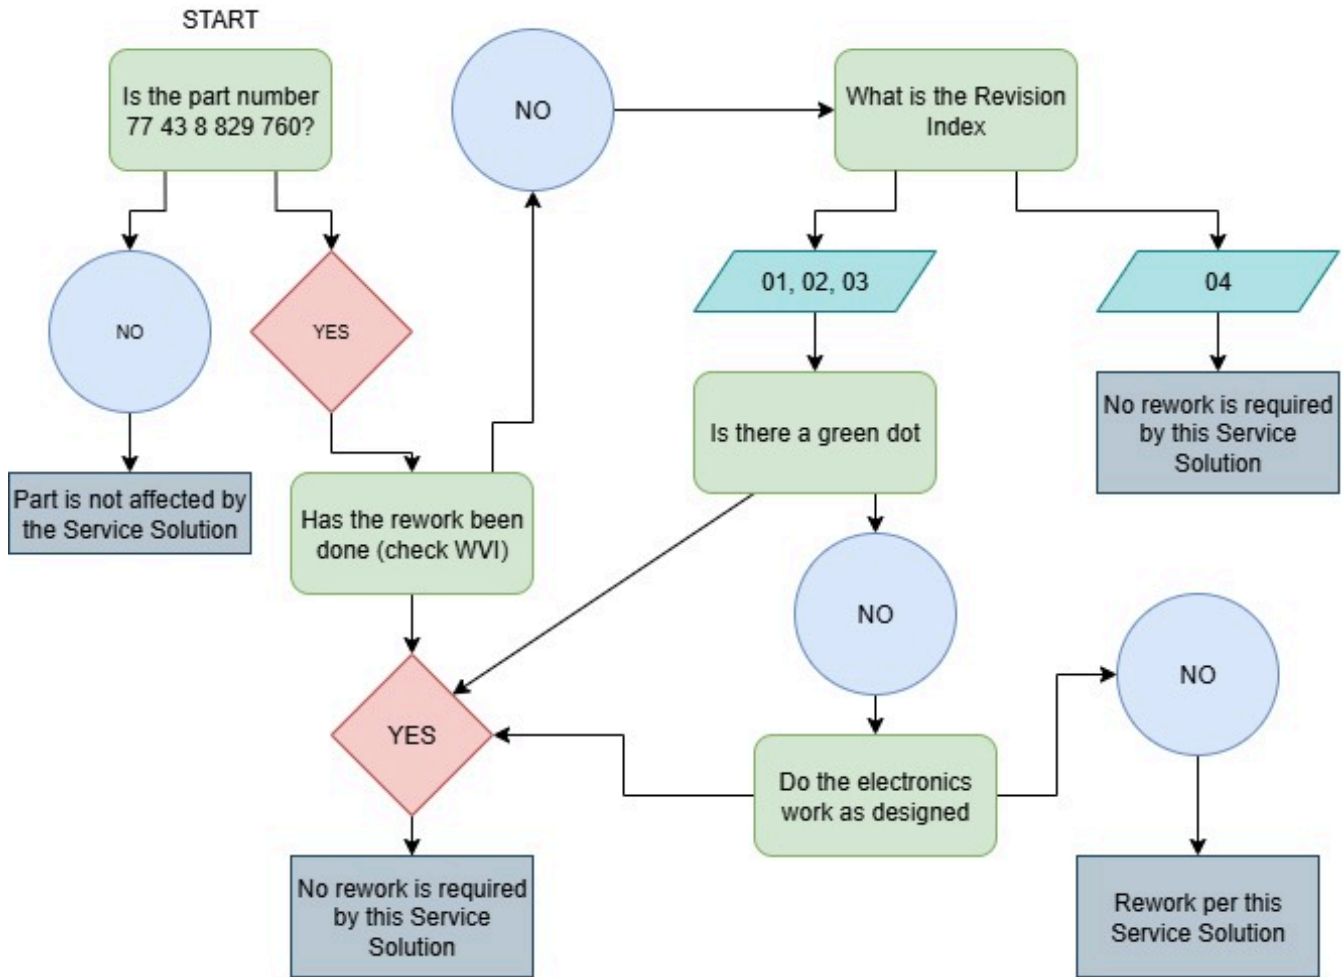
### Visual Diagram for Clarification:

If you have a top case with a Revision Index of **01, 02, or 03 without** a green dot then the dealer must check that the electronics are operating as designed by performing a function check before handing them over to the customer. When installed in the vehicle, the lighting must be active with the ignition switched selected to “on” and a USB load such as a smartphone or tablet must charge at the USB-C charging port.

For top cases with the Revision Index of **04** with or without a green dot the case is correct and does not need any rework per this Service Solution.

If the functional check is unsuccessful, the service solution must be carried out.

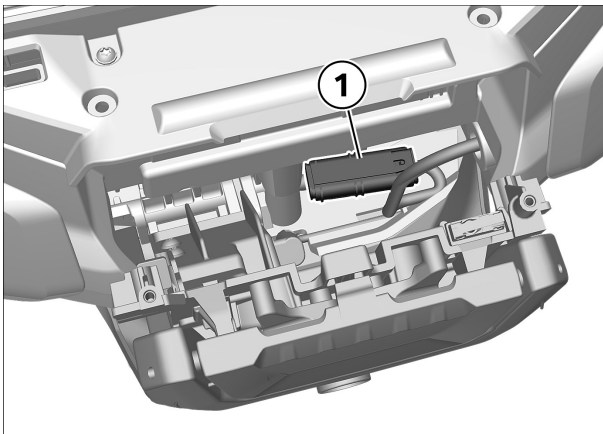
# 2

The lighting in the interior of the top case and the USB-C charging option are inoperable. The cause is a faulty pin assignment of the wiring harness connector in the top case.

#### ► Disconnecting wiring harness in topcase and correcting pin assignment on connector

- Disconnect connector **(1)**.

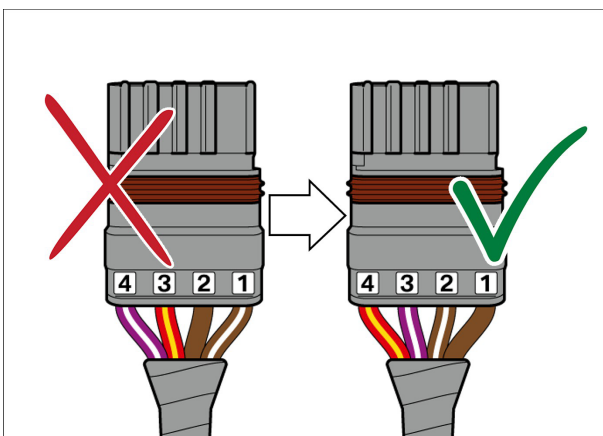
#### • **Correct** assignment:

- 4 - red/yellow
- 3 - purple/white
- 2 - brown/white
- 1 - brown

- Correct pin assignment in connector housing according to the figure.
