## SIB 72 01 25

### G1X/G3X FALSE ALERT RF SEAT OCCUPIED W BELT UNBUCKLED-EXTENDED LIMITED WARRANTY 2025-10-29

This Service Information bulletin (Revision 04) supersedes SI B72 01 25

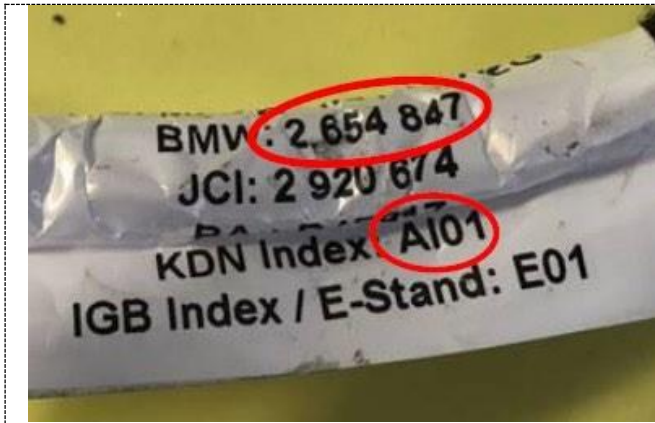
To access the label's information, loosen seat mounting, open the central connector, fold seat to the back, completely.

In this example, the BMW Part Number 2 654 847 is shown (circled).

The corresponding KDN (Revision) Index number "AI01" is shown (circled).

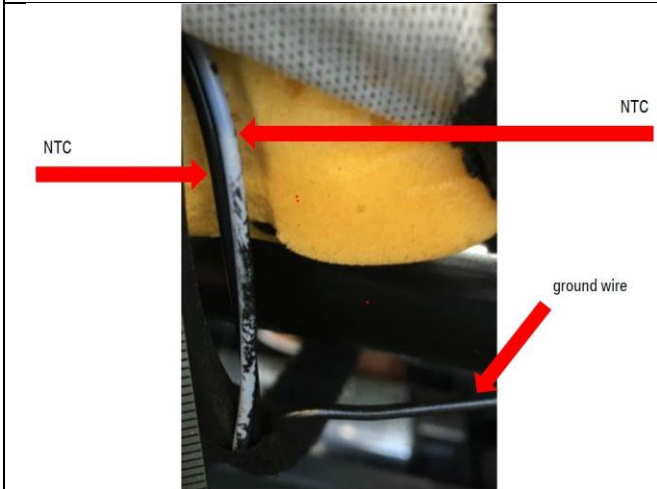
The following cables/cable assemblies are now exposed:

- two NTC cables (negative temperature coefficient lines) for temperature
- Outgoing grounding wire.

**THESE WIRES MUST NOT BE CUT!**

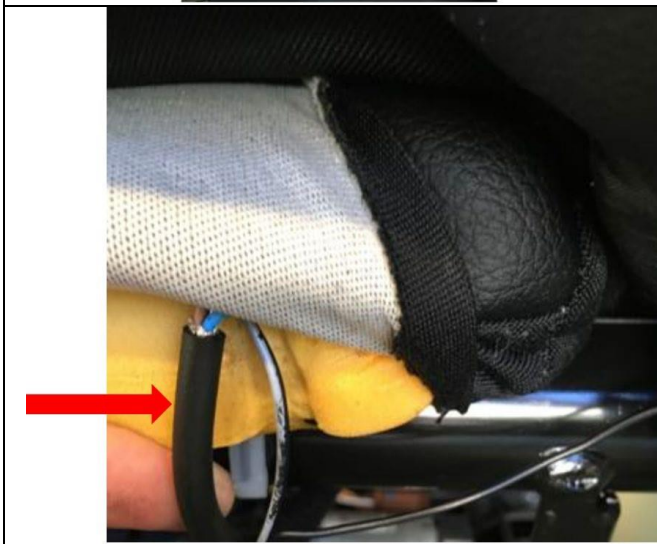
The following cables/cable assemblies are now exposed:

- Cable assembly (4 cables in a rubber jacket) including shielding.

This is the wiring that will be modified

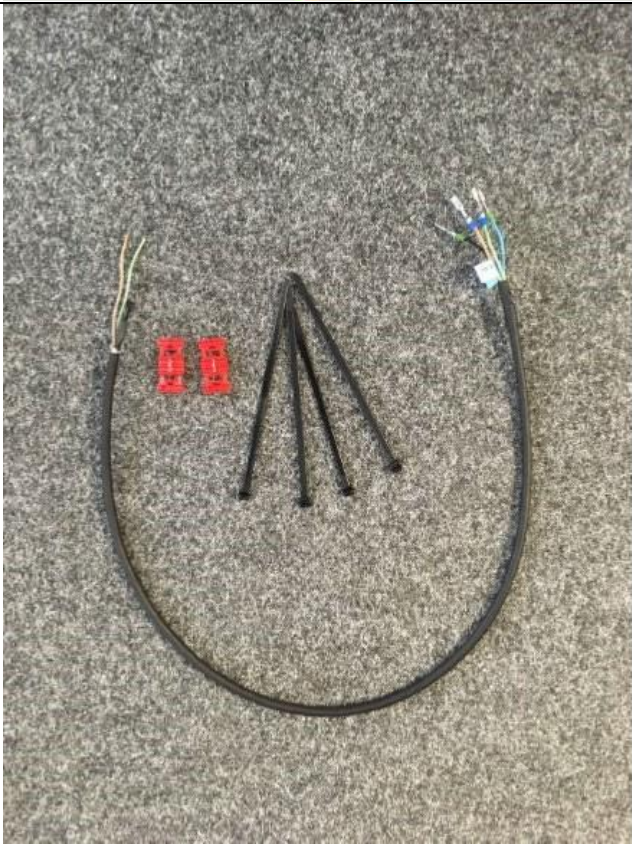
This is the repair kit

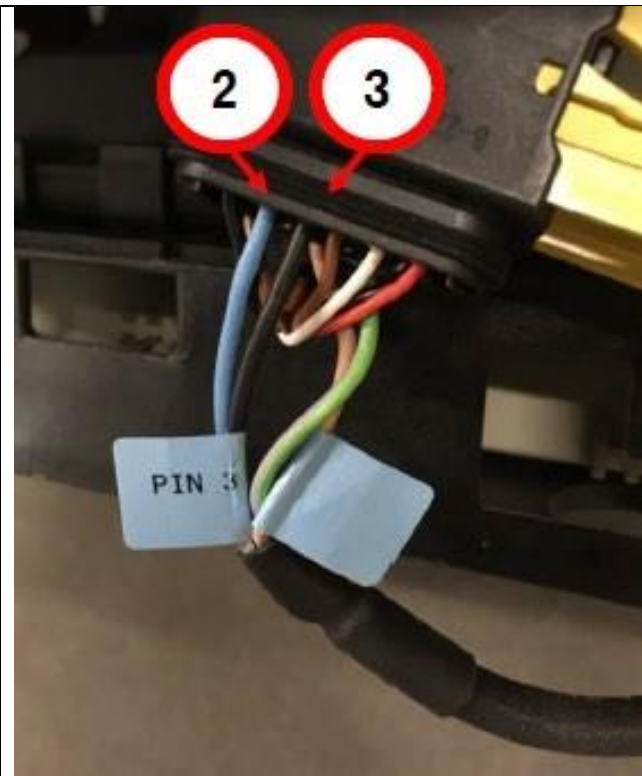
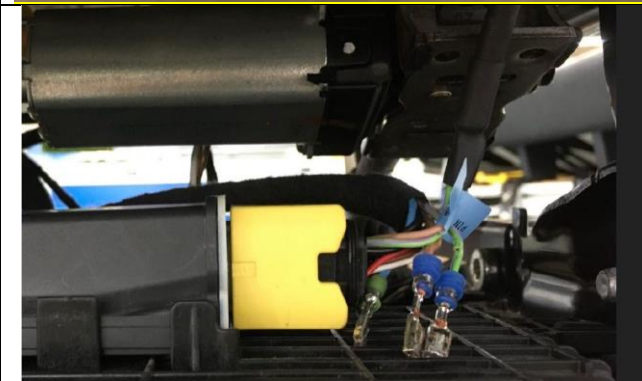
The 4 old cables remain in the wiring harness

<p>Then place the cable harness back into the groove provided for this purpose in the foam cushion</p>
 	<p>Secure and tighten the entire cable harness with cable straps.</p> <p>Important: Make sure the repaired wiring is not under tension.</p>
