Technical Service Bulletin

GROUP CAMPAIGN	NUMBER 25-01-059H
DATE OCTOBER 2025	MODEL(S) TUCSON (NX4)

SUBJECT: DCU SOFTWARE UPDATE
(SERVICE CAMPAIGN TDFA)

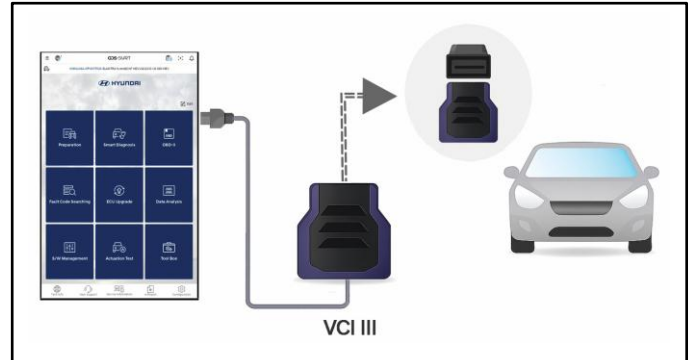
1. Connect the Ethernet Communication Interface (ECI) DLC cable to the OBD connector of the vehicle.
2. Connect the VCI DLC cable to the ECI.
3. Select the appropriate tablet cable (type C, 5-pin) to the ECI.
4. Connect the cable to the tablet PC.

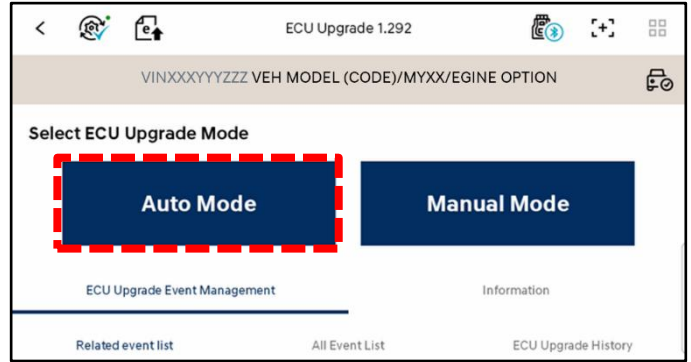
1. Perform the ECU update in **Auto Mode**.

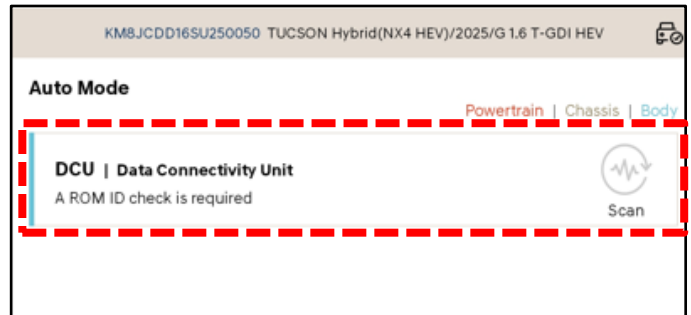
2. Verify the ROM ID by selecting the **DCU** system to scan the vehicle’s current ROM ID.

Check the current ROM ID version and compare it to the ROM ID Information table before attempting to perform the software update.

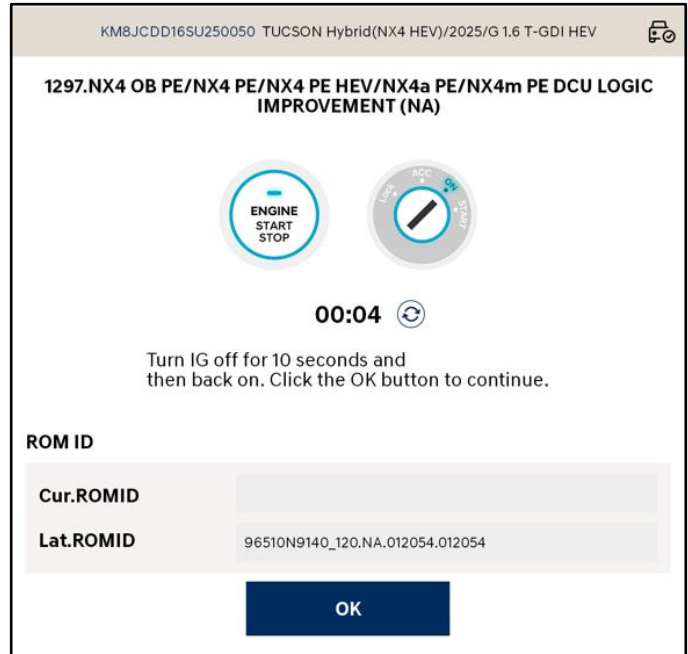
- After the ECU update process shows 100% complete, follow the prompts on the screen to cycle the ignition **OFF** for at least **10 seconds** to reset the control unit (certain models may take up to **30 seconds**).

Use the **Refresh** button to reset the timer.

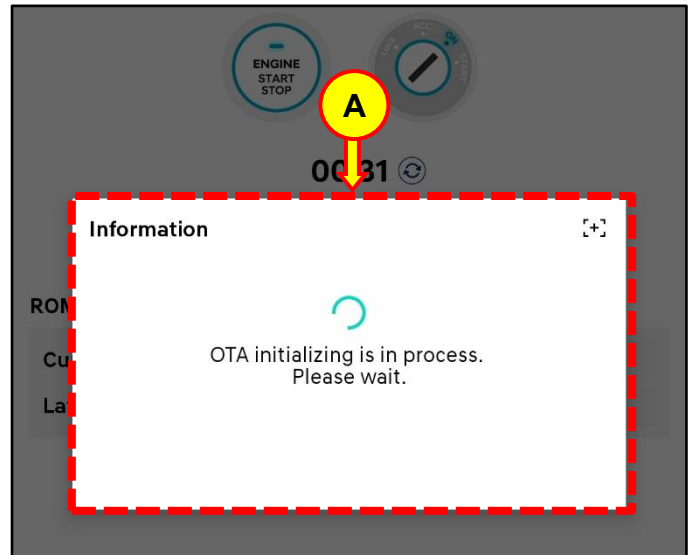
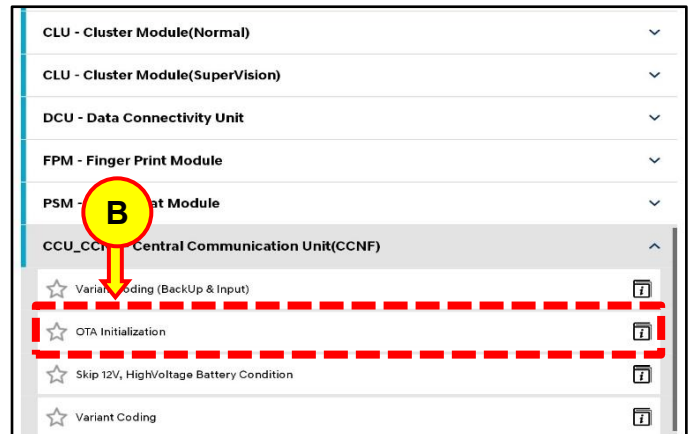
- OTA initialization (A) should perform automatically:
 - If OTA initialization performs automatically, then proceed with the service procedure.
 - If the OTA initialization process fails, complete it manually under: **S/W Management > CCU_CCNF - Central Communication Unit (CCNF) > OTA Initialization (B)**.

Follow the instructions on the screen.

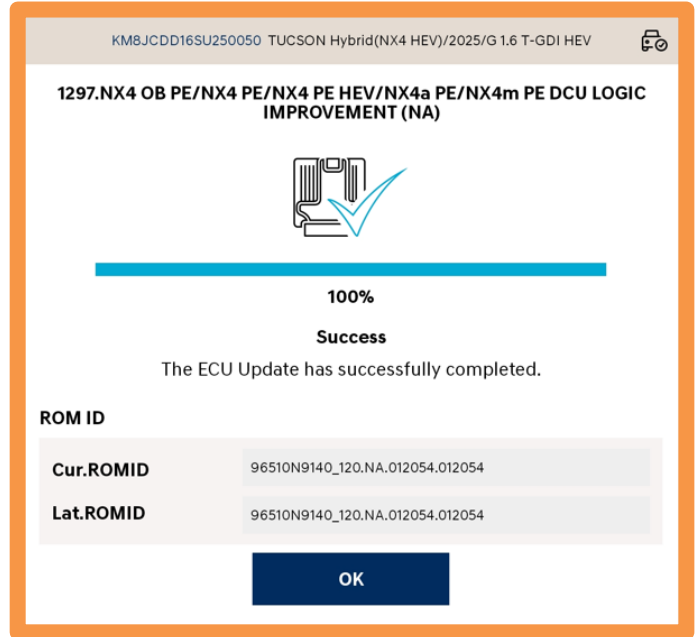
5.

Take a screenshot of the ECU update Success screen using your tablet and upload to STUI.

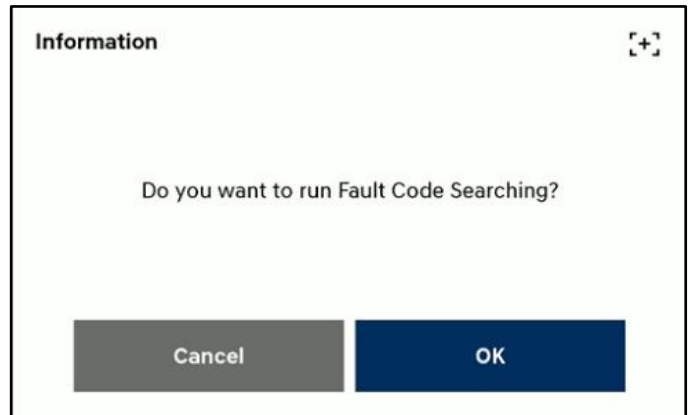
6. Perform an **All Systems Fault Code** search and erase DTC history that had incidentally occurred from the ECU update.
