Technical Service Bulletin

Topic	Creaking From the Rear of the Vehicle - Diagonal Strut Brace Bolt Loose
Market area	Bentley: worldwide (2WBE),China 796 VW Import Comp. Ltd (Vico), Beijing (6796)
Brand	Bentley
Transaction No.	2076757/2
Level	EH
Status	Released for publishing
Release date	Sep 23, 2025

25MY Continental GT & Flying Spur

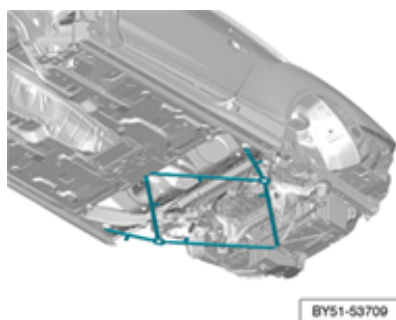
Figure 1

The customer states that there is a creaking/banging noise coming from the rear of the vehicle.

The source of the banging noise is the diagonal strut brace (Figure 1)

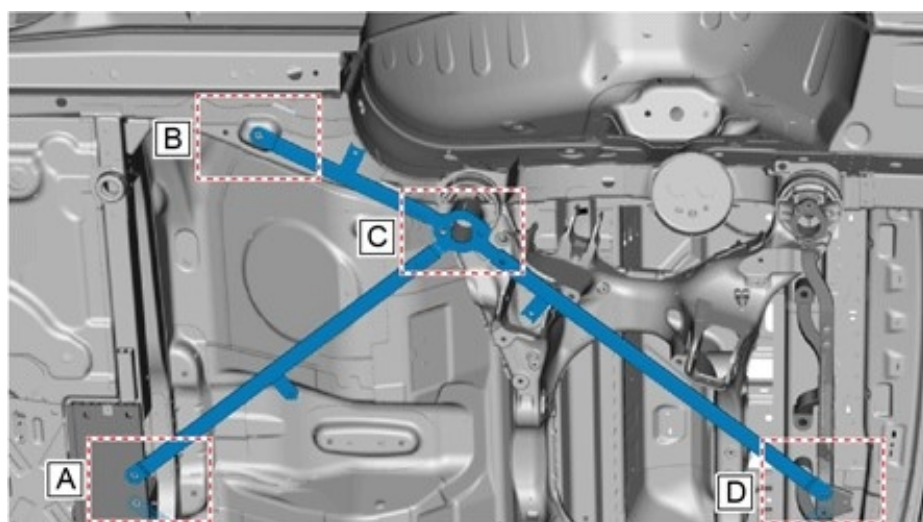
Figure 2

The bolts on either side, highlighted in box B (Figure 2) are coming loose and causing the noises from the diagonal strut brace.

New part number for bolt “B” – N.909.201.02

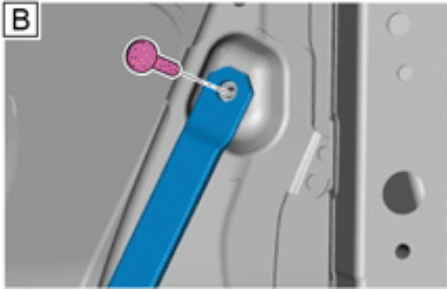
Figure 3

2) If the bolt is not within the specified torque this could be due to contamination. Remove the bolt and replace with the new bolt (see parts information).

1) Check the torque value of bolt "B", highlighted in Figure 3, on BOTH sides of the vehicle. Refer to ElsaPro, Repair group 51 "Diagonal Strut Brace – To remove and fit".

NOTE: Do NOT remove the full diagonal strut brace.

Before replacing the bolt ensure the thread is cleaned to remove any wax.

Ensure the bolts are torque tightened to the specified torque.
