Technical Service Bulletin

Topic	DTC B17B801 and/or B17B804 - evident within address 0019 and/or DTC U112300 evident in 00A5
Market area	Bentley: worldwide (2WBE),China 723 Volkswagen (Anhui) Automotive CO (6723),China 796 VW Import Comp. Ltd (Vico), Beijing (6796)
Brand	Bentley
Transaction No.	2063855/12
Level	EH
Status	Released for publishing
Release date	Sep 23, 2025

New Continental GT/GTC - New Flying Spur - Bentayga Series

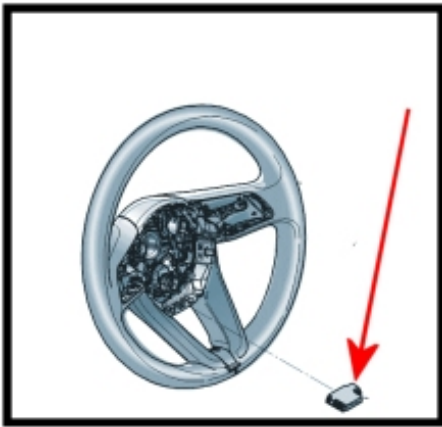
- Lane Assist and / or Traffic Assist are not functional
- DTC - B17B801 - Steering Wheel Touch Recognition Control Module evident within address 0019

- DTC B17B804 - Steering Wheel Touch Recognition Control Module electrical error - evident within address 0019

- DTC U112300 with symptom Code 1123220 within address 00A5

- 1) Referring to Rep.Gr 69 - Remove the driver's air bag
- 2) Referring to Figure 1 - Replace the Steering Wheel Contact Detection control unit (J1158)

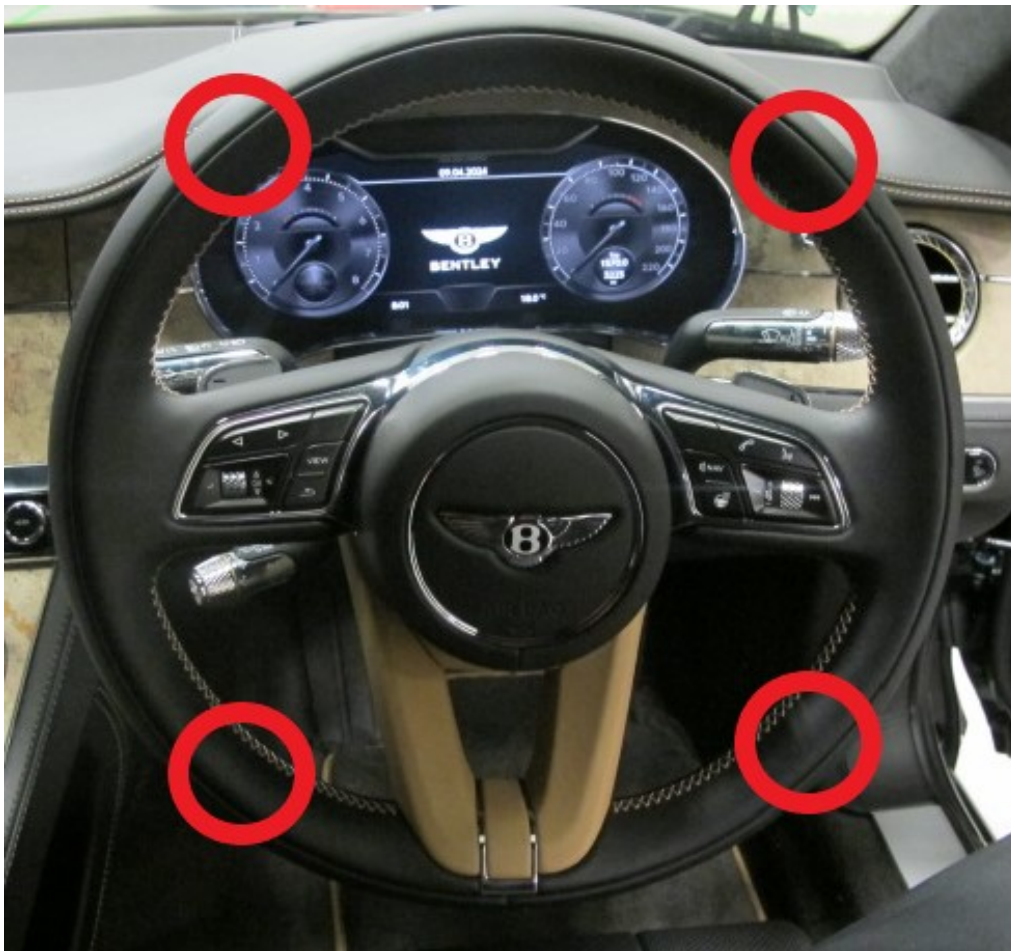
- Monitor the Sensor 2 and Sensor 3 values whilst holding the steering wheel at the points shown - **The expected values are between 40 and 60 and No malfunction Detected**

Sensor 2 and sensor 3 should recognise contact with the steering wheel and will show the values changing if the system is working to specification

- Place hands (light grip) on the steering wheel at the various points as shown in Figure 3

If the values are between 40 and 60 **No malfunction Detected** and no warnings are evident within the DIP no further action is required

In the event the issue is not resolved the operative should raise a DISS query requesting permission to replace the steering wheel
