Technical Service Bulletin

Topic	Earth Stud Anomalies 25MY
Market area	Bentley: worldwide (2WBE),China 796 VW Import Comp. Ltd (Vico), Beijing (6796)
Brand	Bentley
Transaction No.	2077094/2
Level	EH
Status	Released for publishing
Release date	Sep 24, 2025

Contamination or incorrect assembly of an earth stud.

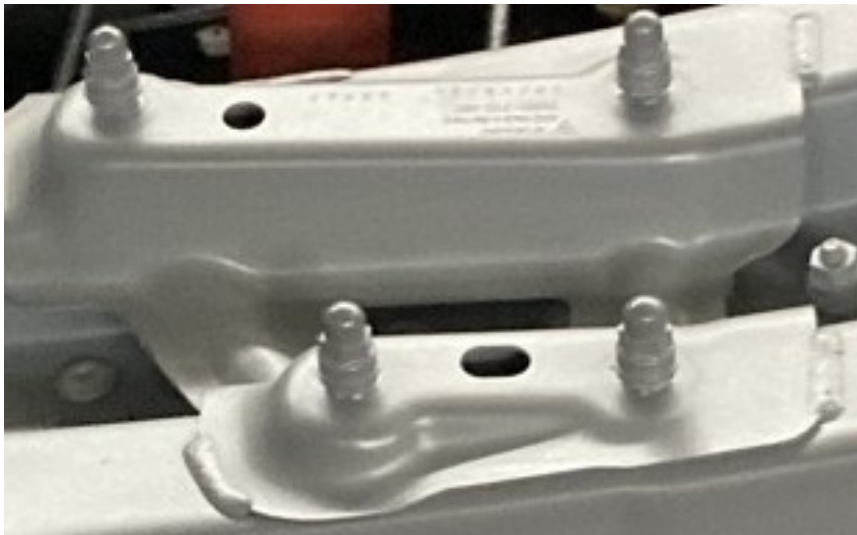
NOTE: The earth stud's shown in Figure 1 are for reference and are NOT defective.

If any earth stud anomalies are encountered, the retailer **must raise a full technical DISS query with photographic evidence (Figure 1)**, prior to any rework on the vehicle, as to capture the defective condition.
