SERVICE BULLETIN

APPLICABILITY: 2020-22MY Outback & Legacy
 2022-25MY BRZ
 2022-23MY WRX

NUMBER: 15-270-20R
DATE: 8/19/2020
REVISED: 10/10/25

SUBJECT: FOTA (Firmware Over-The-Air) Reprogramming for DENSO Gen 4 Audio / Navigation Infotainment Systems

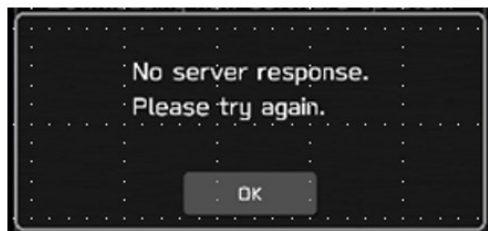
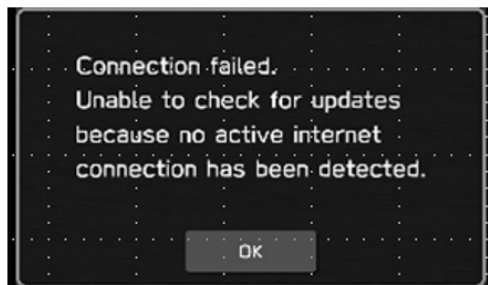
2. If you receive one of the following two messages during the update process:

- a. Check the internet connection to ensure it is active and shows full signal strength.
 - i. Select General tab under “Setting” screen and change the “Wi-Fi” to Off once then turn it back to On again.

- b. Try moving the vehicle closer to the WiFi source or if not possible, try a different WiFi connection such as a mobile hotspot.

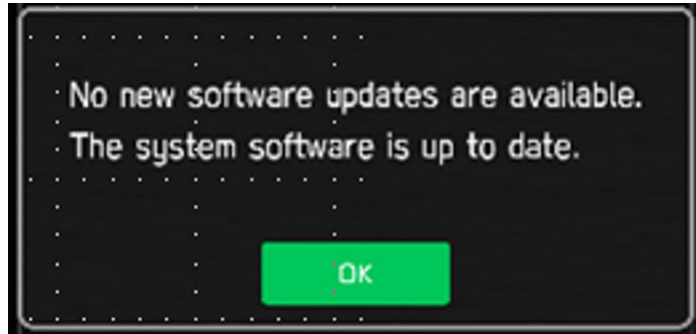
3. If the system says I'm up to date when checking for updates:

- a. If current software version is the latest, you don't need an update and no action is necessary.
- b. If the software version is not the latest, you are likely not eligible for FOTA update at this time. Please proceed with USB update following TSB 15-261-20.
4. If the "OK" button does not respond when I begin the update process:

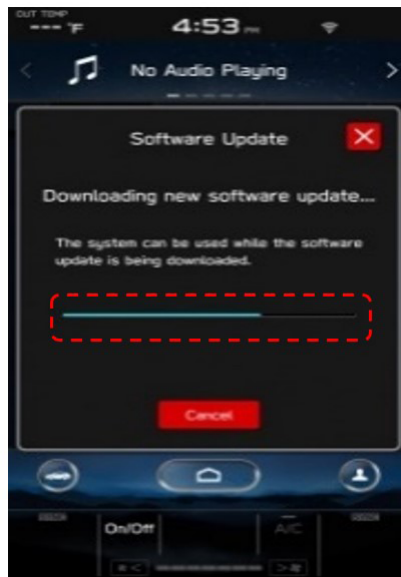
- 5. If the “progress bar” does not progress after selecting “Download” or, if you receive a “Connect to Wi-Fi” popup while downloading:

- a. Check your internet connection to ensure its active and shows full bars of connectivity.
- b. Try moving the vehicle closer to the Wi-Fi source. If that is not possible, try a different Wi-Fi connection such as a phone hotspot.

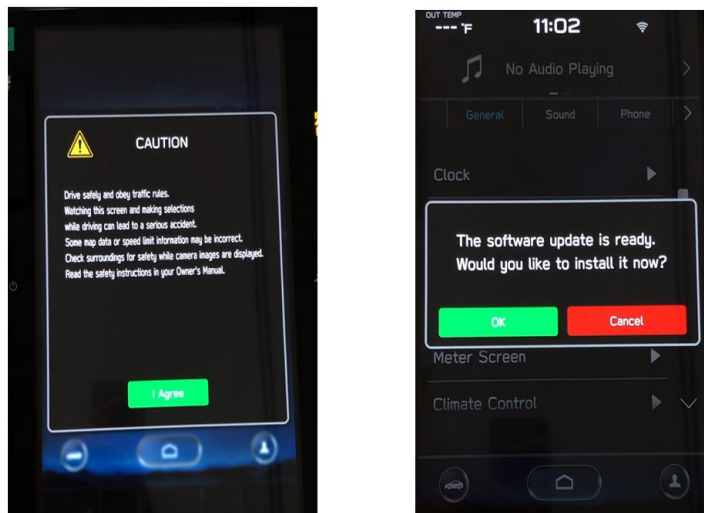
6. If you encounter a blank screen and the update restarts during the installation process:

- a. If the display screen goes blank during the installation process, leave the vehicle on and allow the system to restart. After up to two minutes, you will receive the message: “The software update is ready. Would you like to install it now?”. Press OK to continue.

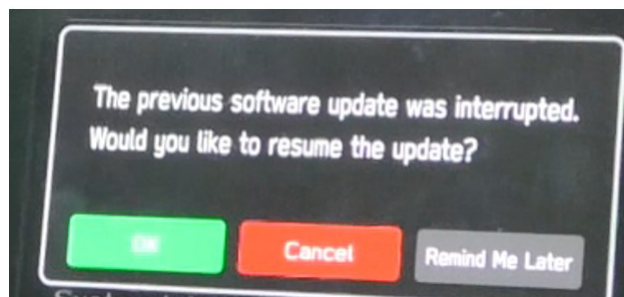
7. If you receive the following message during the update:

- a. The above message will display if the vehicle is turned off during the software update process. Select “OK” to resume the process.

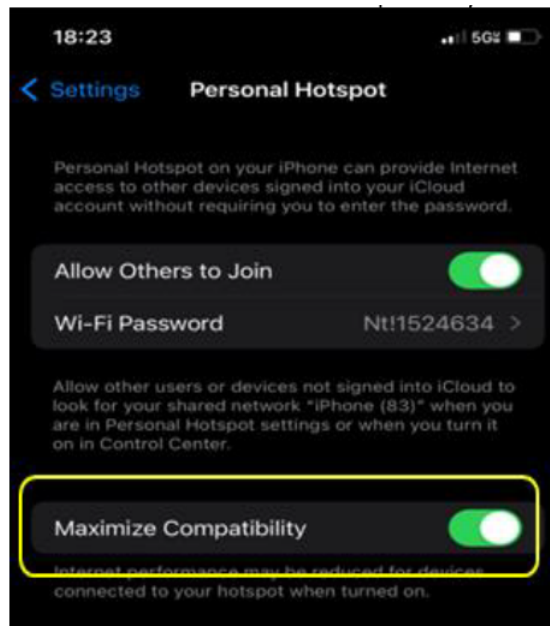
8. CP1 connectivity issues observed when tethered via iPhone hotspot (Phone as Modem/ Wi-Fi Hotspot).

iPhone hotspot, particularly in iPhone 12 and later models, prioritizes 5 GHz Wi-Fi connections, while CP1 is designed for 2.4 GHz networks. This mismatch can lead to connectivity problems.

1. iPhone Settings: Advise the customer to adjust their iPhone hotspot settings as follows:

- Navigate to Settings > Personal Hotspot.
- Enable Maximize Compatibility.

2. Frequency Confirmation: Verify the connected network on the CP1. Ensure it's operating on the 2.4 GHz band. If not, manually select the 2.4 GHz network option on the CP1, if available.

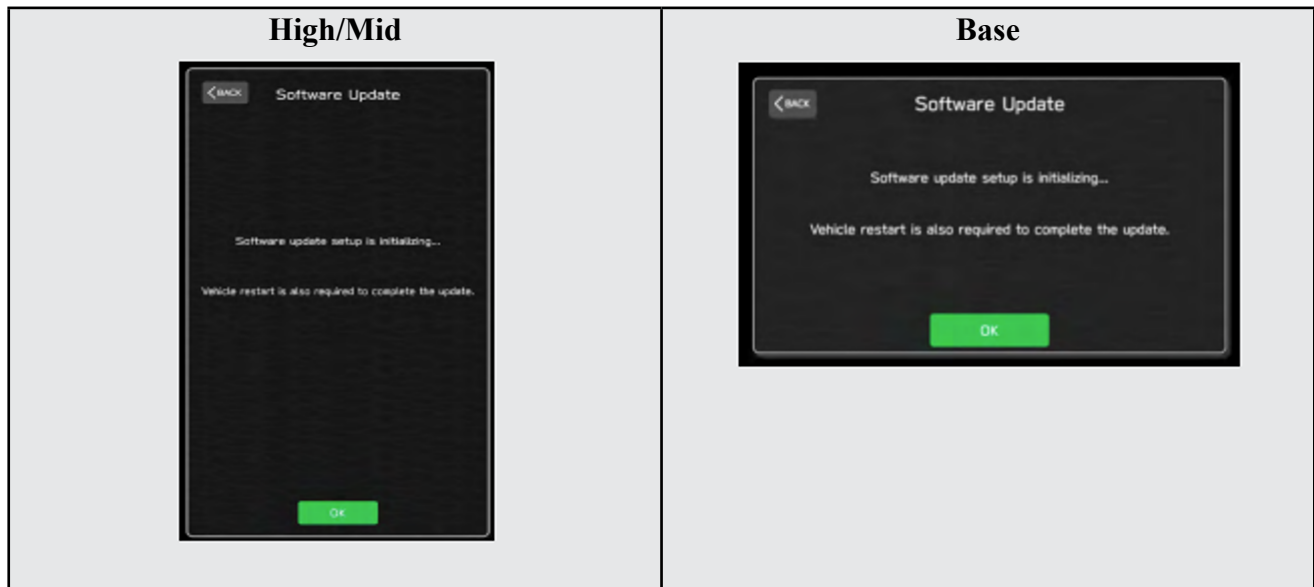
Follow this procedure in the RARE case of “Software update setup is initializing...” message is displayed: • If the screen shown below appears, WAIT for approximately 30 minutes or as long as necessary (waiting for longer than 60 minutes might indicate system malfunction).

1. Turn the ignition OFF, open the driver's door, close the driver's door and **WAIT** for 3 or more minutes before proceeding further.
2. Open the driver's door again and either turn the ignition ON (if a charger is connected) or start the engine.
3. Please proceed with USB Update following TSB 15-261-20.

IMPORTANT NOTE: If this procedure is required, contact Techline as additional action may be necessary
