## SERVICE BULLETIN

**APPLICABILITY:** 23-25MY Outback/Legacy Models (including Wilderness models)  
 23-25MY Ascent Models  
 24-26MY Impreza  
 24-26MY Crosstrek (including Wilderness models)  
 24-25MY WRX  
 25-26MY Forester

**NUMBER:** 15-305-22R  
**DATE:** 11/15/22  
**REVISED:** 10/16/25

**SUBJECT:** Reprogramming File Availability for Optimization of Gen 4.5 Denso CP1.5 Infotainment Systems

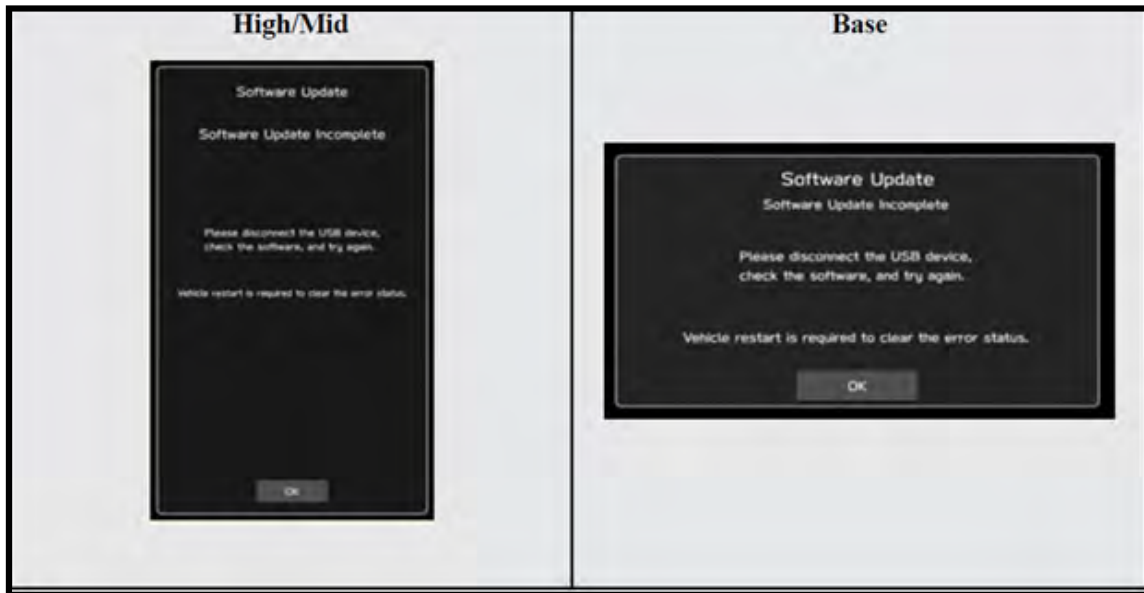
If you get the message **Software Update Incomplete** as shown below, please don't replace the hardware but retry updating the software according to the instructions in [Appendix 6 \(page 30\)](#).

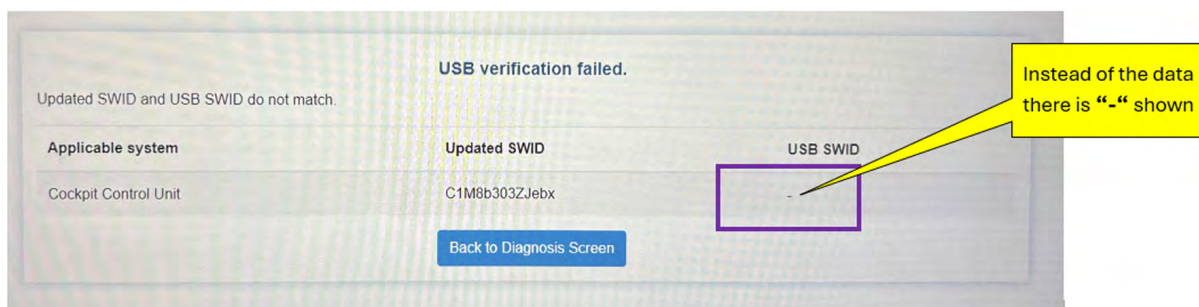
**IMPORTANT NOTE:** In rare cases when the CCU does not complete the USB authentication check in time resulting in the message box below.

This is not to be confused with a typical USB verification failure due to data mismatch.

The recovery steps are outlined below.

- Perform a soft reset of the CP1 by holding down the CID volume knob. Please leave USB Drive connected.
- Once the CP1 has restarted, retry step ii on the previous page and then press the “Start Reprogramming” button. Please wait for 2 minutes after CP1 has restarted, before press the “Start Reprogramming” button.
- If the same failure is encountered again, please proceed with the diagnostic of failure by checking the USB drive data integrity.

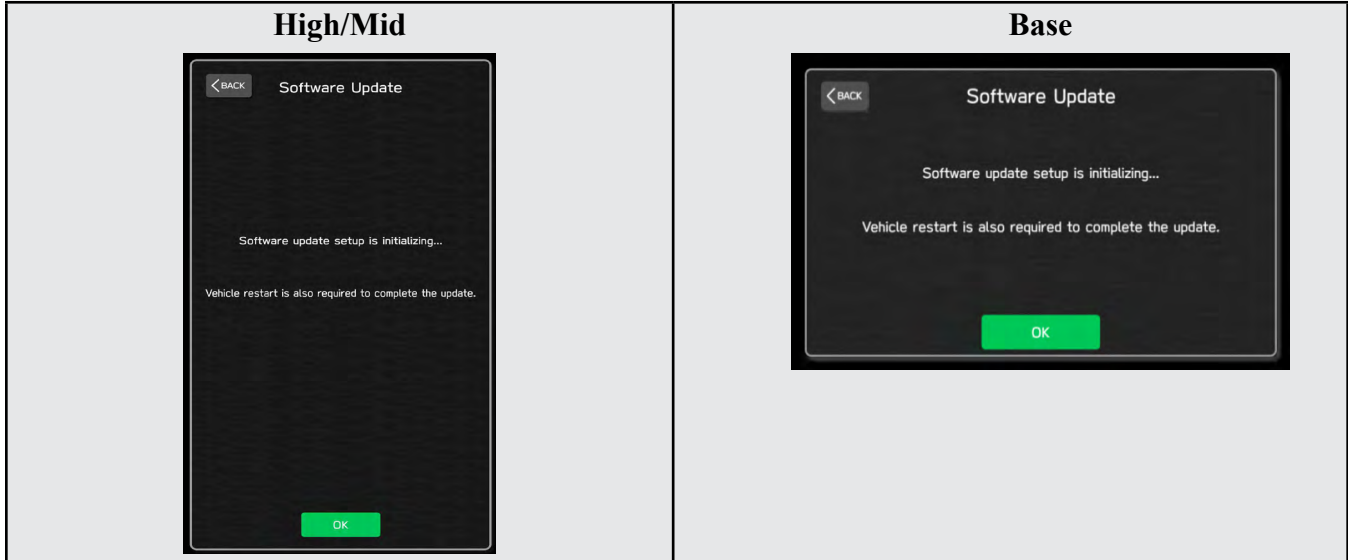
- If the screen shown below appears, **WAIT** for approximately 30 minutes or as long as necessary (waiting for longer than 60 minutes might indicate system malfunction). In that case please perform recovery according to the instructions in [Appendix 6 \(page 30\)](#) to allow the Software update setup initialization process to complete.

1. Turn the ignition OFF, open the driver's door, close the driver's door and WAIT for 3 or more minutes before proceeding further.
2. Open the driver's door again and either turn the ignition ON (if a charger is connected) or start the engine.
3. Go to Dealership Mode menu again (PRESS and HOLD the RIGHT-side temperature control buttons (both up and down) and press the Tune / Scroll knob 6 times then release all to display the Dealership Mode) and select Software Update as in STEP 4c.

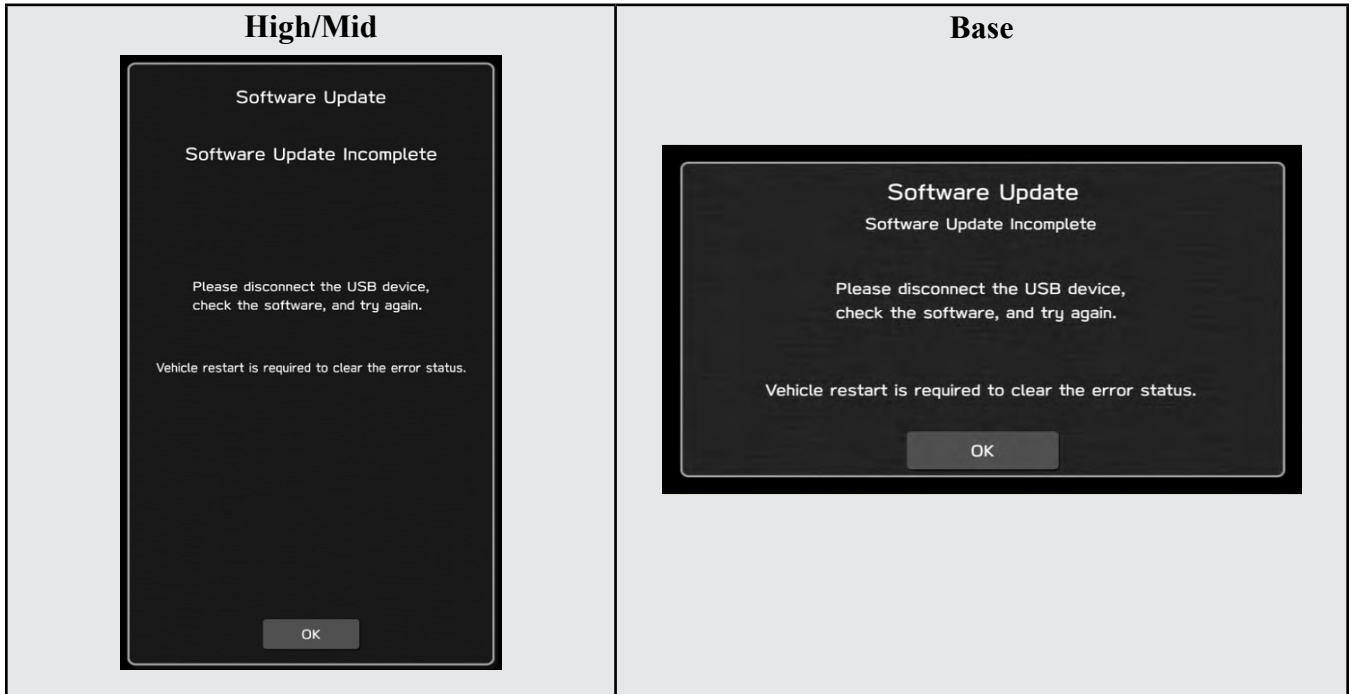
- If the first attempt of update fails with the message below, follow the steps described below 1-2 to 1-8 before retrying the software update.

### 1-1. Select OK in the screen below
