## SERVICE BULLETIN

**APPLICABILITY:** 2012-23MY Impreza  
 2013-21MY Crosstrek 2.0L  
 2014-23MY Forester 2.5(excluding Wilderness)  
 2013-19MY Legacy & Outback 2.5L

**NUMBER:** 16-156-25R  
**DATE:** 09/15/25  
**REVISED:** 10/28/25

**SUBJECT:** CVT Control Valve Body Design Change / P2757, P2762, & P06EF

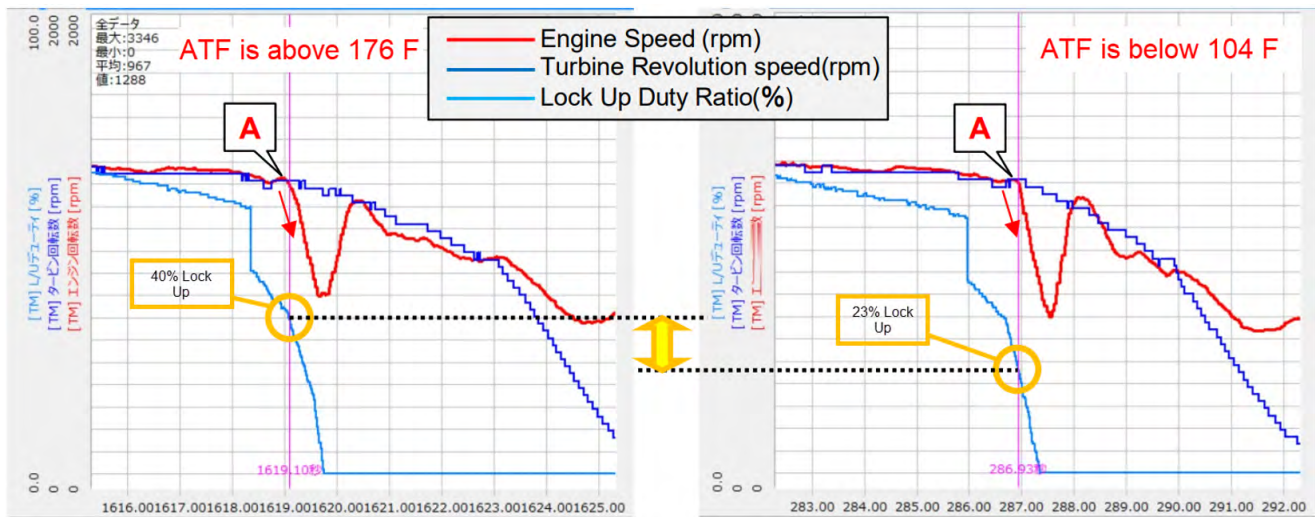
Perform a test drive while recording data using the Subaru Select Monitor, ensuring that all TCM data PIDs are captured. During the test, decelerate the vehicle from 25 mph to a complete stop twice when the CVT fluid temperature is below 104°F, and then twice more when the temperature is above 176°F. Graph the recorded data, set torque converter speed and engine speed range of 0 to 3000 rpm. Analyze the deceleration events where engine speed and torque converter speed no longer overlap on the graph (see example graphs below). At these points, determine whether there is a 10% or greater difference in the Lock-Up Duty Ratio (%) between the data recorded at 176°F and 104°F, specifically when the torque converter clutch is released.

NOTE: 'A' indicates a point where a difference occurs between the engine speed and the turbine revolution speed, marking the moment when the lock-up clutch is disengaged.

Example:  $40\% - 23\% = 17\%$

Note: To determine the difference of Lock-Up duty Ratio Subtract the Lock-Up Duty Ratio when ATF temperature is below 104°F from the Lock-Up Duty Ratio when ATF temperature is above 176°F.

**Yes** – Replace the valve body and go to Step 5.

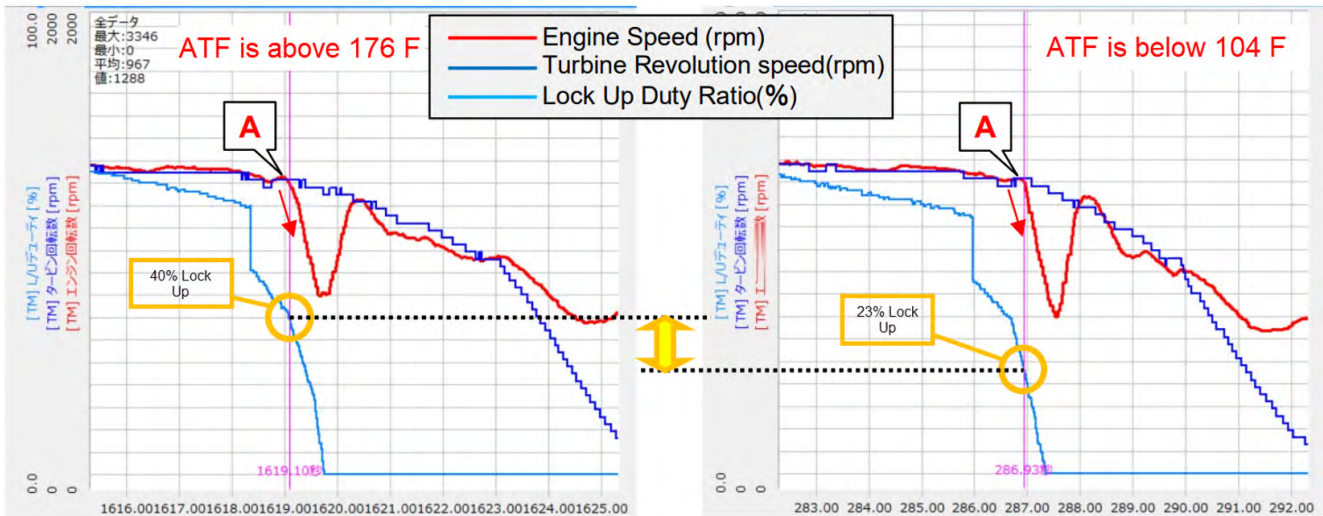
Perform a test drive while recording data using the Subaru Select Monitor, ensuring that all TCM data PIDs are captured. During the test, decelerate the vehicle from 25 mph to a complete stop twice when the CVT fluid temperature is below 104°F, and then twice more when the temperature is above 176°F. Graph the recorded data, set torque converter speed and engine speed range of 0 to 3000 rpm. Analyze the deceleration events where engine speed and torque converter speed no longer overlap on the graph (see example graphs below). At these points, determine whether there is a 10% or greater difference in the Lock-Up Duty Ratio (%) between the data recorded at 176°F and 104°F, specifically when the torque converter clutch is released.

NOTE: 'A' indicates a point where a difference occurs between the engine speed and the turbine revolution speed, marking the moment when the lock-up clutch is disengaged.

Example: 40%-23%=17%

Note: To determine the difference of Lock-Up duty Ratio Subtract the Lock-Up Duty Ratio when ATF temperature is below 104°F from the Lock-Up Duty Ratio when ATF temperature is above 176°F.

**Yes** – Replace the valve body and go to step 7.
