## SERVICE BULLETIN

**APPLICABILITY:** 2020+ MY Legacy & Outback  
 2022+ MY WRX (A/T Only)  
 2019+ MY Ascent

**NUMBER:** 16-151-24R

**SUBJECT:** TR690 Chain Slip, Judder, Shudder, & Hesitation Concerns

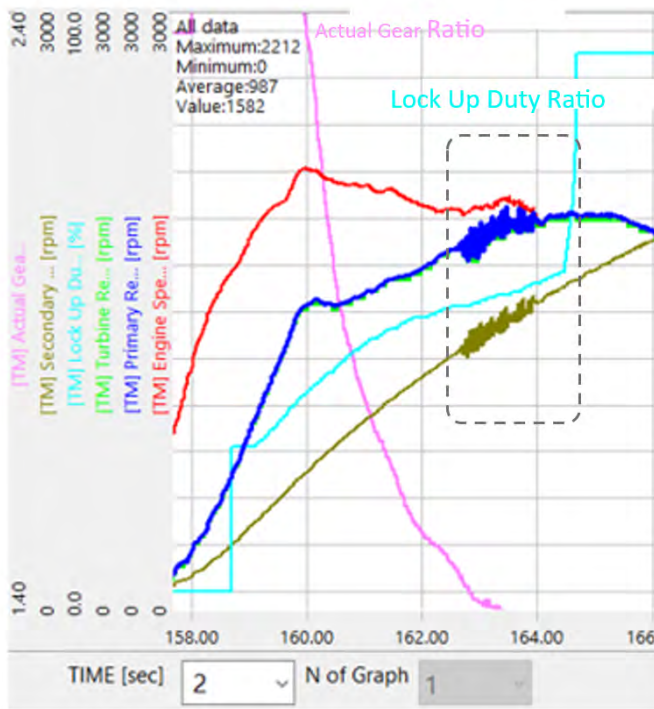
Example Graph for Lockup Judder Type A:

After the test drive has been completed with replication of the symptom, refer to the judgement criteria and example graph below to determine if the condition matches Lockup Judder Type A. If replication has not been completed, refer to the replication steps below.

**Lockup Judder Type A & B:** Torque Convertor (p.n. 31100AB460) replacement, CVT Fluid (p.n. 31333AA160) replacement, and TCM software reprogramming (newest software available).

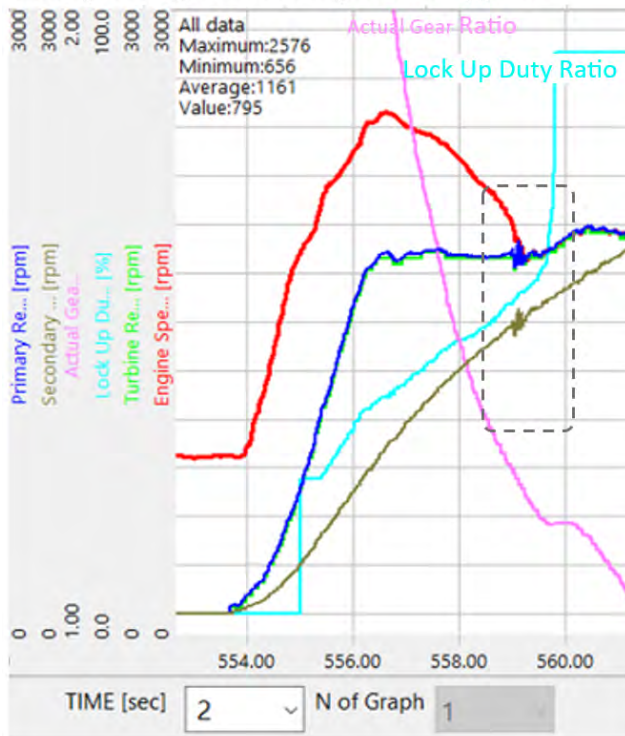
Example Graph for Lockup Judder Type B:

#### Judgement Criteria

- There are fluctuations in Turbine Revolution and Primary Rev Speed:

Peak to Peak > 50 rpm

Duration < 1 second

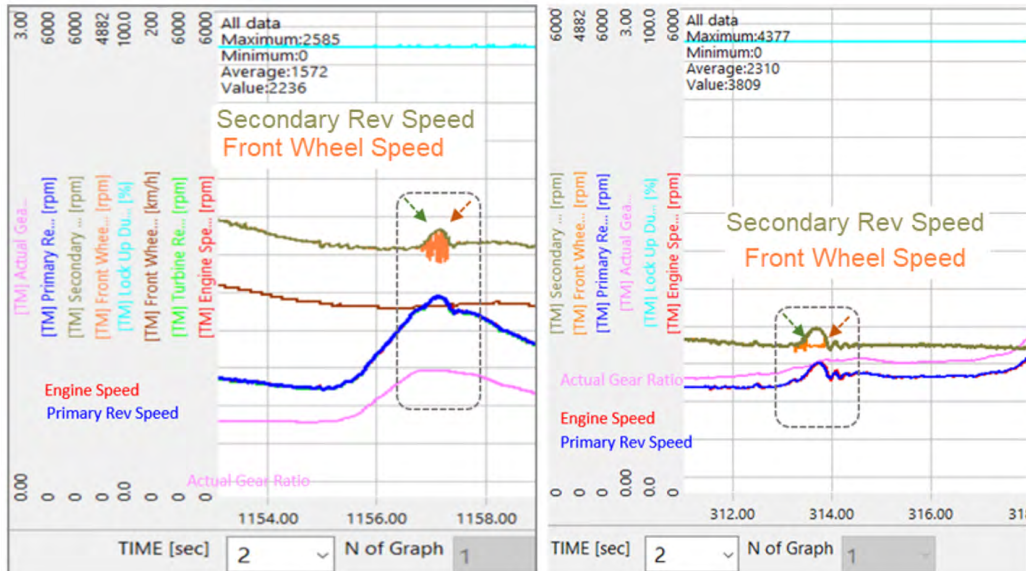
Examples Graph for Forward Clutch Judder:

#### Judgement Criteria

The rotational speeds of the upstream and downstream sides of the forward clutch do not synchronize during driving.

**Upstream side of the forward clutch:** Secondary Rev Speed

**Downstream side of the forward clutch:** Front Wheel Speed

**Forward Clutch Judder:** CVT Fluid (p.n. 31333AA160) replacement and TCM software reprogramming (newest software available).

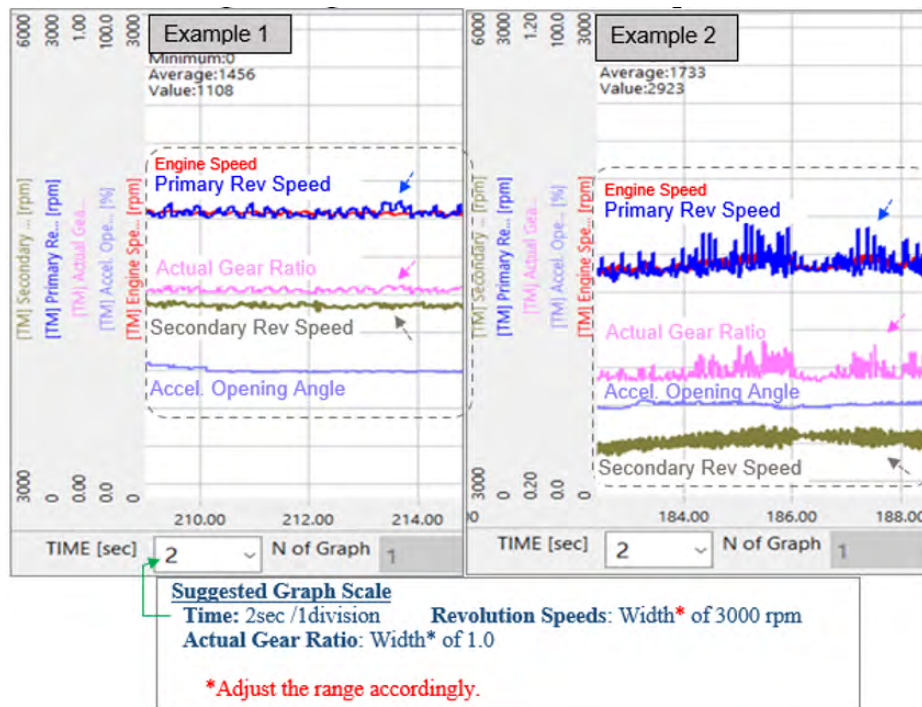
Examples of the data monitoring during Continuous Micro-Slip:

During a continuous micro-slip, while the Accelerator Opening Angle monitor displays a stable value for more than one second, there are fluctuations in the Actual Gear Ratio monitor:

**Peak to Peak > 0.02**

**Frequency > 3 cycles per 1 second**

There are fluctuations in the Primary Rev Speed and/or Secondary Rev Speed monitor:

**Peak to Peak > 50 rpm**

Using Subaru Select Monitor (SSM), check and record data monitors and compare to the three examples listed below. If the recorded data from the vehicle matches the examples below, the CVT will require replacement. The SSM data will be required for claim submission. A QMR containing the same information will also be required.

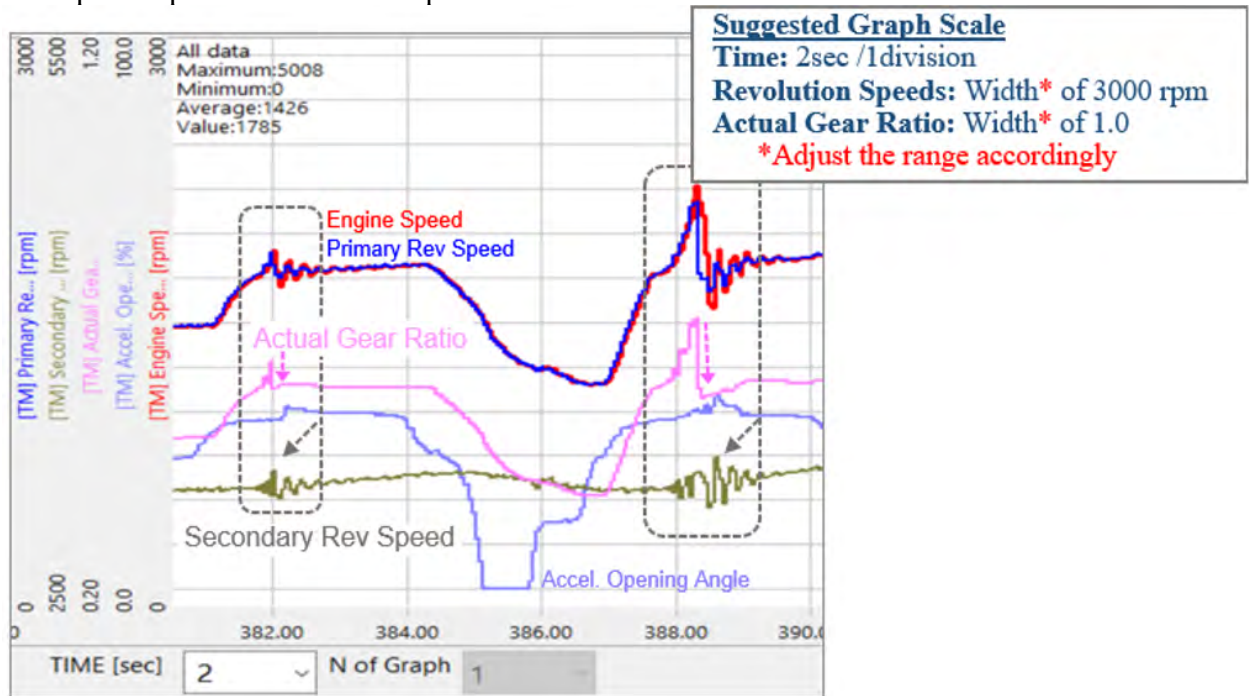
Example Graph of Short Time Slip:

When a short-time slip occurs, the changes in the Actual Gear Ratio monitor will be larger than 0.1 per 0.1 second. After the Actual Gear Ratio monitor resumes to stable conditions, distinct fluctuations in revolution speed continues.

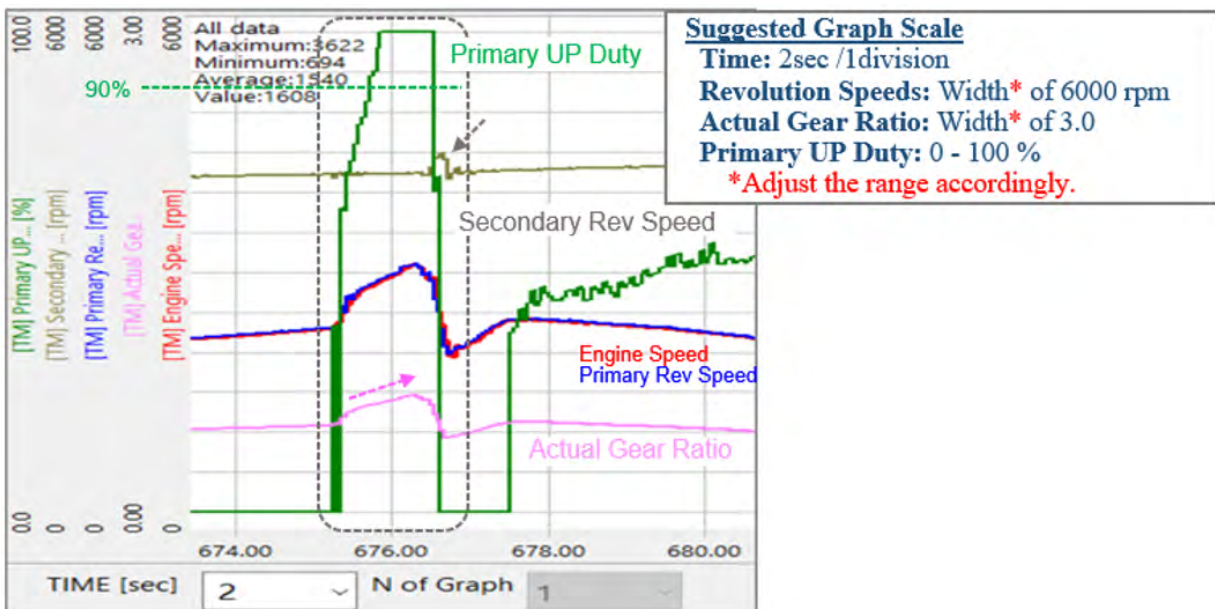
## 3. Long-Time Slip

When a long-time slip occurs, the Primary UP Duty monitor will be larger than 90% and the Actual Pulley Ratio monitor lowers for a duration of 0.5 seconds or more. Even after the Actual Gear Ratio monitor resumes to stable conditions, distinct fluctuations in revolution speed continues.
