SERVICE BULLETIN

APPLICABILITY: 2023-25MY Ascent
 2024-26MY Impreza
 2024-25MY WRX
 2025-26MY Forester
 2024-26MY Crosstrek (including Wilderness models)
 2023-25MY Outback & Legacy (including Wilderness models)

NUMBER: 15-330-25
DATE: 10/28/25

SUBJECT: CP1 Memory Initialization when restoring operation after a failed DCM FOTA update

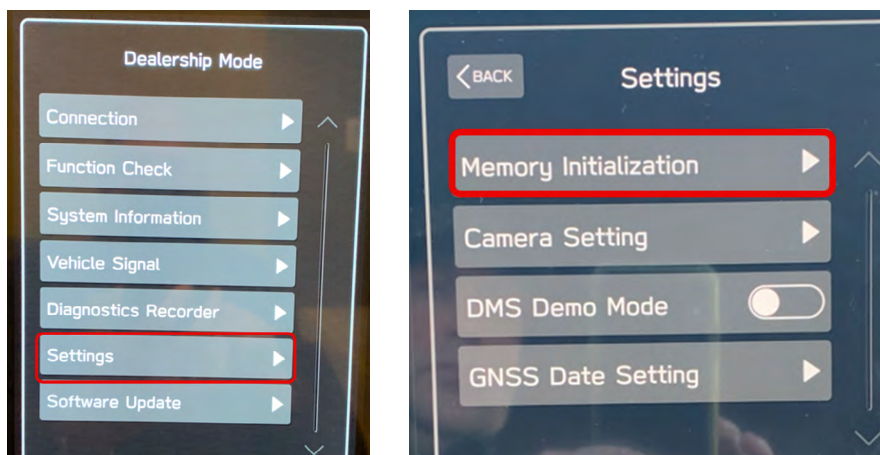
Step 3. Select Settings to access Memory Initialization screen as shown.

Step 4. Perform the memory initialization from Dealership Mode.
