## 2025 Prologue Vehicle-Wide Programming #3

Year	Model	Trim Level	VIN Range
2025	Prologue	ALL	ALL

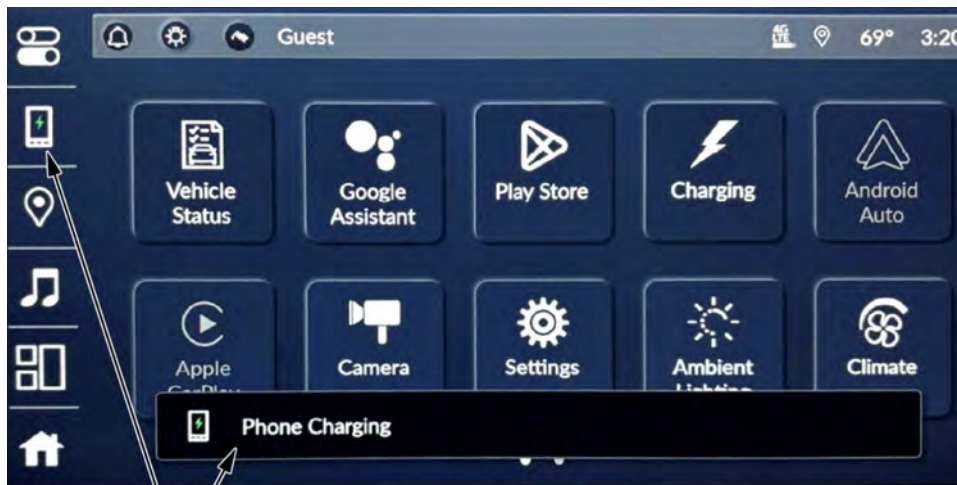
**PHONE CHARGING**

Is the phone icon flashing (on the center display) when the cell phone is charging?

- NO** – Go to step 5.  
**YES** – Go to step 4.
4. [Replace the Wireless Charging System Module.](#)
  5. Perform the VWP update.  
**NOTE:** refer to JobAid [Updating Control Unit Modules with TECHLINE CONNECT.](#)
