Programa de satisfacción del cliente 25B52

## Customer Satisfaction Program 25B52

**SUBJECT:** **Customer Satisfaction Program 25B52**  
Certain 2025 Model Year Explorer and Aviator  
Missing Audio Tile – Accessory Protocol Interface Module Software Update

## CERTAIN 2025 MODEL YEAR AVIATOR AND EXPLORER VEHICLES — MISSING AUDIO TILE

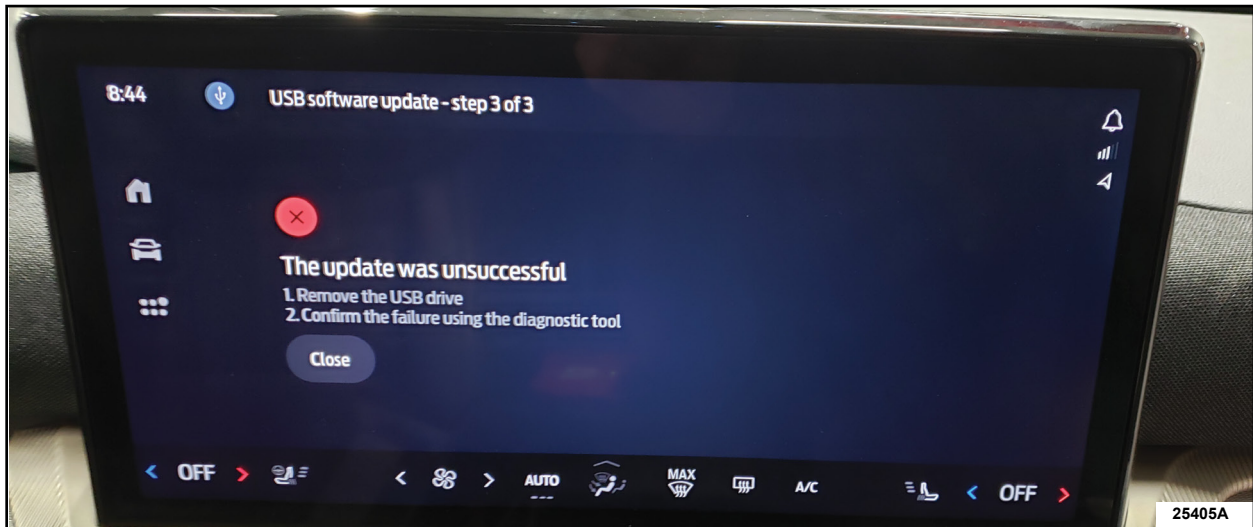
**FIGURE 2**

**NOTE:** During the APIM SW update, the center display screen may display a message stating "The update was unsuccessful". See Figure 2. Disregard this message and select Close on the center display screen. Remove the USB flash drive from the USB hub and connect it to the FDRS. Select Yes on FDRS indicating the update installed successfully. Continue by following FDRS instructions carefully.
