Service Bulletin

Bulletin No.: 25-NA-127

Subject: Air Inlet Panel Extension Assembly May Become Disengaged After Hood Open Beyond the Prop Rod Height

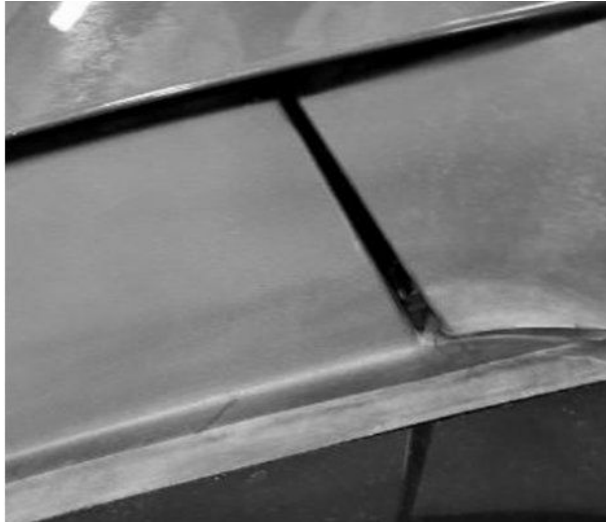
6934010

Involved Region or Country	North America, Middle East, S. Korea
Condition	  <p data-bbox="528 1547 1485 1608">Some customers may notice that the air inlet grille panel extension on the right or left side may have become disengaged from the center air inlet grille panel. 6934009</p>

These customers may also notice a gap between these components.
This may also occur if the hood has been opened recently beyond the prop rod height.

Cause	The cause of this condition may be that the hood has been raised excessively beyond the prop rod engagement point. The result is hard interference between hood hinge and air inlet grille panel extension consequentially leading to the extensions detaching from the air inlet grille panel.
Correction	Refer to the procedure below to correct this condition.

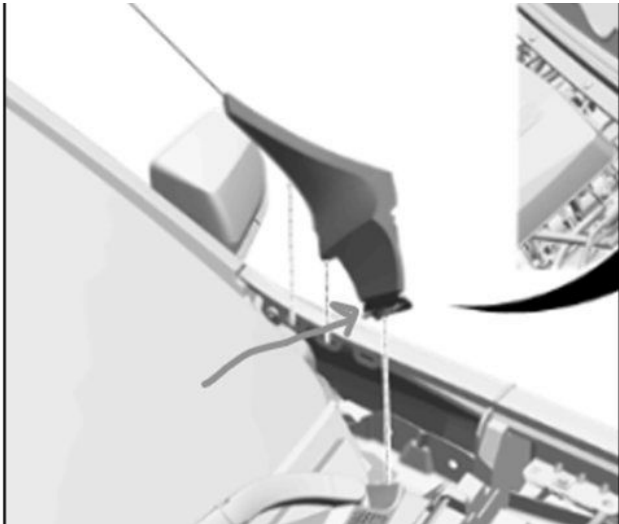
6934011

Inspect the air inlet grille panel extension clip tab for damage.

If damage exists, the affected air inlet grille panel extension must be replaced. Refer to Air Inlet Grille Panel Extension Replacement in SI. (see image on specific clip)
