Repeat DPRs for Chassis Leans

Problem Description

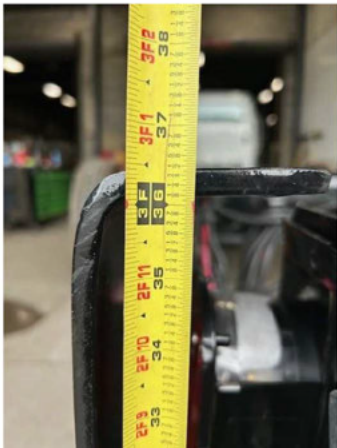
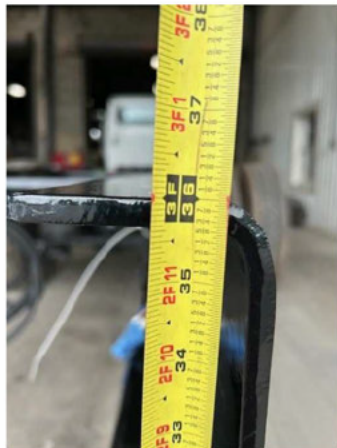
- Many trucks arriving at dealers and body builders with chassis leans greater than 3/8 of an inch

- It was found that all plants were using different methods, tools, & Wis and in some cases not enforcing the chassis lean check process

- Service hosted a series of meetings with the plant QA managers, Corp. ME, & Engineering to heighten awareness and the need for all plants to measure & document chassis lean data in ShopTech the same

- New Wis K09-P0015-049 and measuring tools were developed for the plants
