Tuftrac GEN2 Suspension Field Issues

Problem Description

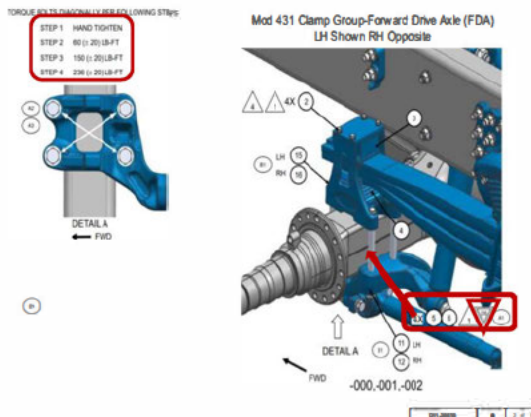
- M2/SD/X-Series TufTrac Gen 2 Clamp Group failures. Axle clamp bolts break due to improper torque at factories

- Improper torque tools for the install, Improper processes at point of install, & Improper torque audit frequency

FRACAS needs to address more than the torque issues. There are supplier part issues here bolts wont properly thread into clamps. This can cause galling which can lead to cracking and improper torque

- Quality alerts were issued at the plants and manual checks for proper torque initiated

- New pulse/torque tools being implemented at the plants for the install process to ensure proper torque and torque sequence
