# Wiring/Airing Routing and Clipping

## Problem Description

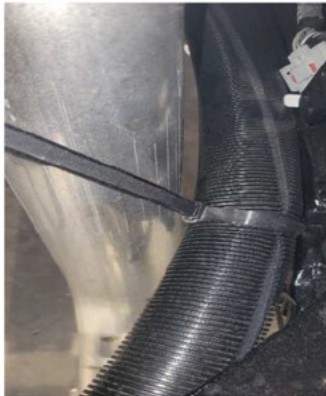
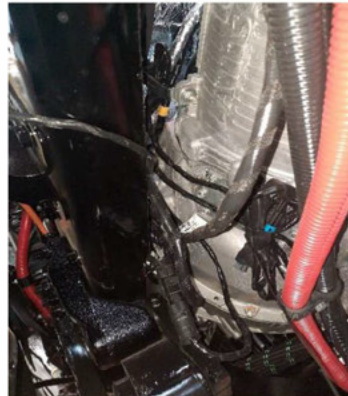
- Many customer/dealer complaints for poor routing of airlines and wire harnesses causing rubs and premature failures/breakdowns.

- Plants not following guidelines in K09-S0000-018 & K09-S0003-009 WIs

- These complaints are consistent with plants not following routing and clipping guidelines.
