Enabling Virtual Regen Request Switch in ICU Menu

TSB-54-371-FTL

Engine or Vehicle Affected:

- ▶ 108SD Plus/114SD Plus
- ▶ Business Class M2-Plus

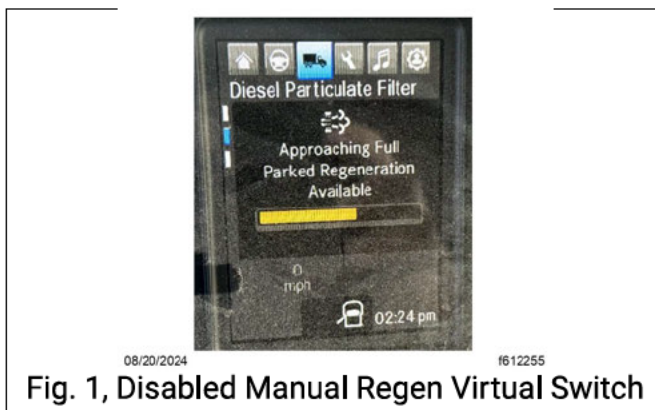
M2 Plus, 108SD Plus, and 114SD Plus vehicles built from May 9, 2023, through March 28, 2024, and equipped with a Cummins engine may experience an issue where the virtual regen request switch is not enabled in the ICUC, preventing the driver from manually requesting a regeneration. Changing the parameter in the Instrumentation Control Unit (ICUC) will enable the virtual switch. See Fig. 1. Follow the procedure below to change the parameter and reprogram the ICUC01T to enable the virtual manual regen request switch. See Fig. 2.

Fig. 1, Disabled Manual Regen Virtual Switch

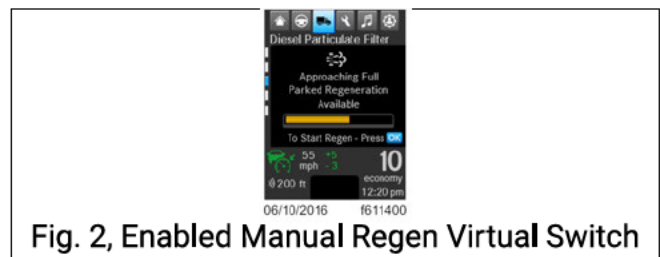
Fig. 2, Enabled Manual Regen Virtual Switch

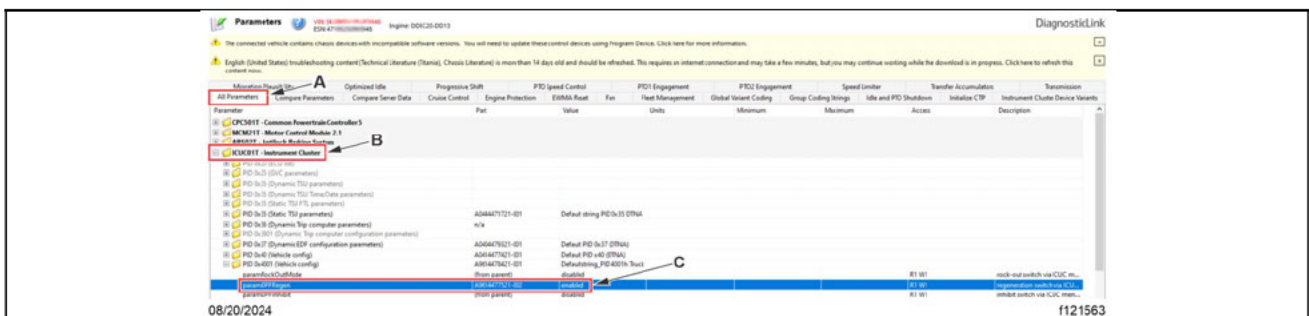
Fig. 4, Updating the ICUC Parameter Part Number

10. Select the 'paramDPFRegen' parameter, and set the parameter value to 'A9614477521-002.' See Fig. 4.

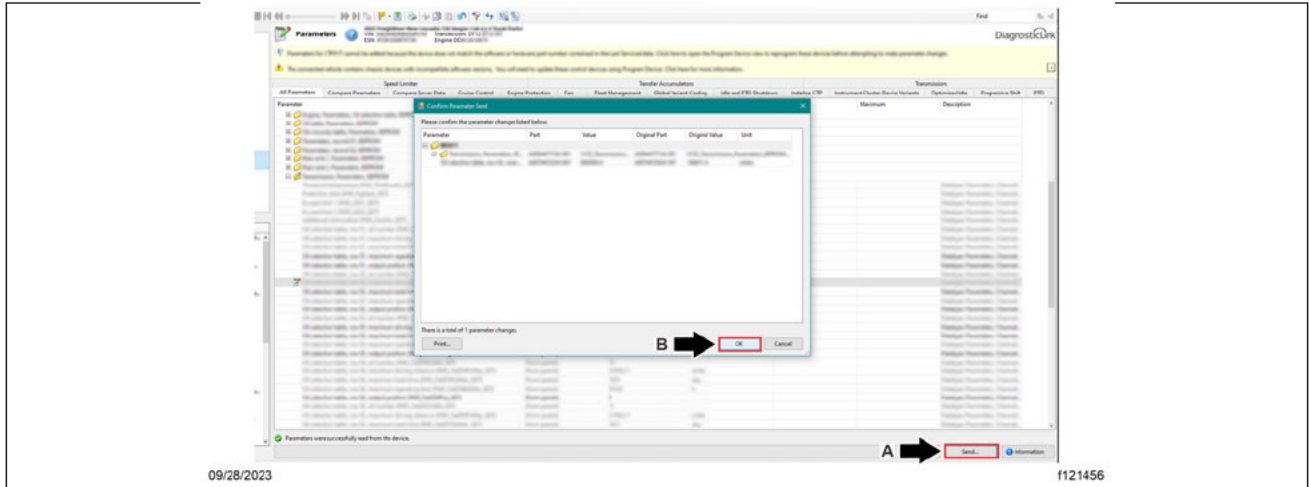
Fig. 5, Writing the Parameter Changes to the Vehicle

11. Select the 'Send' button to write the parameter changes to the ICUC01T Electronic Control Unit (ECU) in the vehicle. A window opens asking to confirm the parameter change; select 'OK.' See [5](#).

- A. Select the 'Send' button. B. Select 'OK' to confirm the parameter changes.

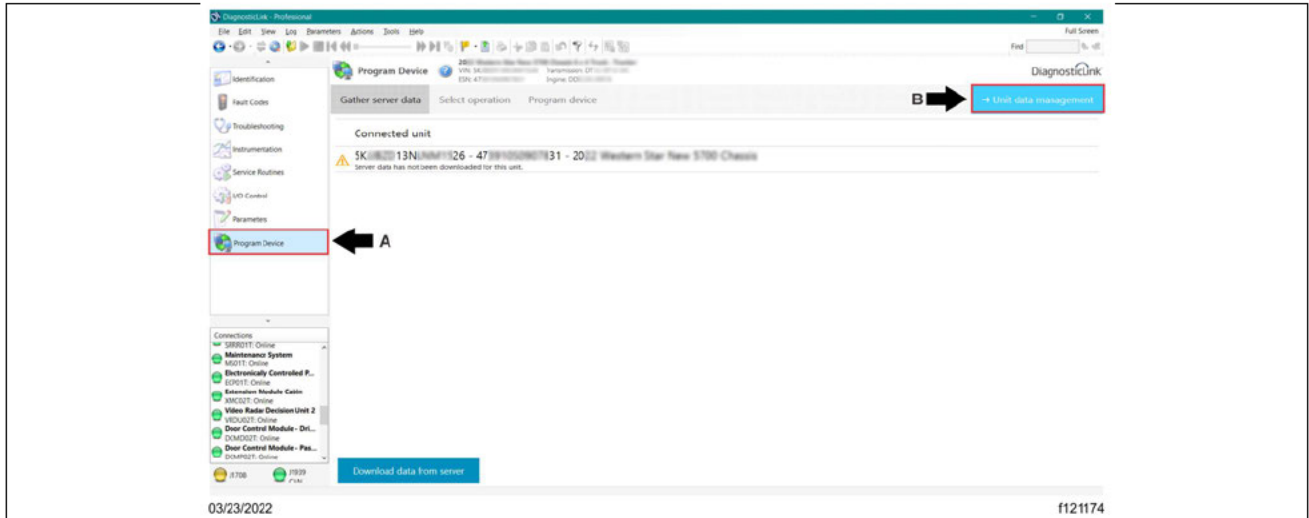
Fig. 6, Selecting Unit Data Management

12. Once the parameter change is complete, go to the 'Program Device' tab. Select 'Unit data management' in the upper-right corner. See [Fig. 6](#).

- A. Go to the 'Program Device' tab. B. Select 'Unit data management.'

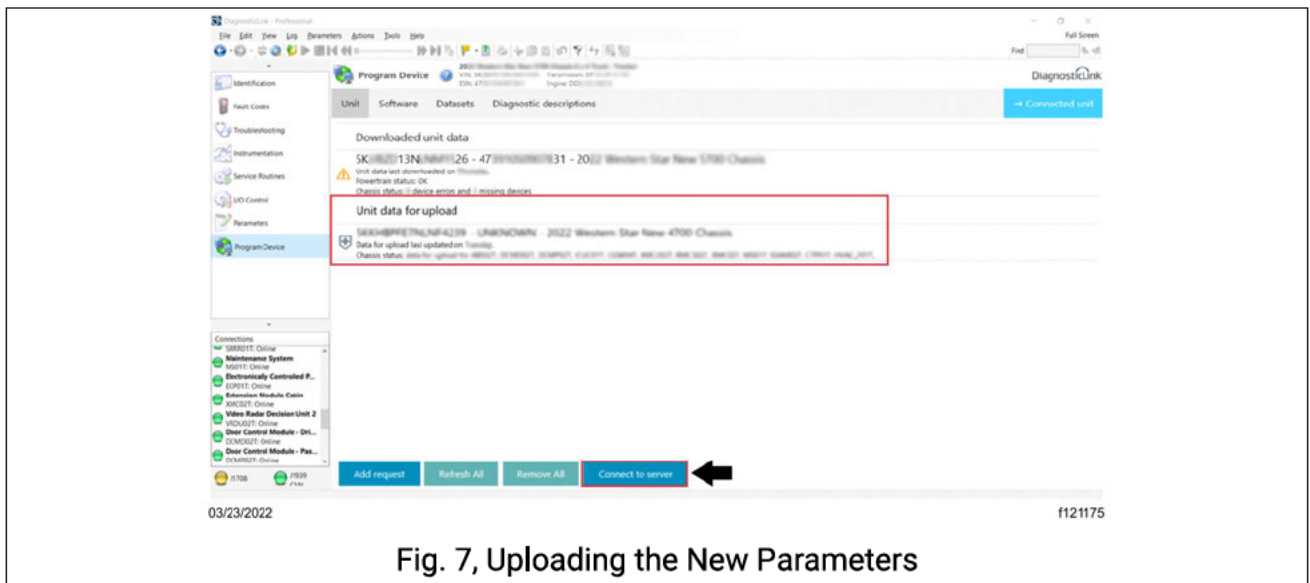
Fig. 7, Uploading the New Parameters

13. The information corresponding to the VIN should appear under the 'Unit data for upload' panel. Select 'Connect to server' to upload the new parameters. See [Fig. 7](#).
