Technical Service Bulletin

| Subject: REAR SUBWOOFER AUDIO SOUND PAUSES AT HIGH VOLUME LEVEL (Bose® AUDIO ONLY) | Bulletin No.: 09-040/25 |
| | Last Issued : 10/23/2025 |

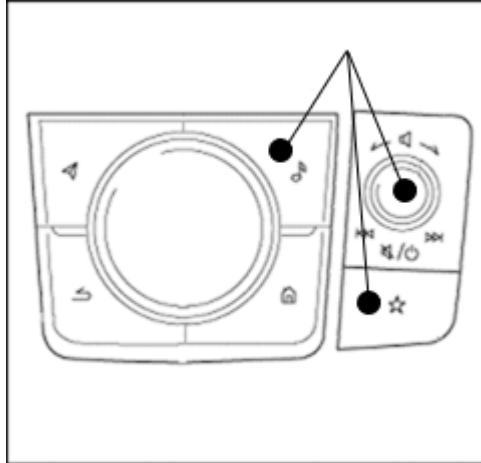
1. Verify customer concern.
 2. Confirm the audio amplifier (AMP) part number following steps a-f below.
 - a. Turn ignition ON (or ACC) with the push button start.
 - b. Press and hold the Volume Mute, Music and Favorite buttons at the same time and hold them all for 3-5 seconds.
- The "Factory/Service Inspection" screen will appear.

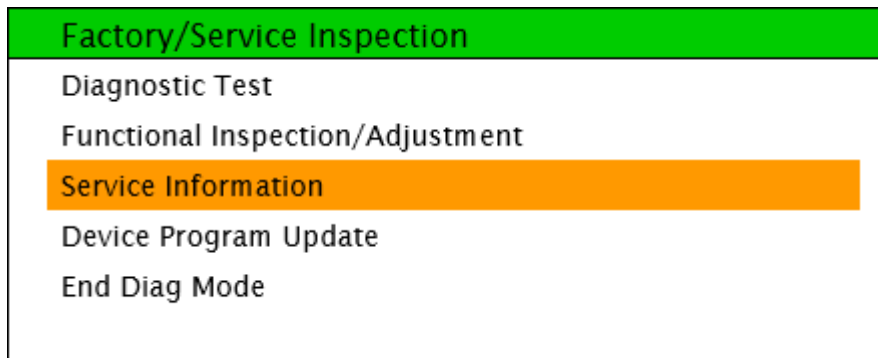
- c. Select "Service Information".

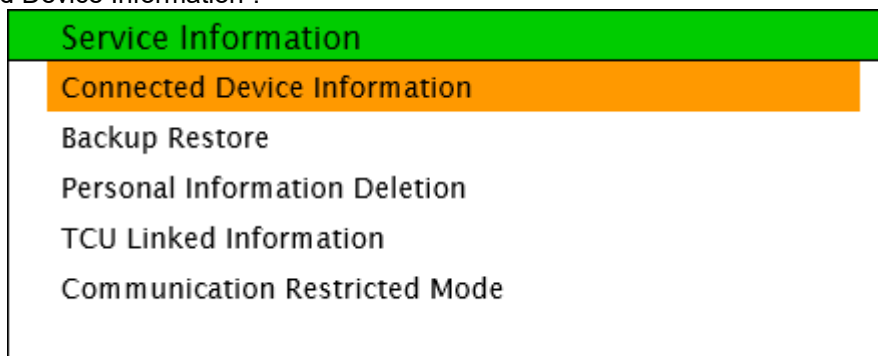
- d. Select "Connected Device Information".
