Subject: REAR BUMPER DISTORTED	Service Alert No.: SA-041/25
	Last Issued : 10/31/2025

2023 CX-50 with VINS lower than 7MMVA*****105398 (produced before May 17, 2022)

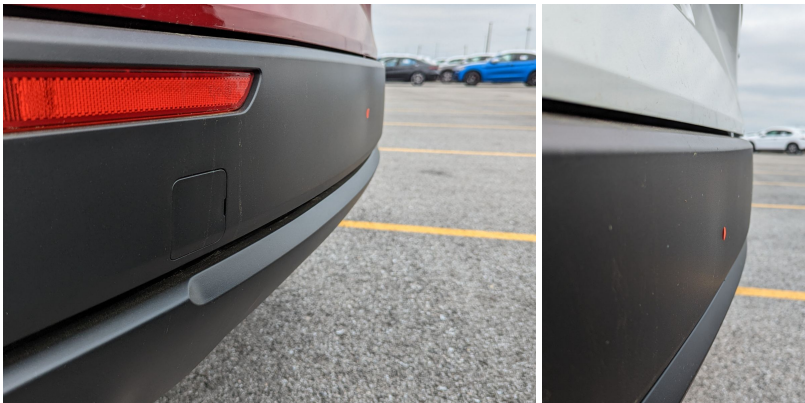
During PDI, an indentation in the rear bumper may be noticed, or in some cases, the customer may return after delivery to report the indentation. Follow the steps below to repair the concern.

Is the indentation in the same location (red dot) on the bumper as in the examples shown below?
