# Service Alert

<b>Subject:</b> <b>TELEMATICS COMMUNICATION UNIT (TCU) REPLACEMENT / ACTIVATION PROCEDURE</b>	<b>Service Alert No.: SA-047/25</b>
	<b>Last Issued : 10/07/2025</b>

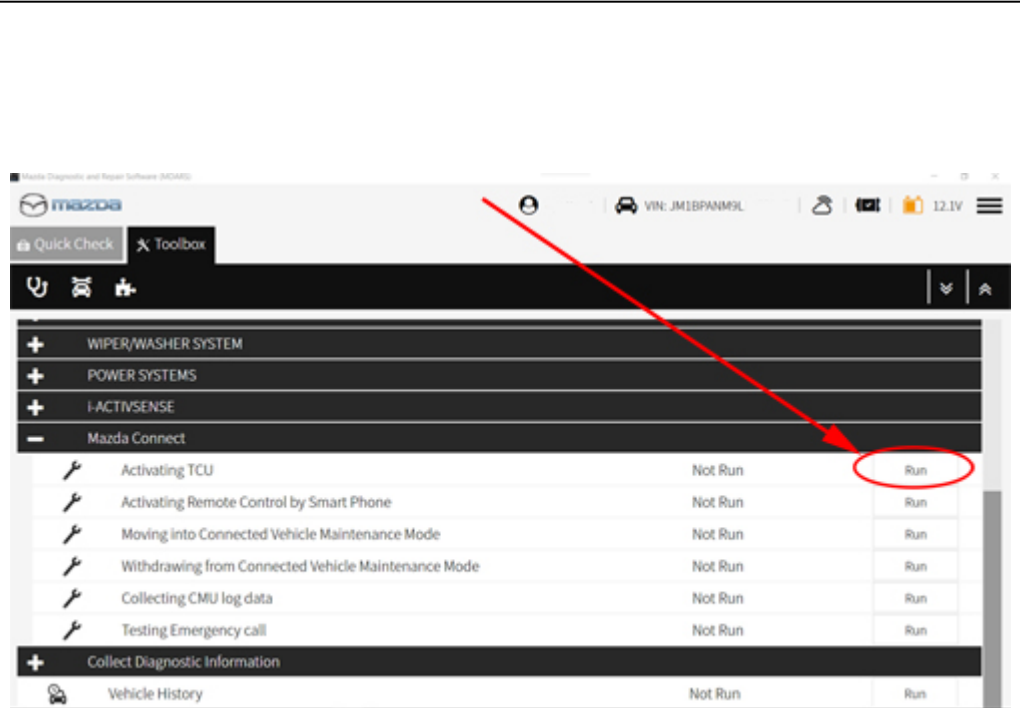
9. Select Activating TCU (links TCU to server) -> "Run". Wait for "initialization complete" message.

**NOTE:** MDARS may show "Incomplete". This may be caused by:

- Advanced key is not in the vehicle.
- Connected vehicle maintenance mode is enabled.
- Pacemaker radio wave interference prevention is enabled. See [SECURITY AND LOCKS-RELATED PARTS PROGRAMMING \[SECURITY AND LOCKS\]](#)
- key transmitter power saving function is enabled. See [SA-020/21](#).

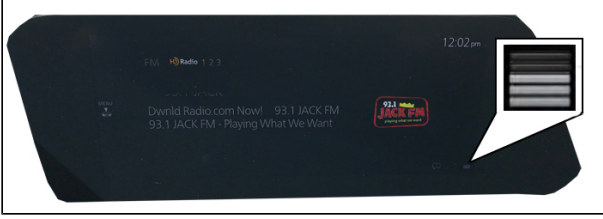
If customer was previously enrolled, reception strength icon will show normal

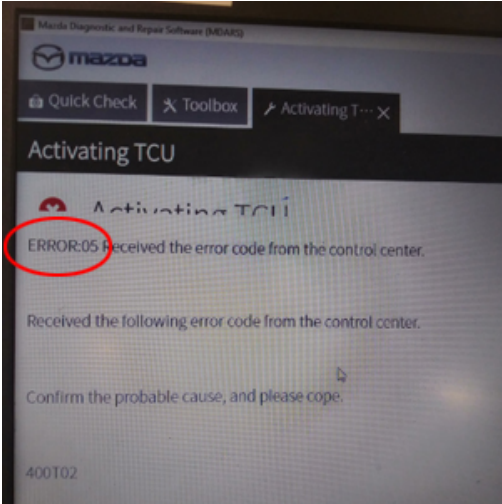
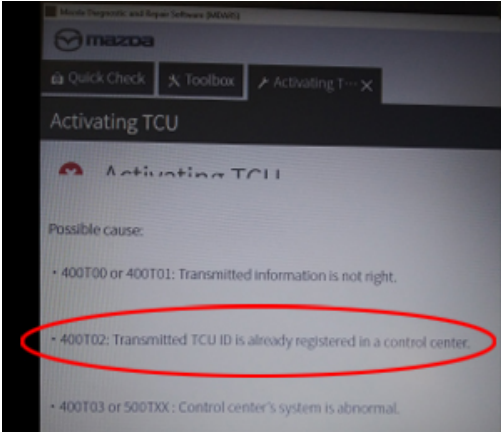
ERROR:05	Error code 400t02

- If DTC U2050:55-TCU (Activation of remote control not implemented) is stored, go to TSB [09-013/20 - DTC U2050:55 STORED AFTER REPLACING OR REPROGRAMMING TCU](#).
- If the TCU was not replaced and MDARS shows error code 400t02 and/or ERROR:05, TCU activation was previously completed. Ignore these errors as TCU activation is not required.
