L636-A.19.25

Panoramic roof gasket

Urus SE

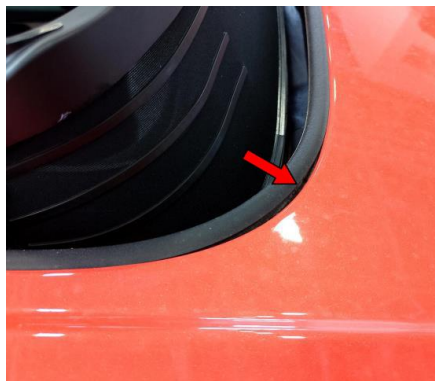
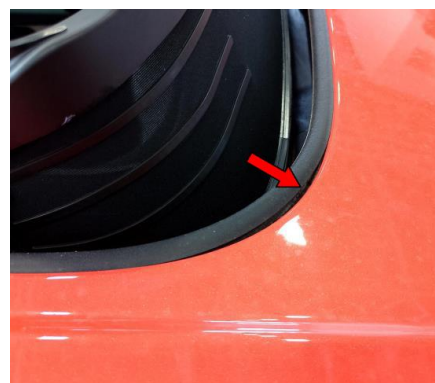
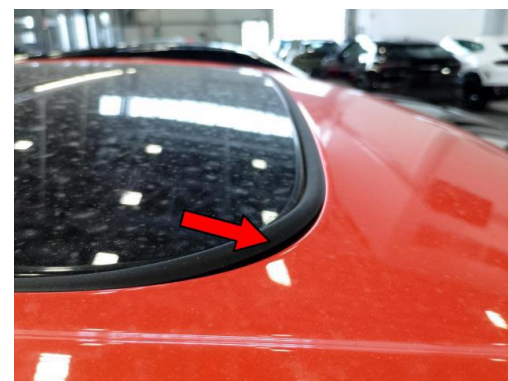
During ongoing product monitoring, Automobili Lamborghini S.p.A. identified a visual imperfection in the panoramic roof gasket

If the issue shown in the following image is identified, proceed with Operation B. Otherwise, the check concludes with Operation A

Replace panoramic roof gasket

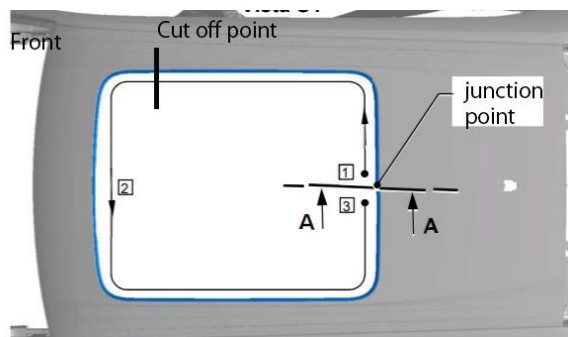
1. Check the perimeter of the sunroof, especially the corners.
