Keystone RV Company

10/31/25

SERVICE ADVISORY # 25-474

Underslung Axle Tank Clearance

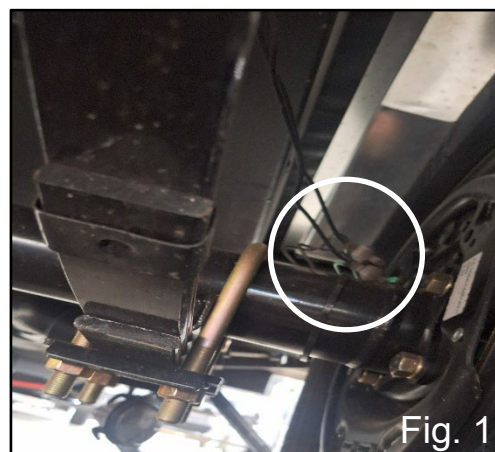
Fig. 1

Disconnect the wiring from the brake backing plates. Make note of how the wires connect to the unit as they will be reconnected in a later step. (See Fig.1)

Connect the wires from the brake backing plates on the new axle to the previously disconnected wires in Step 7.

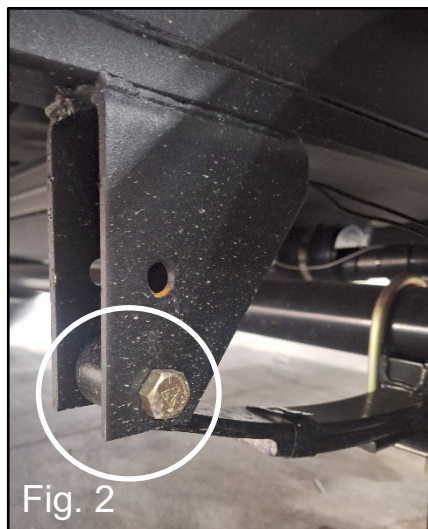
Remove the existing AP axle kit hardware. Remove the existing underslung axle from underneath the unit. (See Fig. 2 – Fig. 3)

Install the overslung axle using the new AP hardware kit. (KRV # 600065 - Axle – A/P Kit – Single – Wax Flange Nuts) in the same manner as the previous AP hardware was installed. (See Fig. 2 – Fig. 3)

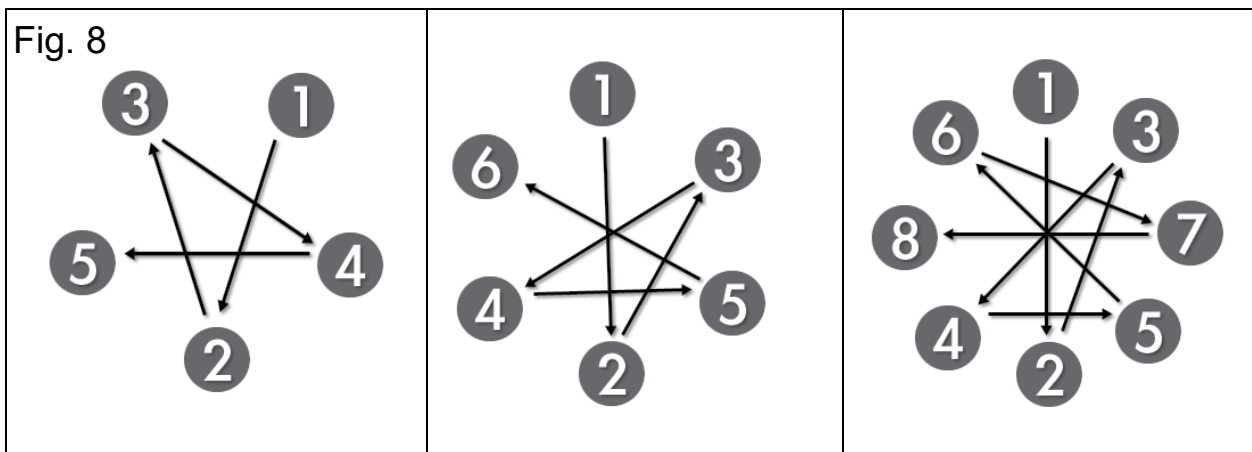
You must use the star pattern and torque wrench when tightening the lug nuts to the wheel. This sequencing pattern shows how to progressively tighten the lug nuts to best achieve the proper torques and clamp load. (See Fig. 8)

Using the star pattern outlined in Fig. 8, tighten the lug nuts until the 1st stage torque (20-25 ft/lbs.) Verify the lug nuts are properly positioned in the tapered seats of the wheel. (See Fig. 9)

Using the star pattern outlined in Fig. 8, tighten the lug nuts until the 2nd stage torque (50-60 ft/lbs.) (See Fig. 9)

Using the star pattern outlined in Fig. 8, tighten the lug nuts until the 3rd and final stage (110-120 ft/lbs.) (See Fig. 9)
