## Technical Service Bulletin (TSB)

### Gasoline Particulate Sensor Lines Incorrect Routing

| REFERENCE: | TSB: 25-001-25 REV. A<br>GROUP: 25 - Emissions Control | Date: | October 29, 2025 | REVISION: | 25-001-25 |

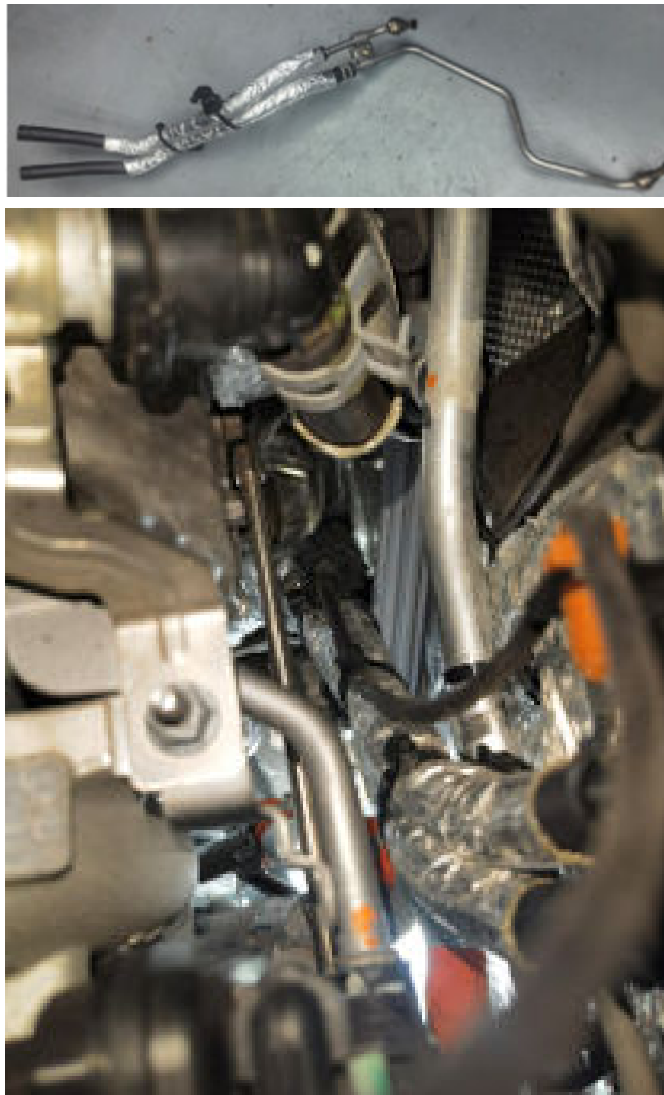
**Fig. 1**

Correct Orientation

1. Using wiTECH, select PCM and then the Data menu. Monitor the PFPS DELPRESS signal for changes when varying RPM.
2. Does the PCM -PFPS DELPRESS (PSI) signal vary with RPM?
  - YES>>> This bulletin does not apply. Use Inspect LOP (25-06-06-02) to close the active RSU.
  - NO>>> Proceed to [Step 3](#).
3. Return the gasoline particulate differential pressure sensor lines to the correct orientation. Refer to the detailed service procedures available in DealerCONNECT/Service Library under: Service Info> 11 - Exhaust System / SENSOR, Differential Pressure / Removal and Installation.

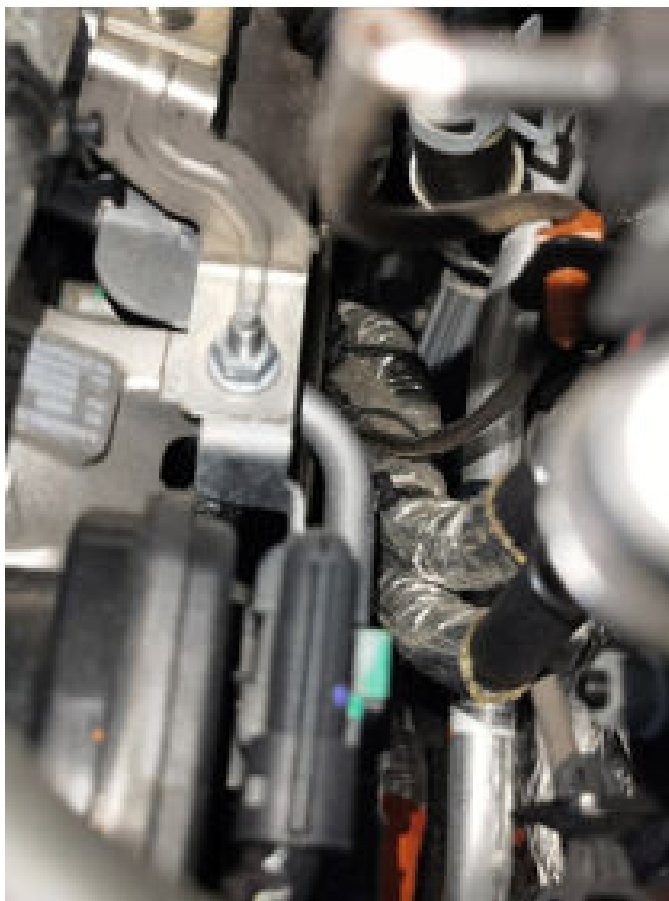
**Fig. 3**  
Incorrect Orientation
