STAR ONLINE PUBLICATION

Case Number: S2508000095

Symptom/Vehicle Issue: Cluster Displays “Blindspot Alert Unavailable Service Required” Warning Message, Driver/Passenger Mirror Blind Spot Detection Lights Stay ON, ADAS Features Disabled. Multiple DTC’s Active Or Stored

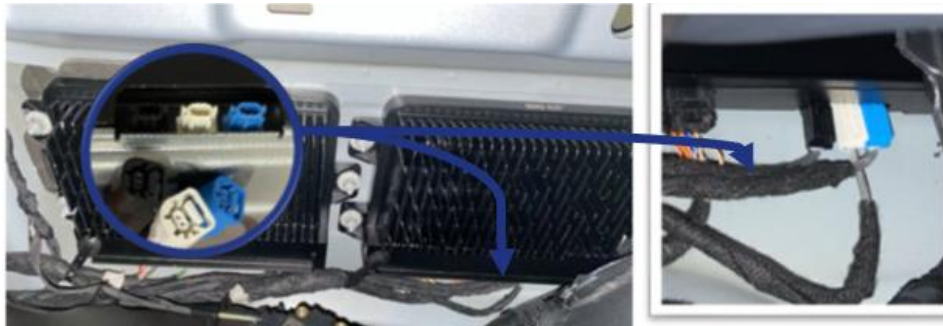
- **Connector**
 - *Ensure all 3 Ethernet Connector(s) are properly installed, fully inserted and clicked into place*
- **Replace the Ethernet Harness for any of the below conditions. DO NOT REPAIR ETHERNET CABLES; DID-I - Upload Image of Harness/Connectors at CADM (MID), CADM2 (MAP) and GNMM**
 - *Bent, pushed out, or misaligned pins/terminals (male and female sides)*
 - *Fretting corrosion (small black or dark spots)*
 - *Pulled, loose, wiggly, or poorly crimped wires at the harness side*
 - *Evidence of overheating, burning, or melted plastic*
 - *Signs of crimping, excessive strain (see Figure 2 below), or improper routing to the harness/cables*
 - *In event of intermittent fault persists*

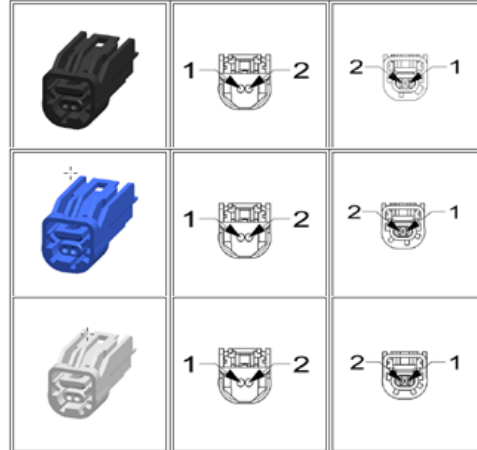
Figure 2: Inspect Ethernet Connectors

MAP ↔ MID
ENET-AD2

MAP ↔ GNMM
ENET-AD3

MAP ↔ SGW
ENET-AD1
