## STAR ONLINE PUBLICATION

**Case Number:** S2508000097

**Symptom/Vehicle Issue:** Driver And Passenger Blind Spot Camera View Soft Key On Radio Screen Displays Surround Camera View Instead

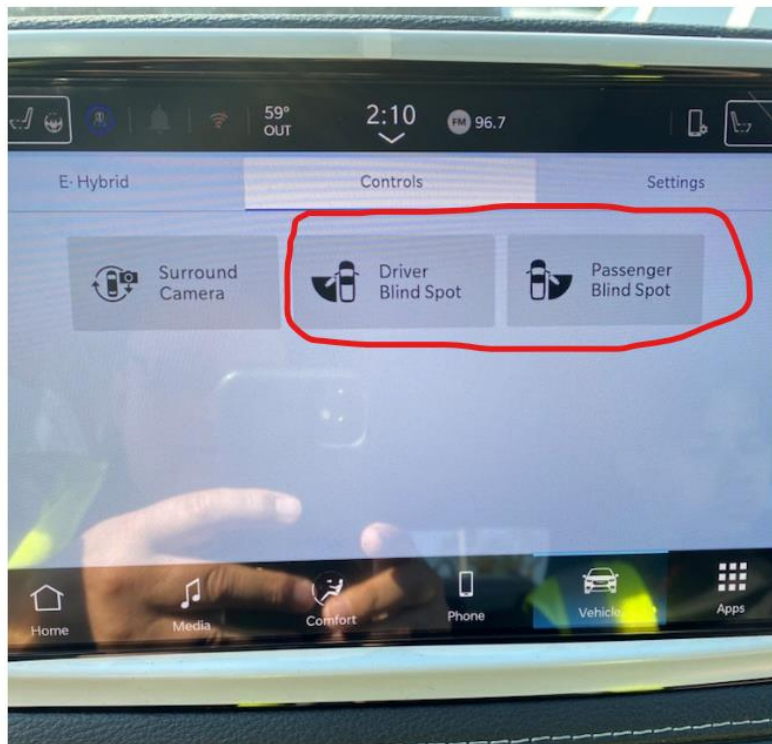
**Driver and Passenger Blind Spot Camera View Soft Keys**

**Discussion:** The customer may discover that when pressing the driver or passenger Blind Spot Camera view soft key, that the Surround Camera view is incorrectly displayed instead.

The Blind Spot Camera view feature was not intended to be available on 2026 Model Year RU (Pacifica). The feature was intended to be released starting in 2027 Model Year. The Blind Spot Camera view soft keys are improperly displayed with Radio software U40.20 (U40C) on 2026 Model Year RU.

**Do not replace any components for this concern.** Advise the customer that the vehicle was not intended to have this feature, and this is why it is inoperative. Engineering is developing a Radio software update for 2026 Model Year to eliminate the Driver/Passenger Blind Spot Camera view soft keys from the radio. Tentative timing for this release is second quarter of 2026.
