Porsche Mobile Charger NEMA Supply Cable Initialization Failure

Vehicles Affected

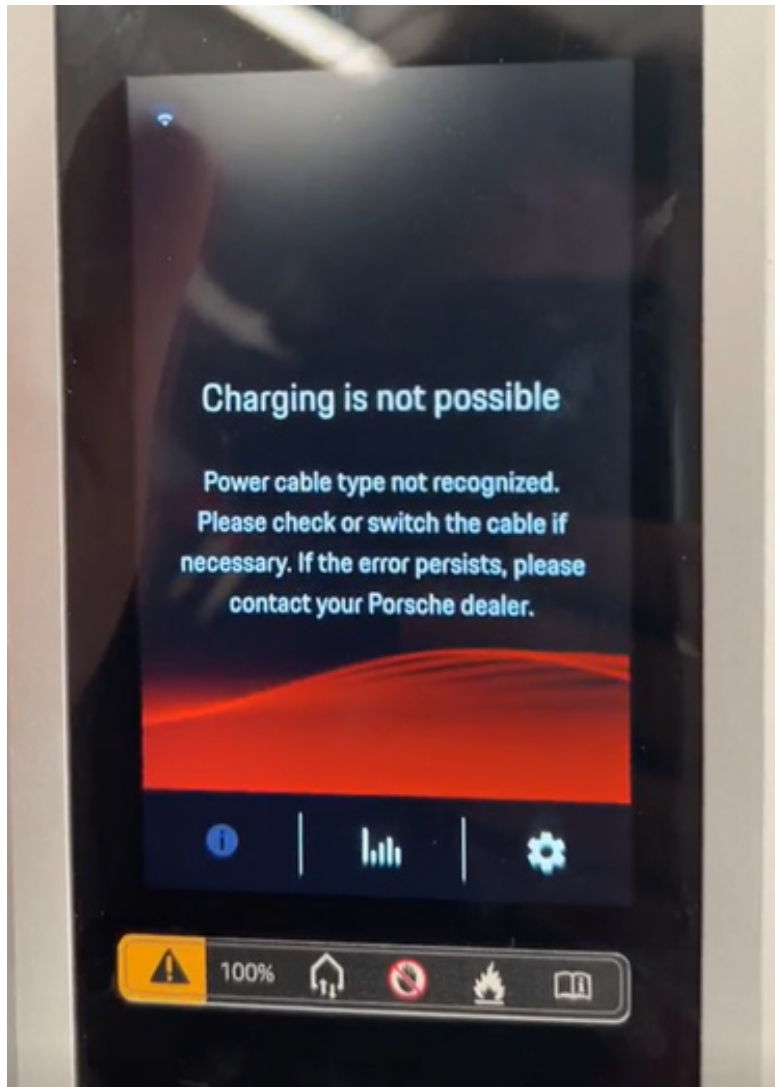
A similar fault occurrence can present in the PMCC variants on start-up. The lights will illuminate red after plugging into the power outlet, with the message in Figure 3 shown on screen.

While the Operating Instructions recommend removing and reinserting the power plug, this does not always remedy the condition. There is currently no known correlation of this condition to supply cable production date. If a charger exhibits the described behavior with a particular supply cable, normal operation cannot be guaranteed with a power supply cable of later production date. Each cable must be physically tested with the customer's charger at the Porsche Center to confirm functionality before returning the updated charger and new supply cable to the customer.

This condition is not directly a fault of the temperature-sensing supply cable. New cables that do not work on the affected PMC+/PMCC devices demonstrating this condition can work normally on PMC Basic part number variants with updated software. If the customer PMC+/PMCC continues to display this behavior with at least 5 replacement supply cables after multiple outlet plug-in cycles, it should be replaced. **Please test 5 different supply cables before replacing the PMC+ or PMCC.**
