Surround View Camera Intermittent Operation

Models	Model Year	Model Type	VIN Range	Vehicle-Specific Equipment
911	As of 2020 up to 2024	992	N/A	KA6

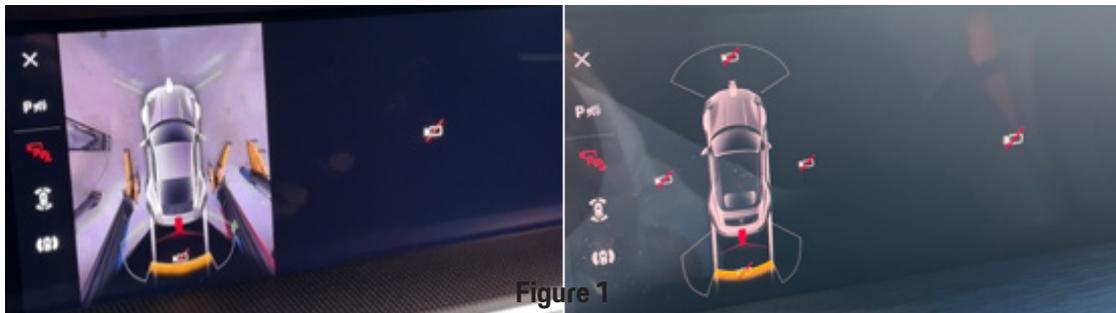
Customer complains of intermittent operation for one or multiple surround view cameras. Failed surround camera(s) appear blank with a crossed-out camera icon.
