Technical Service Bulletin

Continental GT/C - Flying Spur - Bentayga Series

Transaction No.:
2075331/3

Engine light in the DIP - Various oxygen sensor / Fuel ratio DTC's logged within the Engine Control Module(s)

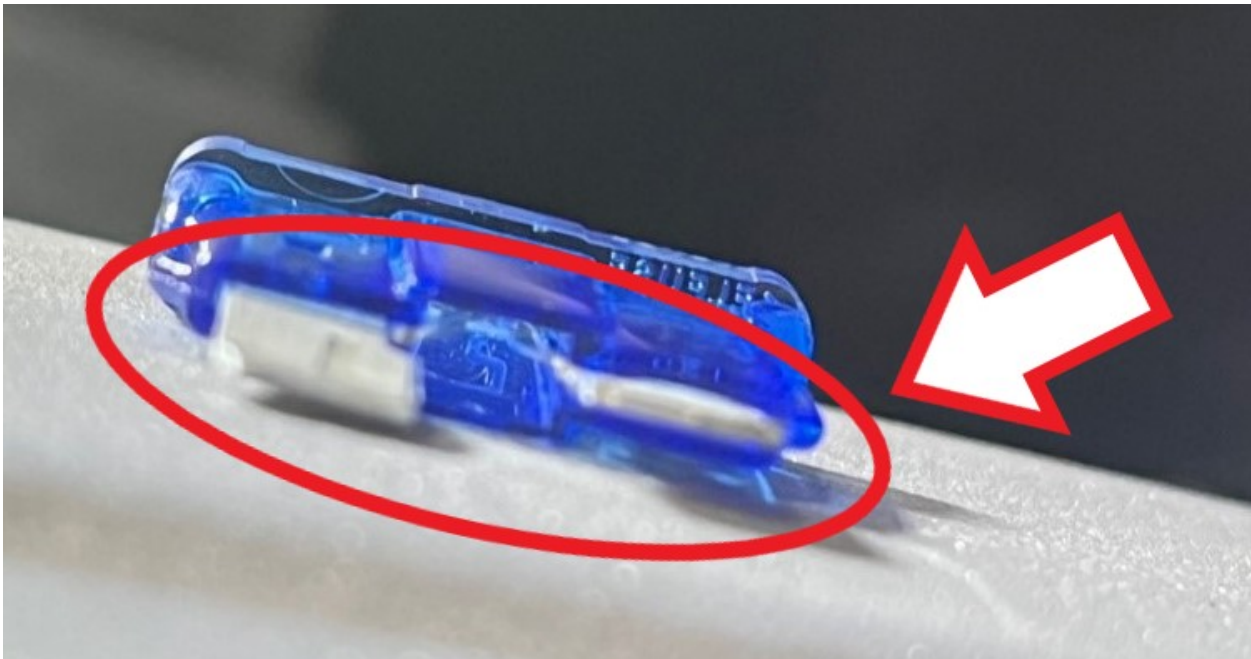
Hint: The fuse blades shown in Figure 1 are damaged / bent, in this scenario the fuse must be renewed, ensure both blades are aligned to both terminals before fitting the fuse

Hint: In this scenario the terminals must be repaired / replaced (depending on damage) once repaired / replaced the fuse must be renewed, ensure both fuse blades are aligned to both terminals before fitting the fuse
